# **Burke Creek Restoration Potential and Design Concepts**

**For Portions Both Inside and Outside the Sierra Colina Parcel  
and for  
Consideration in the TRPA Burke Creek EIP #161 Study**

## **Final Memorandum**

Prepared by:  
**Northwest Hydraulic Consultants, Inc.  
West Sacramento, CA**

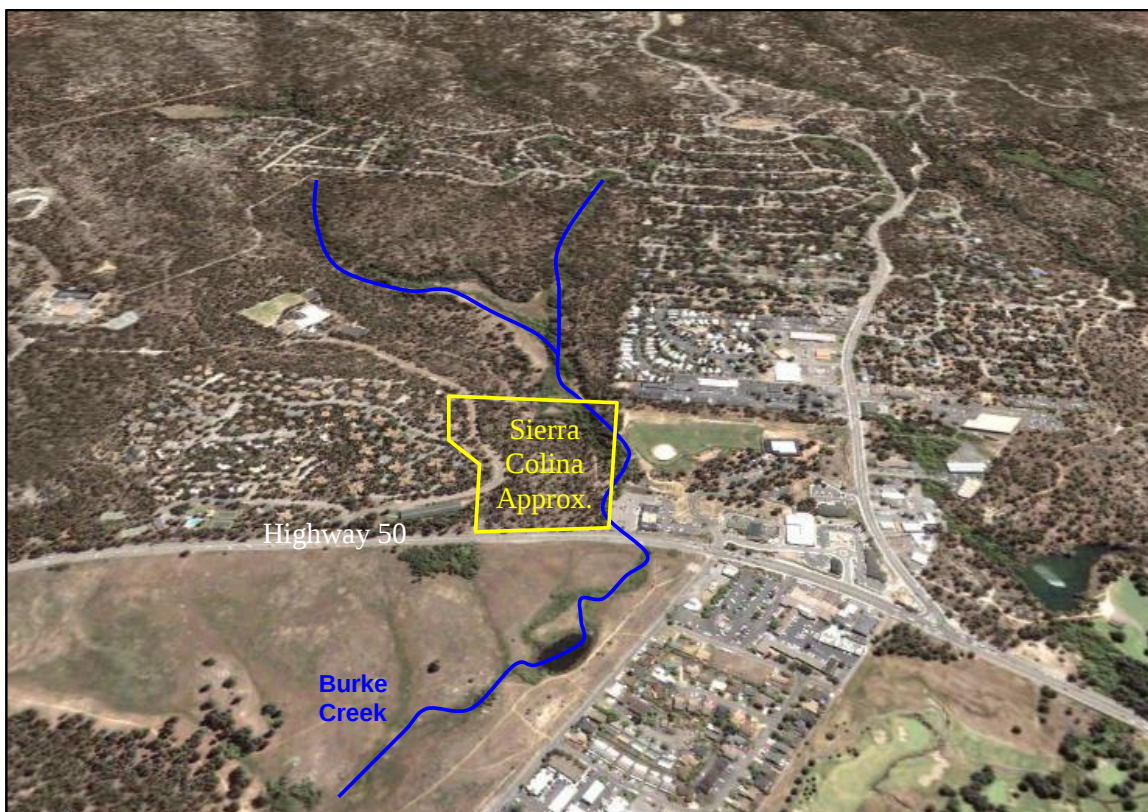
At two locations, Burke Creek crosses the Sierra Colina parcel (APN #1318-23-301-001) in Stateline Nevada, as shown in Figure 1. The portion of the channel nearest Highway 50 on the Sierra Colina property was realigned by adjacent commercial and public property owners, primarily in the 1970s and 1980s, to the north of its historical location and onto the Sierra Colina parcel. This work resulted in a constructed channel that runs near the southern boundary of the parcel. Restoration of the Burke Creek channel, including this realigned portion, has been the subject of several previous studies, and is the focus of an ongoing project by the Tahoe Regional Planning Agency (TRPA) as Environmental Improvement Project (EIP) #161.

Figure 1. Approximate Alignment of Burke Creek Looking Upstream

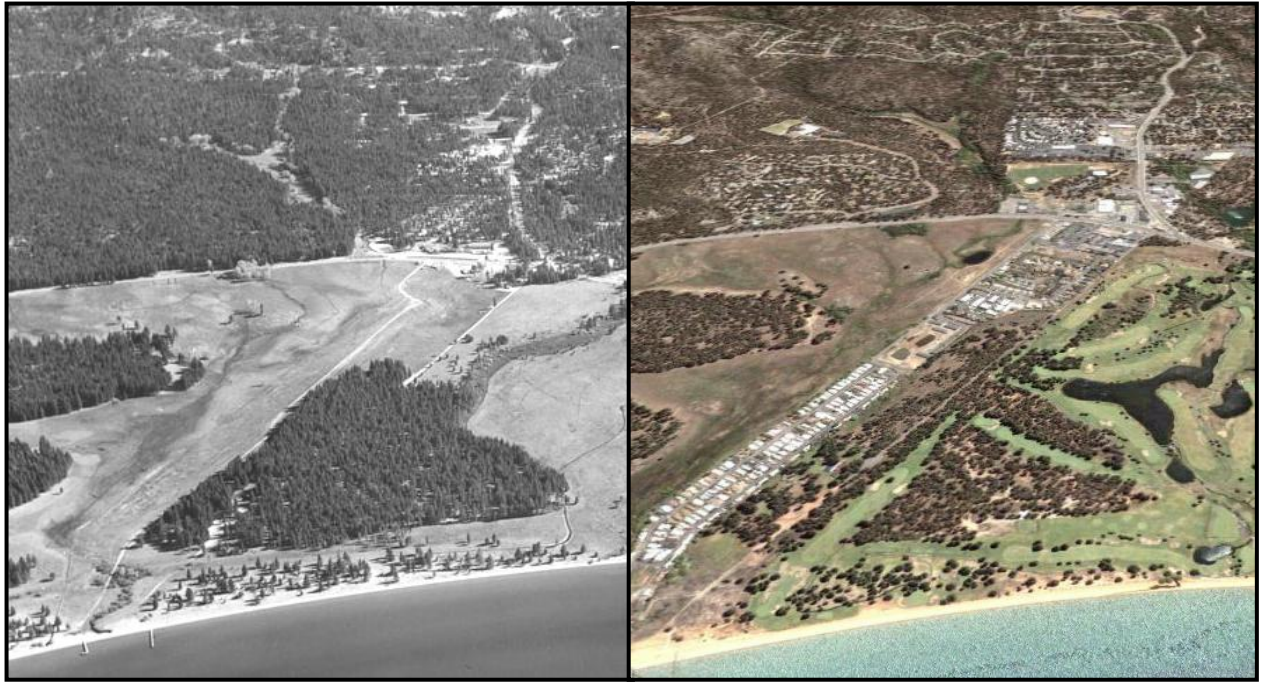
Figure 2 shows a comparison of the historical (1950s) and existing conditions for Burke Creek, indicating extensive channel relocation and modification of the SEZ. The reach downstream of the highway has been the subject of an extensive restoration effort by the USFS following construction activities for the Jennings Casino near Highway 50. The highway culvert crossing and a portion of the channel located along the parking lot upstream of Highway 50 (including a portion of the channel on the Sierra Colina property) were modified and relocated some time in the 1970's. The channel in this area was relocated to the north, and the original SEZ excavated for construction of a commercial parking lot adjacent to the Sierra Colina southern property line. Just upstream of the parking lot, the SEZ was later altered and affected by fill for construction of the Douglas County Kahle Park Community Recreation Center and ballfields. A slope failure in this fill material occurred during the January 1997 flood event, and filled the channel with sediment. The section of the Burke Creek channel between Highway 50 and Kahle Park is among the most highly affected by past disturbances. Upstream of the Kahle Park, historical modification is less obvious, but includes a berm in the SEZ near the upstream end of the Sierra Colina property, with probable straightening or confinement of the channel upstream.

Figure 2. Comparison of Historical and Existing Conditions

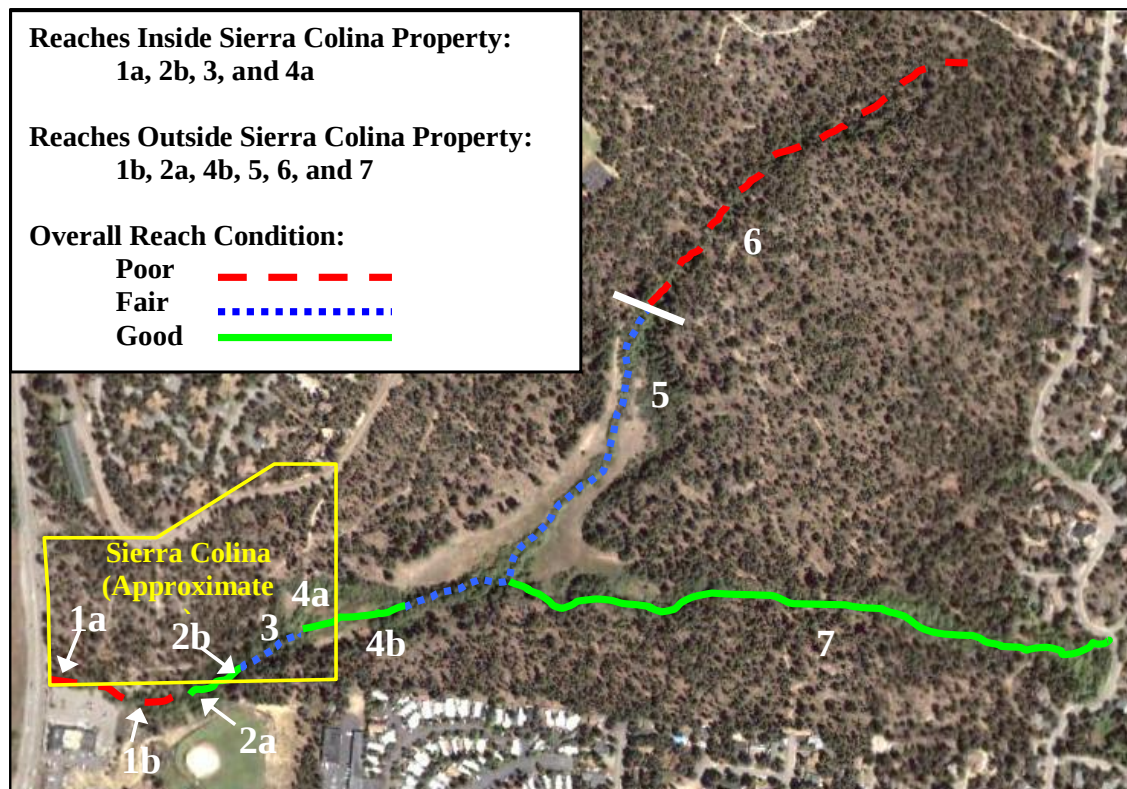
To assist in describing observed conditions, seven reaches were delineated based on stream morphology and other conditions relating to the objectives described above (Figure 3). Conditions in each reach are summarized in Table 2, and briefly described below. Initial field observations by reach are presented here; recommended restoration concepts are presented in Section 4. The reach designations are based on geomorphic characteristics. Land ownership within each reach is noted on Figure 3 and in parentheses in the text header for each reach. Each text header contains the approximate length of the delineated reach in Figure 3 by land owner.

Figure 3. Reach Map
