Figure 1. Map showing watershed boundaries for Third and Incline Creeks.

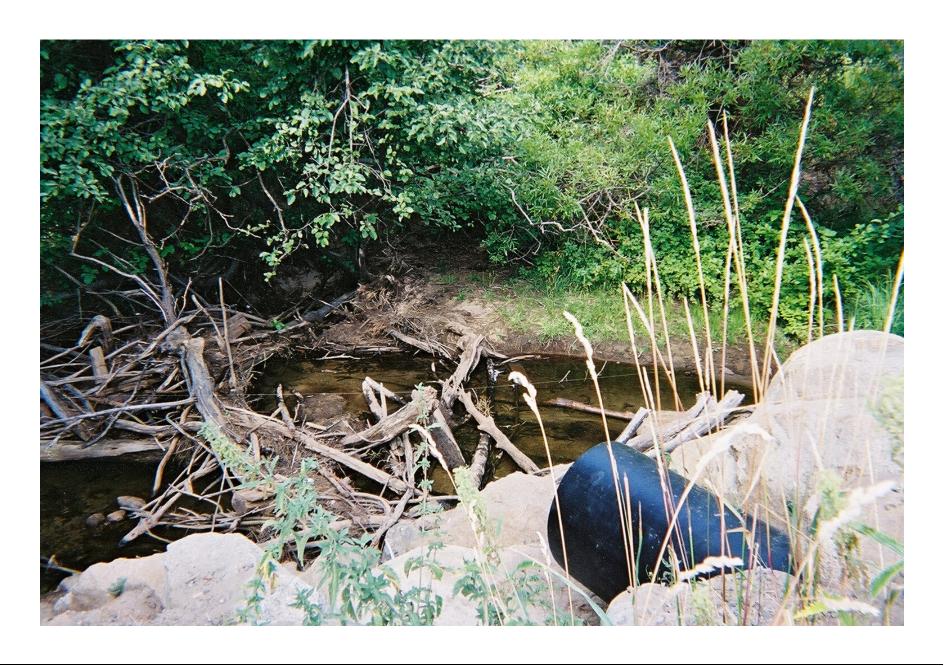
Figure 5-2. Photograph of sand impounded behind a woody debris jam on Third Creek. This site is located about 600 ft downstream of Incline Way near station 18+50.

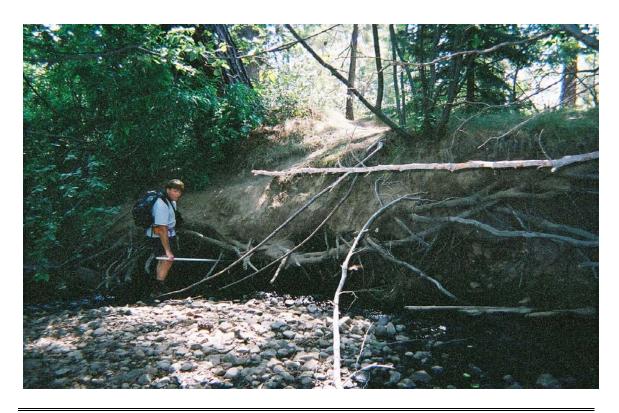
Figure 5-3. Bank undercutting to a depth of 5ft on Third Creek (station 12+00).

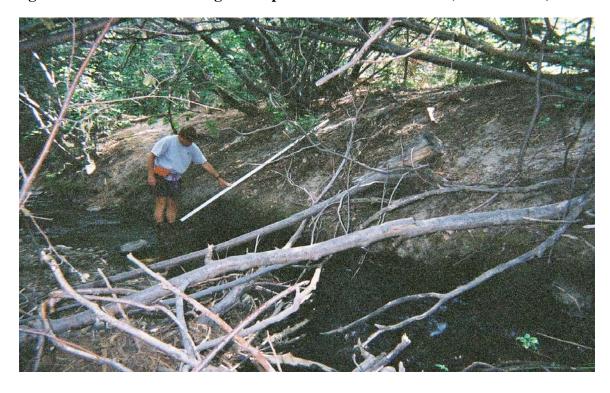
Figure 5-4. Bank collapse as an integral unit on Third Creek (station 17+74). The Survey rod indicates the new bank angle of repose.

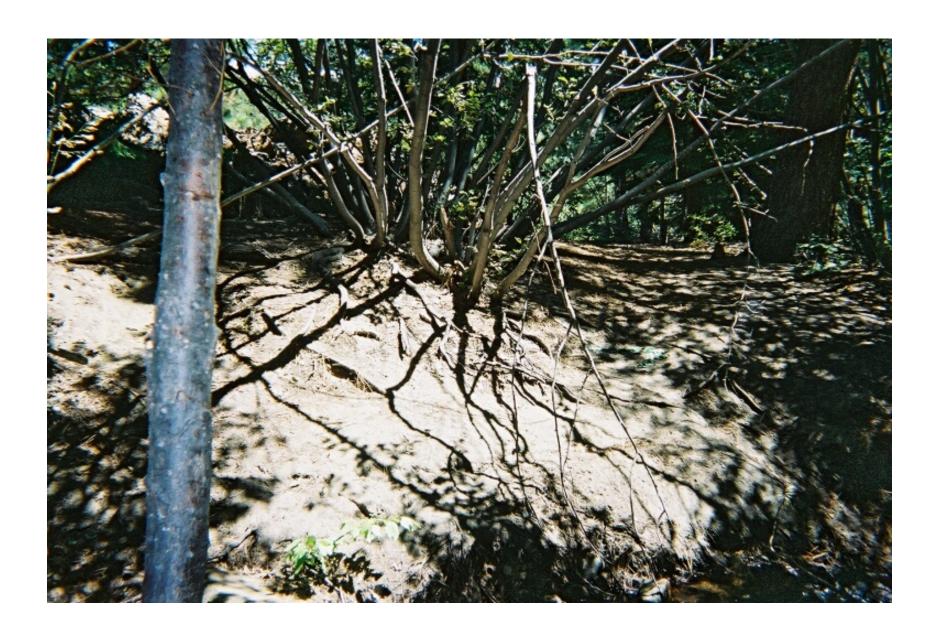
Figure 5-5. Example of streambank erosion caused by foot-traffic along Third Creek (near station 22+00).

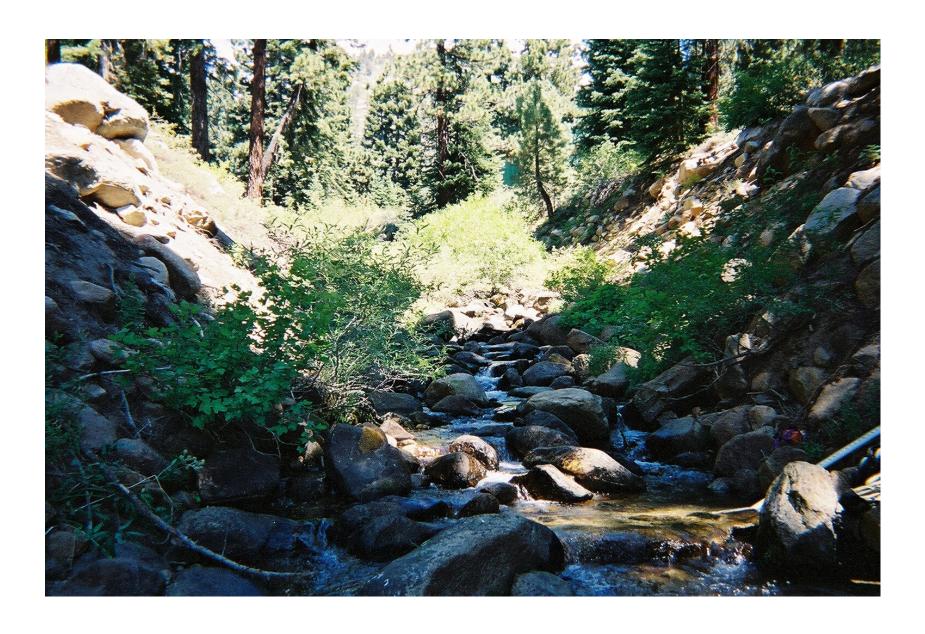
$Figure 5-7. \ Entrenched, confined channel with cascade bedform, Third Creek upstream of SR-431 (station 157+00).$

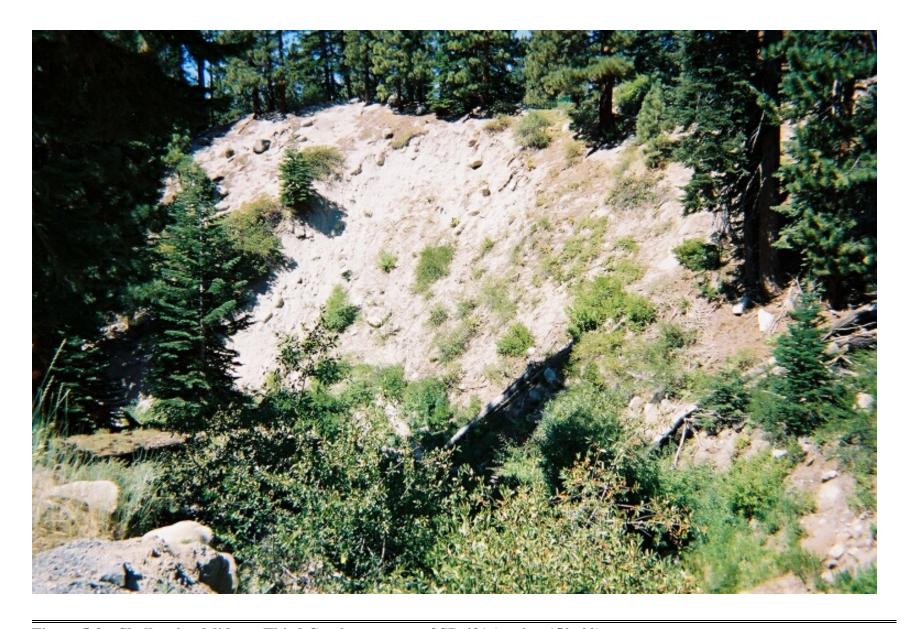
Figure 5-8. Shallow landslide on Third Creek upstream of SR 431 (station 150+00).

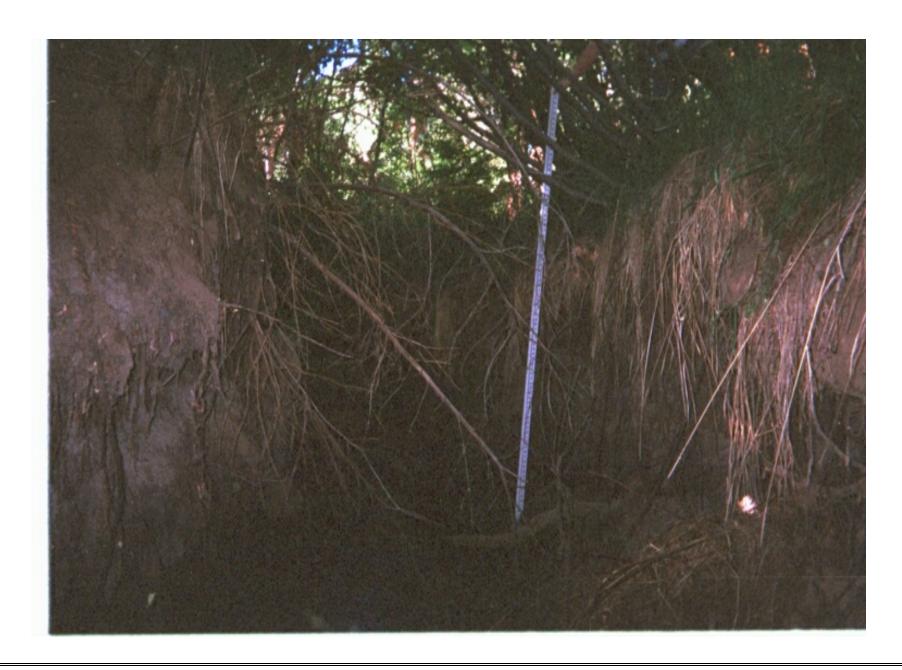
Figure 5-10. Channel incision and bank erosion on Rosewood Creek. The bank height is over 7 ft about station 52+40.

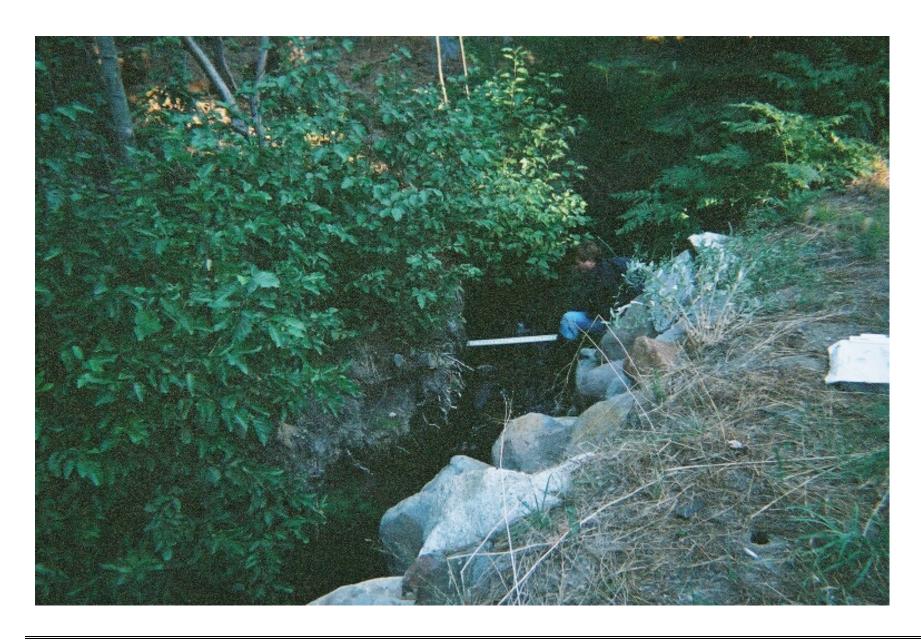
Figure 5-12. Undercut bank (approximately 1.5 ft) on Rosewood Creek along Village Blvd. Rip-Rap placement on left bank is likely accelerating erosion.

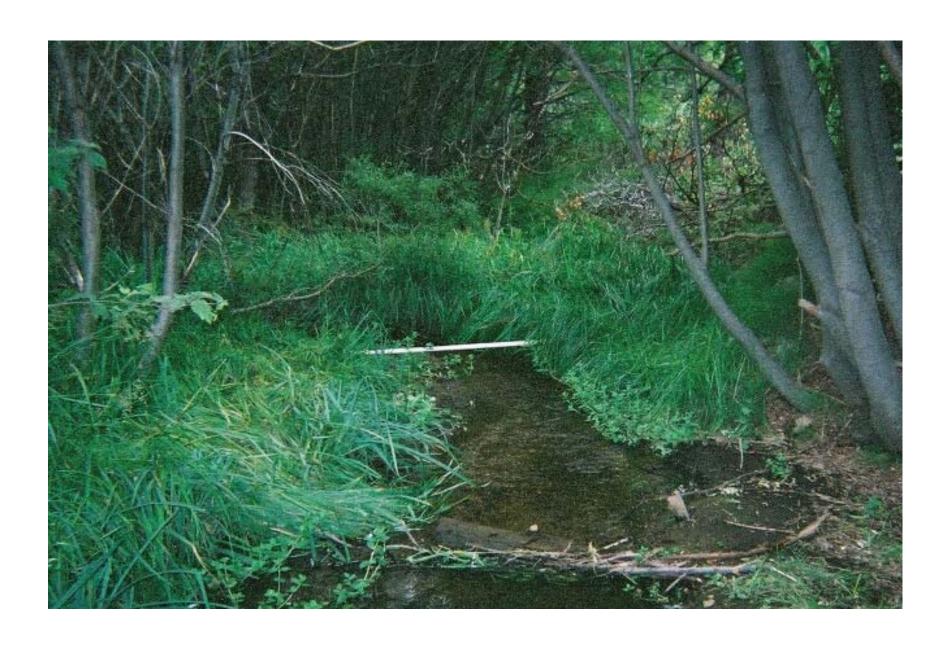
Figure 5-13. Rosewood Creek immediately upstream from Northwood Blvd. Channel is approximately 5 ft wide and 1.5 ft deep.

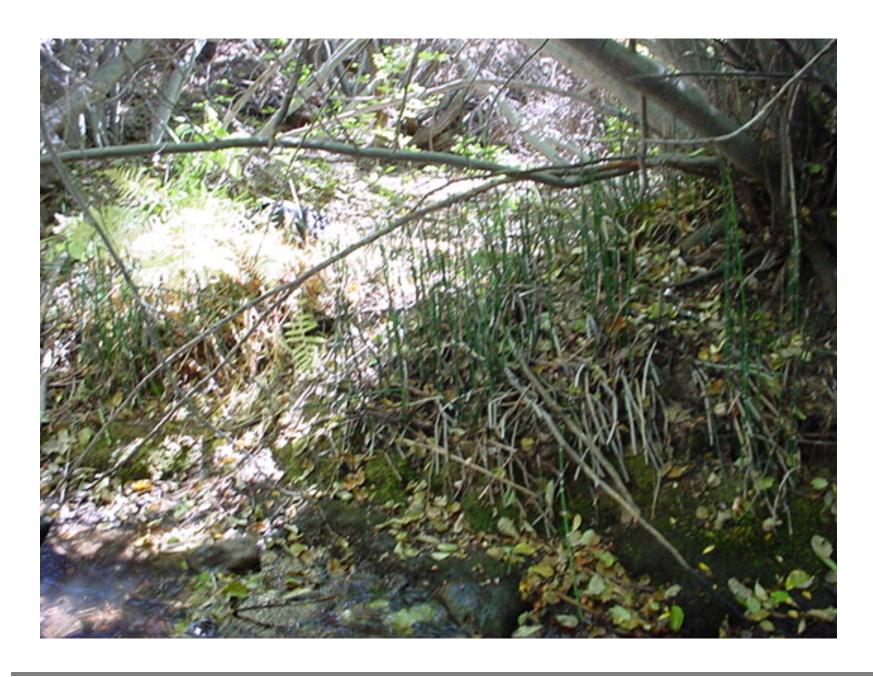
Figure 5-14. Incline Creek remnant meander channel (near station 30+00).
