MIDDLE ROSEWOOD CREEK GEOMORPHIC AND RIPARIAN ASSESSMENT

Geomorphic and Riparian Vegetation Assessment

FINAL

November 30, 2005

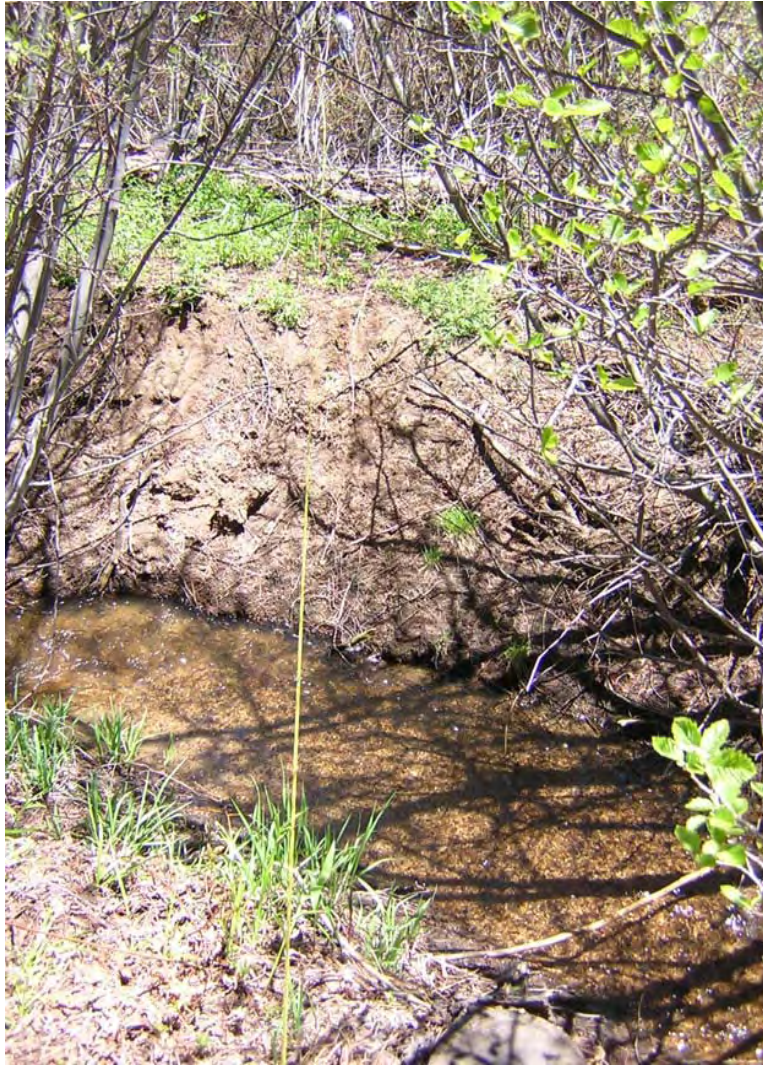
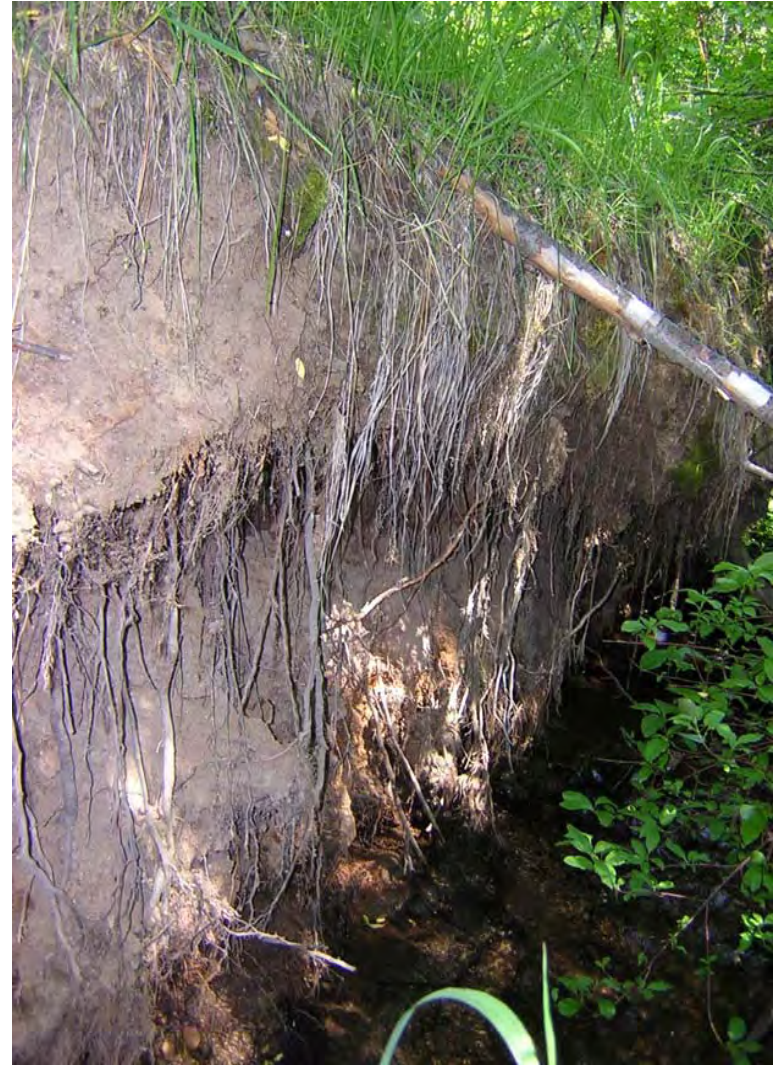
Reach 2 consists of a channel in the advanced stages of channel incision, with an inner floodplain and a meandering channel. This reach is the most advanced of any of the incised stream segments within the study reach, having the widest top width and the most developed inner floodplain. The channel and entrenched valley condition suggest that this reach is near the end of the incised channel evolution continuum. It serves as an example of the state that other incising reaches of Rosewood Creek might reach as the incision process matures. The channel grade is stable and is controlled in places by collections of small woody material. The streambed consists of small gravel. The former floodplain is densely vegetated, with a former channel on the east side that seeps year-round (per Reach 1). The landowner of this reach, 41 years old, recalls that during the 1970s and 1980s, a grass meadow existed in the current channel location through much of this reach (Tony Robinson, landowner, personal communication).

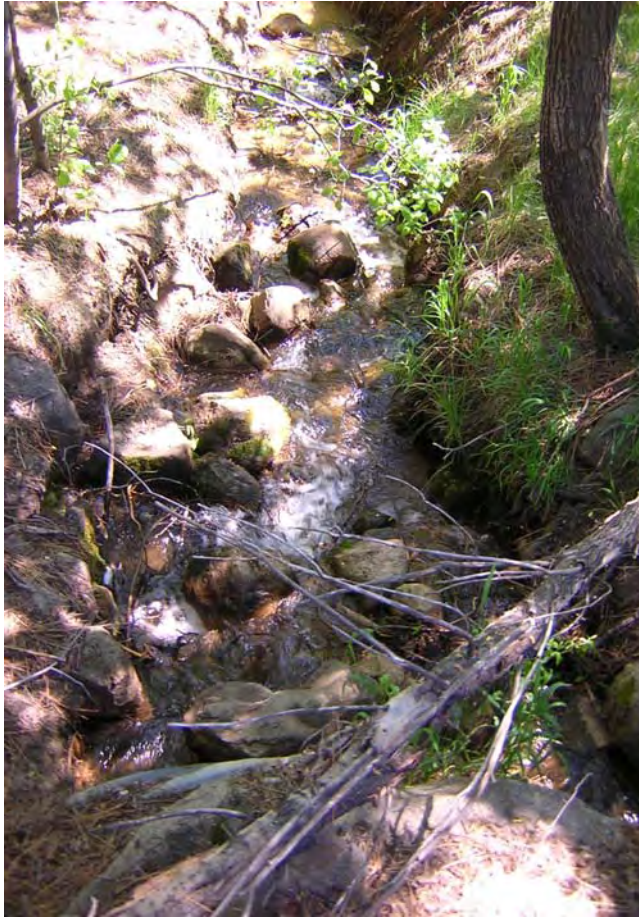
Reach 6 exhibits channel and floodplain aggradation, the only segment within the study with such conditions. The channel slope through this reach was likely reduced by the placement of the Northwood Blvd. culvert. Subsequent aggradation has resulted in a wide, saturated floodplain supporting moisture-tolerant vegetation. The presence of dead and dying upland vegetation suggests that the floodplain aggradation is recent (within a few decades) and likely ongoing. The construction of Northwood Blvd. appears to be the primary driver that caused the aggraded conditions. It appears that construction of Northwood Blvd. included the following activities: relocation of the channel to the east (evidenced by the channel not located in the topographic low area downstream of Northwood Blvd.); fill placed north of Northwood Blvd.; and culverts installed at a relatively flat slope.

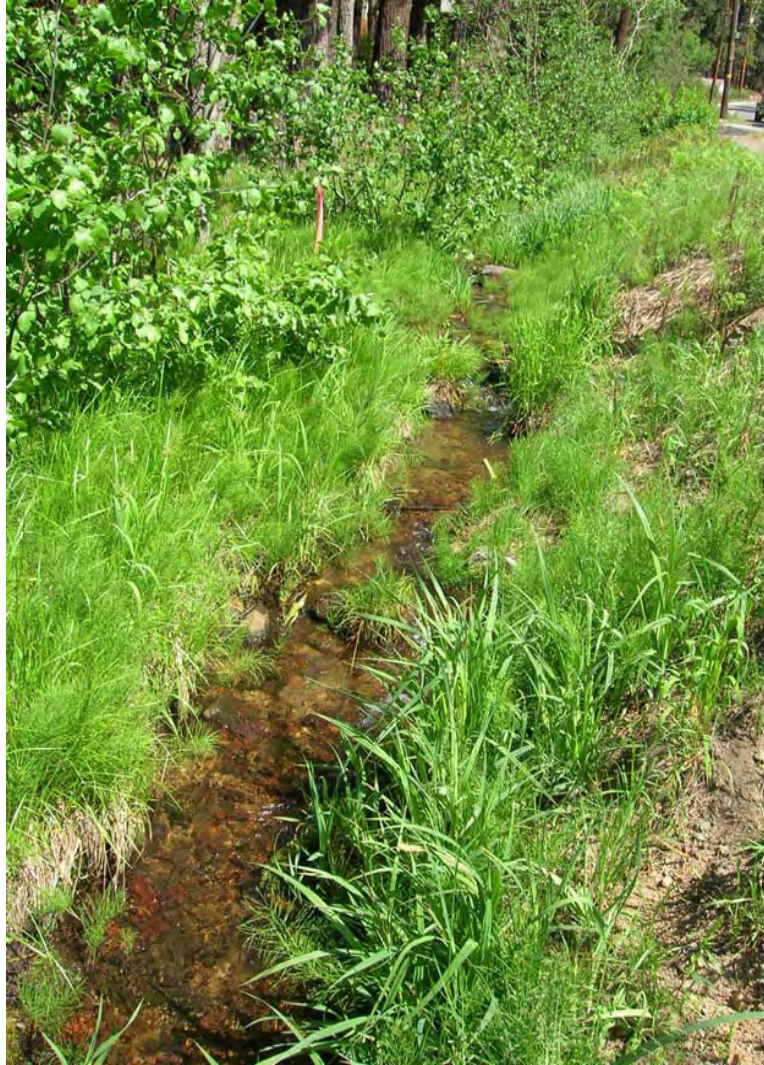
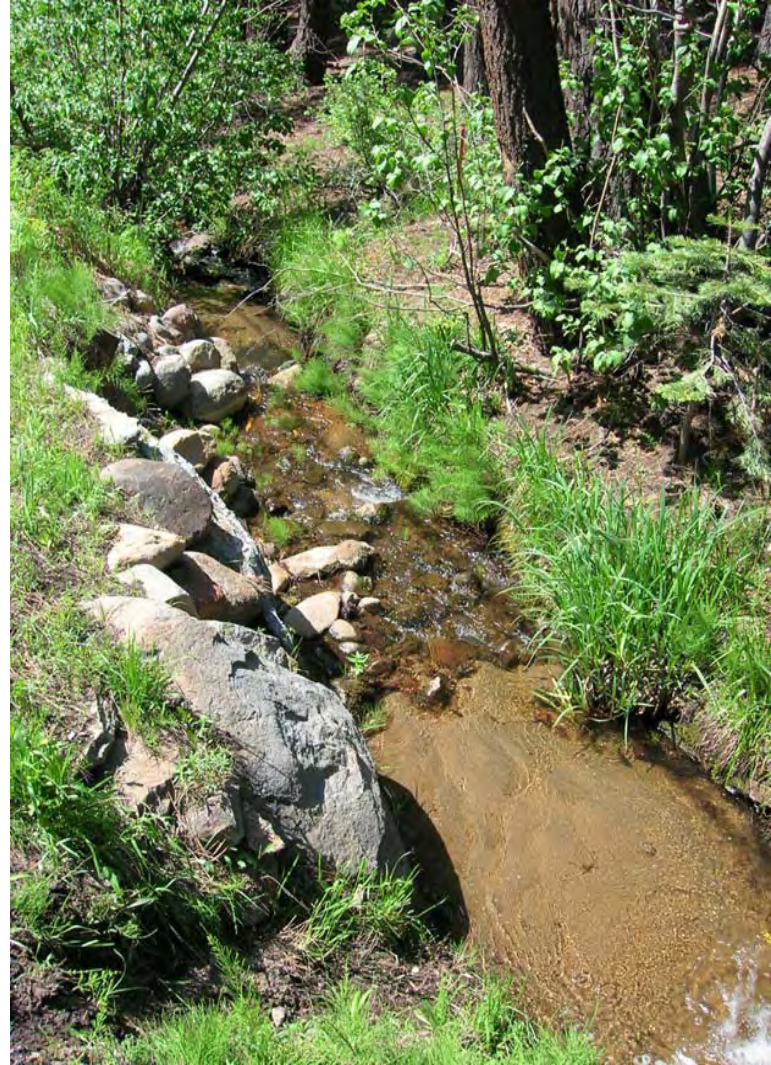
Reach 11 is a segment of Rosewood Creek that has been relocated from a former location to the west (between the current location and Village Blvd.) It appears that the stream was relocated in order to move it an adequate distance from Village Blvd. For much of this reach, the conditions include: no riparian vegetation other than upland trees; pronounced, unvegetated berms on both sides of the channel; and incision up to 5 feet in depth; and bank failure caused by undercutting.

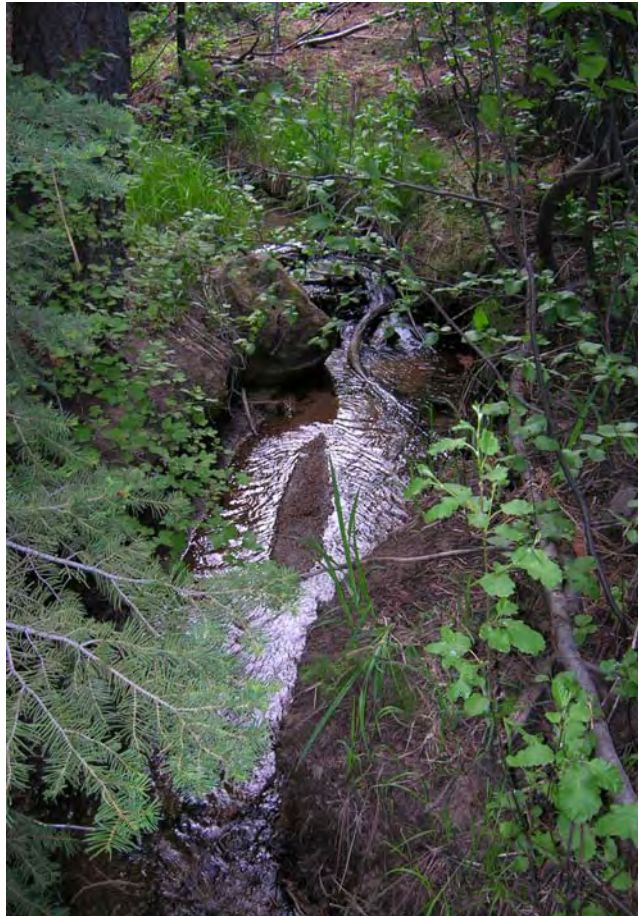
Reach 12 is a confined segment of stream with the Village Blvd. and associated bike path immediately to the east (forming a vertical left bank) and individual private parcels to the west. The channel was clearly moved to this position in order to accommodate the location of Village Blvd. The bed consists of gravel. Vegetation is sporadic. The channel is stable, although there are locations where it has degraded and banks are undercut. Riprap has been placed in a few locations. Upstream of this reach Rosewood Creek flows through 100 feet of culvert along Village Blvd.

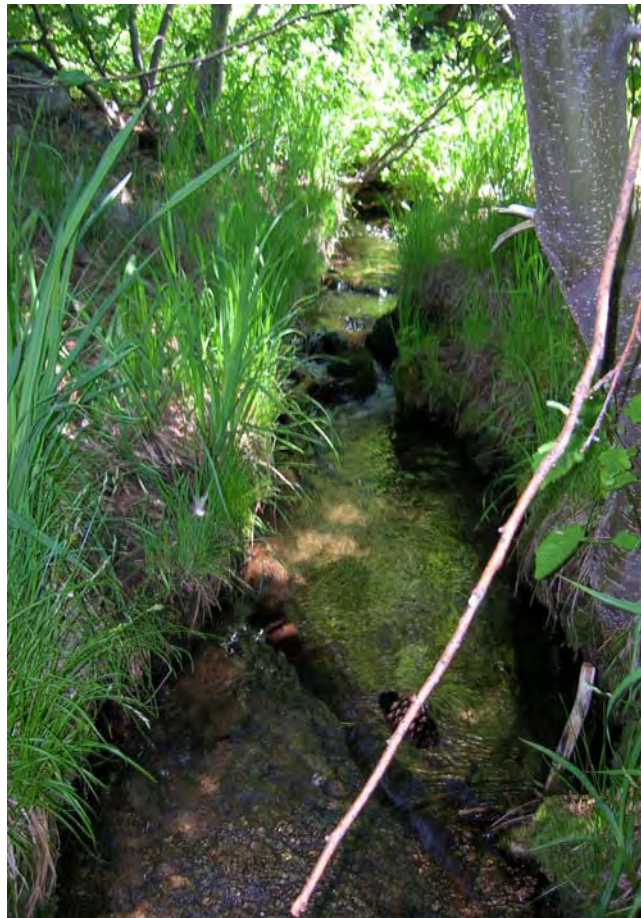
Reach 16 has been highly modified. The culverts at Titlist Drive were placed substantially below grade, requiring an abrupt drop in the channel elevation. The channel was relocated to the east and lined with riprap along the entire length. The likely former channel location is to the west; portions have been obscured by the construction of residences, but some former channel segments are clearly visible. Most of the reach exhibits primary and secondary stages of incision. In one location, the riprap failed as the channel widened, resulting in vertical eroding banks. At the upper end of the reach, the channel has been confined by berms in an attempt to protect an adjacent residence. The former channel orientation and elevation put this structure at risk of flooding.
