Final Report

Rosewood Creek Restoration, Area A

March 2017

Prepared by
Nevada Tahoe Conservation District
400 Dorla Court
Zephyr Cove, NV 89448

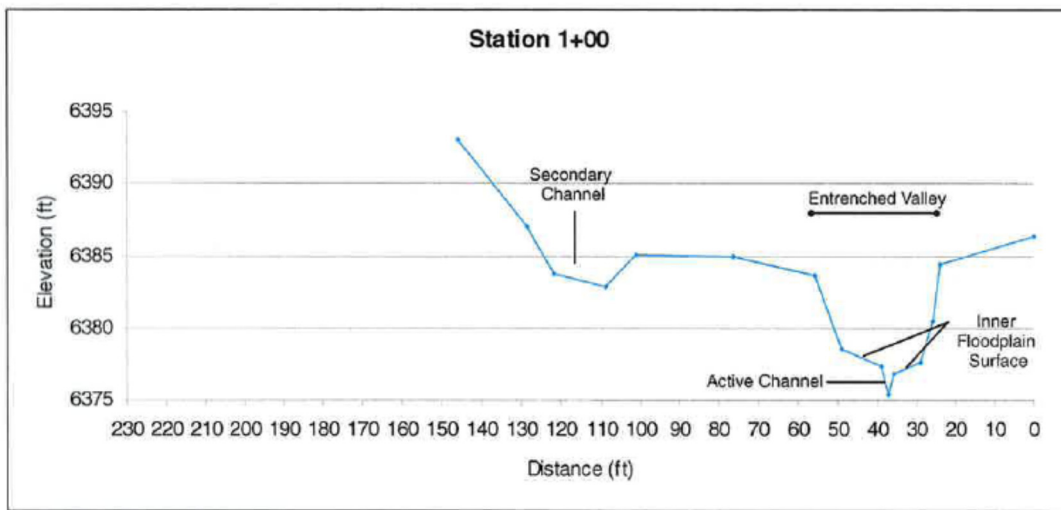
Figure 3. Cross-section of Rosewood Creek at Station 1+00 representing the condition of Area A for 400 feet upstream on State Route 28.

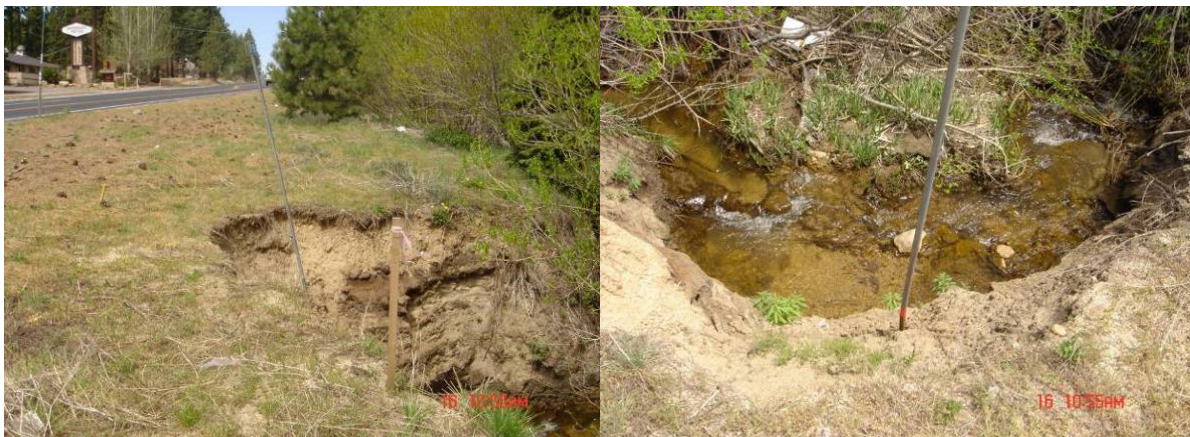
Figure 4. Photos of the large headcut near the crossing at State Route 28.

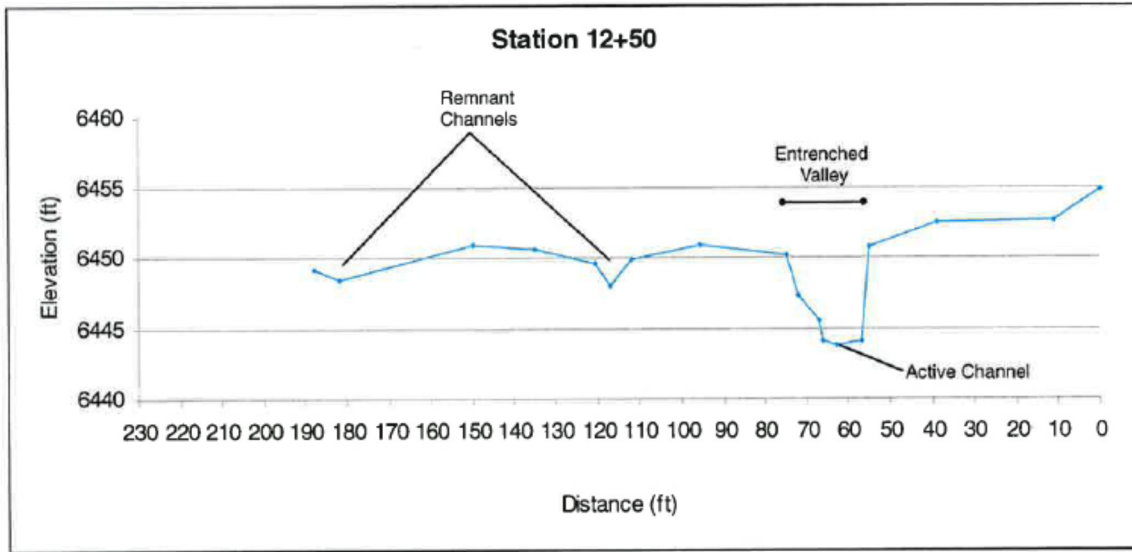
Figure 5. Cross-section of Rosewood Creek at Station 12+50 representing the condition of Area A 400-600 feet upstream of State Route 28.

The dramatic headcut described above was migrating upstream. The next upstream 200 feet of the Rosewood Creek channel was nearly 6 feet deep with vertical or undercut banks (Figure 5). The potential for additional incision and bank failure was high. If the headcut was allowed to migrate, it would affect a relatively stable upstream section of creek. The section of creek 600 feet to 880 feet above State Route 28 represented a potential model for restoration of the entire Area A of Rosewood Creek. However, the next 900 feet upstream to just downstream of Northwood Blvd "exhibits extreme, severe incision, generally reflecting the initial stages of rapid downcutting with vertical banks" (NTCD, 2005) (Figure 6). This section of the creek also appeared to have been relocated out of its original channel, west to a channel higher on the floodplain. Immediately upstream of Northwood Blvd, the creek was relatively stable.

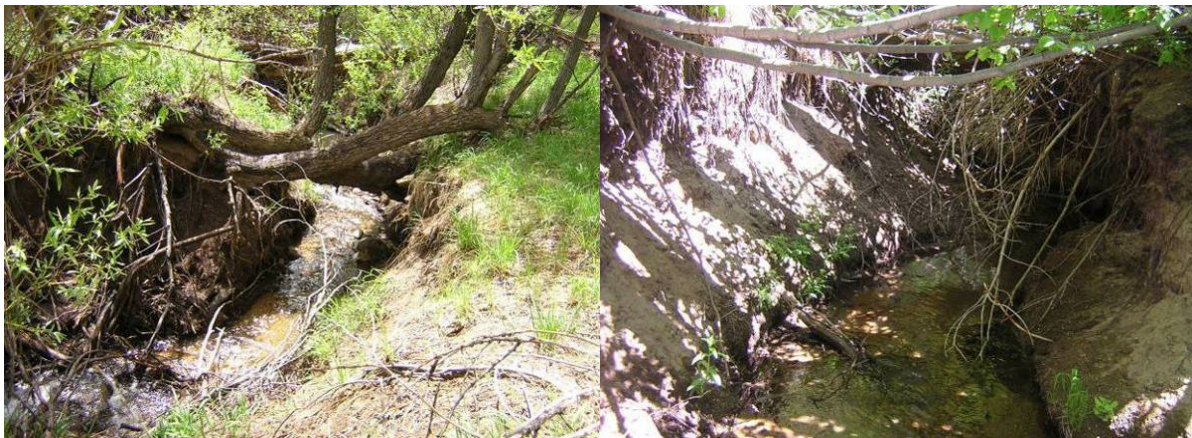
Figure 6. Photos of the large headcut near the crossing at Northwood Blvd.

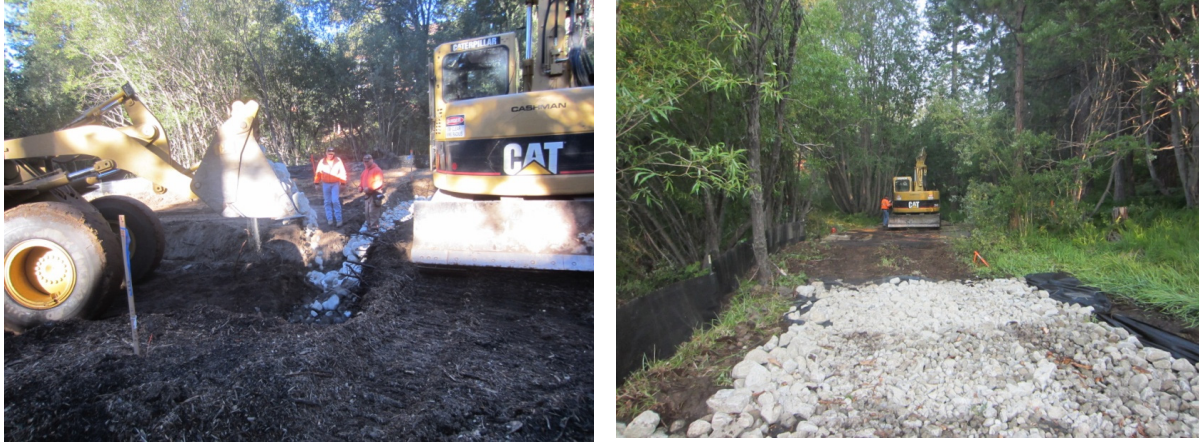
Figure 9. Left: At the beginning of Phase I, an access road was built into the project area and numerous willows and alders were removed. Right: The construction of valley and channel wide grade control structures involved placing subsurface rock.

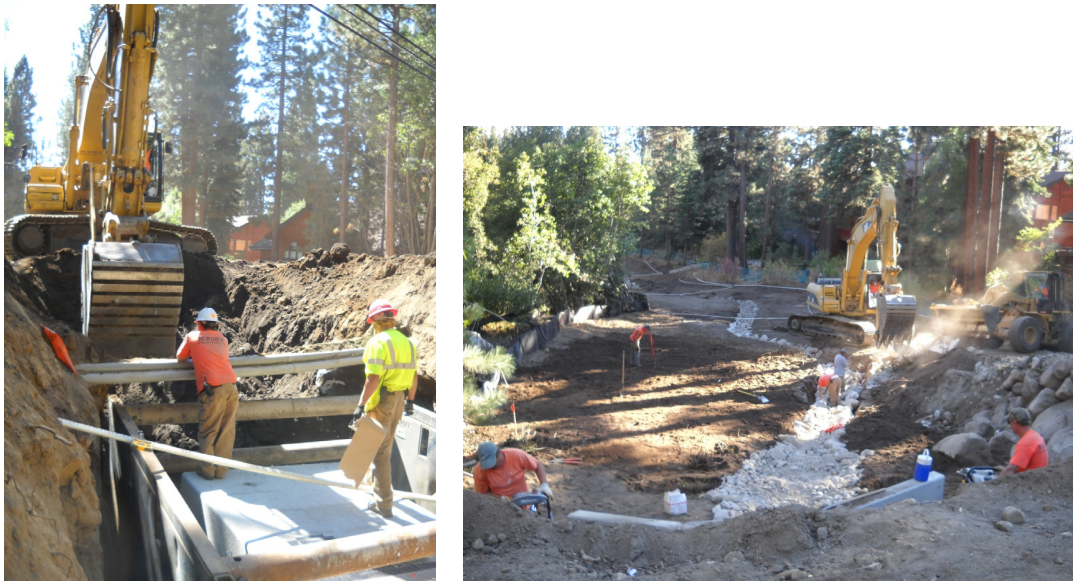
Figure 10. Left: Installation of the culvert presented difficulties as many existing utilities were present. Right: The construction of the channel immediately downstream of the newly installed culvert.

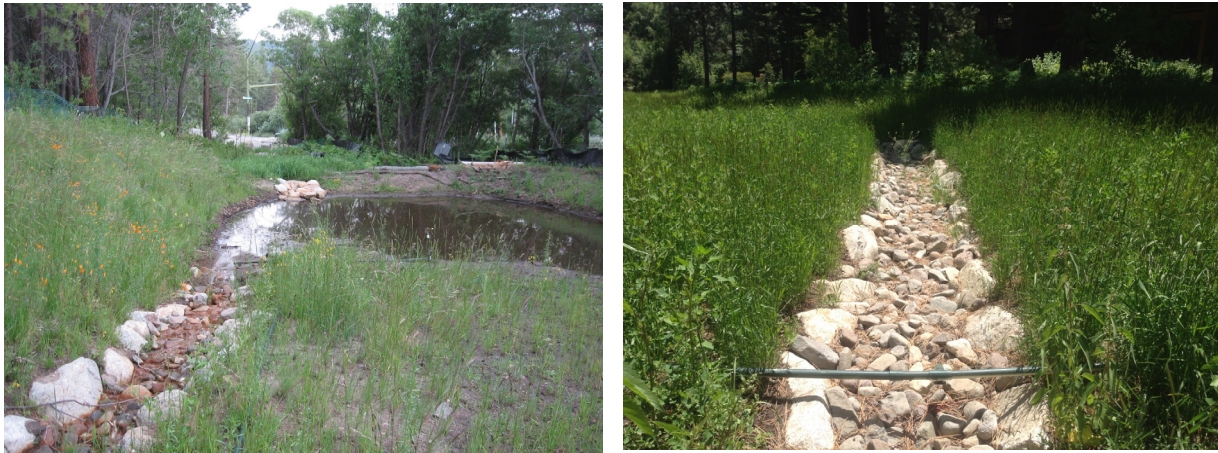
Figure 11. Left: Phase II, June 2013, vegetation showing remarkable success. Right: Phase II, July 2013, having an area at the bottom of the inactive channel for water to pond was essential for erosion prevention.

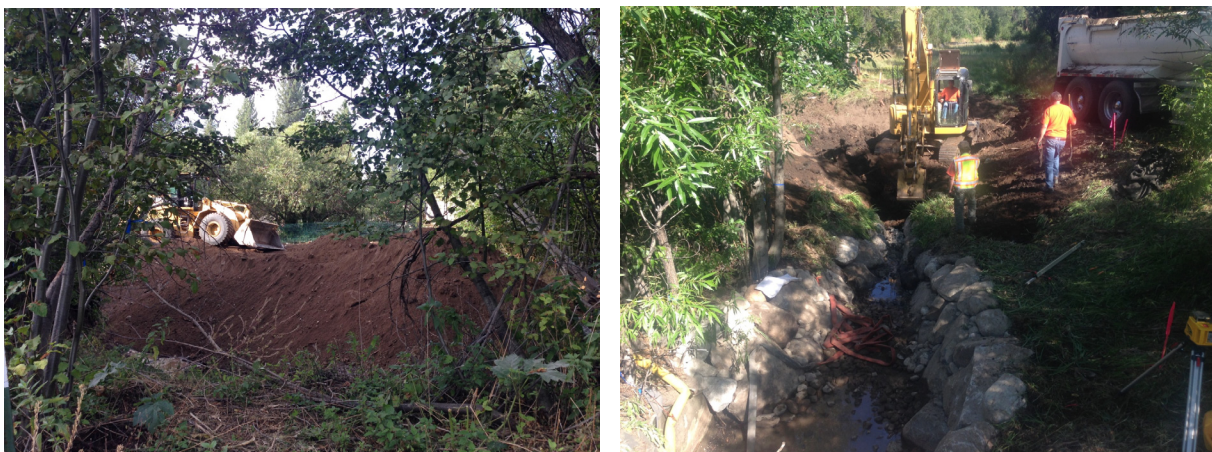
Figure 12. Left: Construction of the downstream tie-in occurred at the beginning of Phase III. Right: Filling the old channel commenced after the construction of the downstream tie-in.

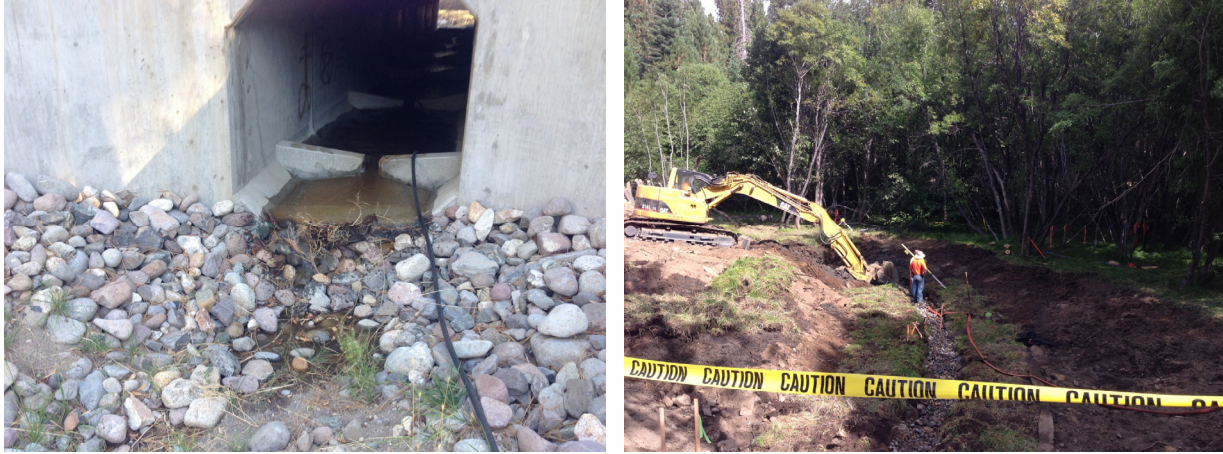
Figure 13. Left: Construction of the upstream tie-in. With the completion of this tie-in, the new Rosewood Creek channel could finally receive flow. Right: The new Rosewood Creek culvert receiving flow for the first time on September 11, 2014.

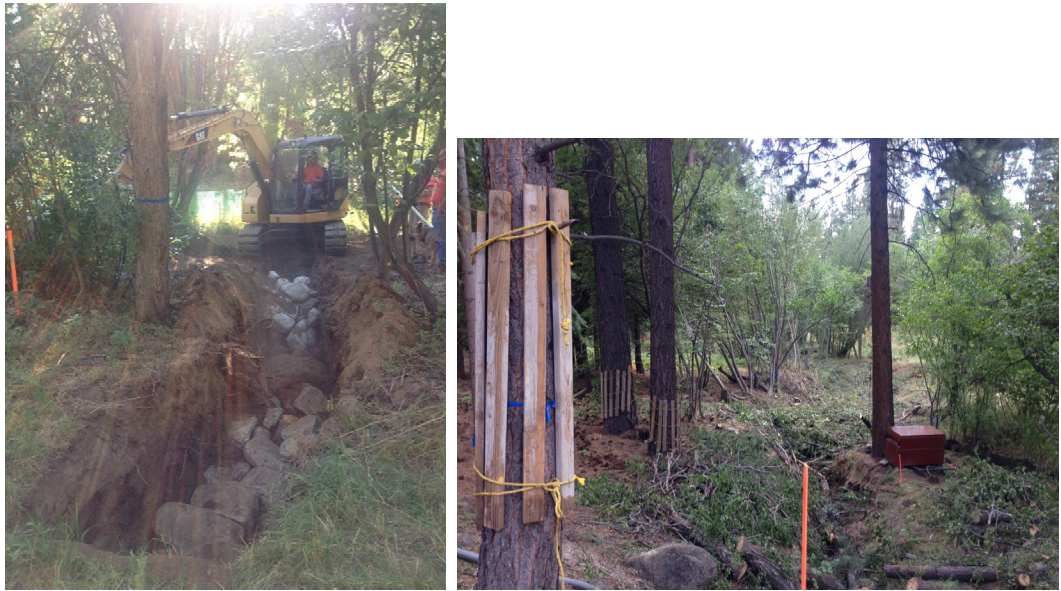
Figure 14. Left: With the water diverted from the old creek location to a pipe for the construction of Phase III, the monitoring station had to be moved upstream of Northwood. Right: The portion of the valley-wide grade controls that crossed the existing channel had to be constructed during Phase I and marked with a 2x4 so that the Phase III portions could be aligned.

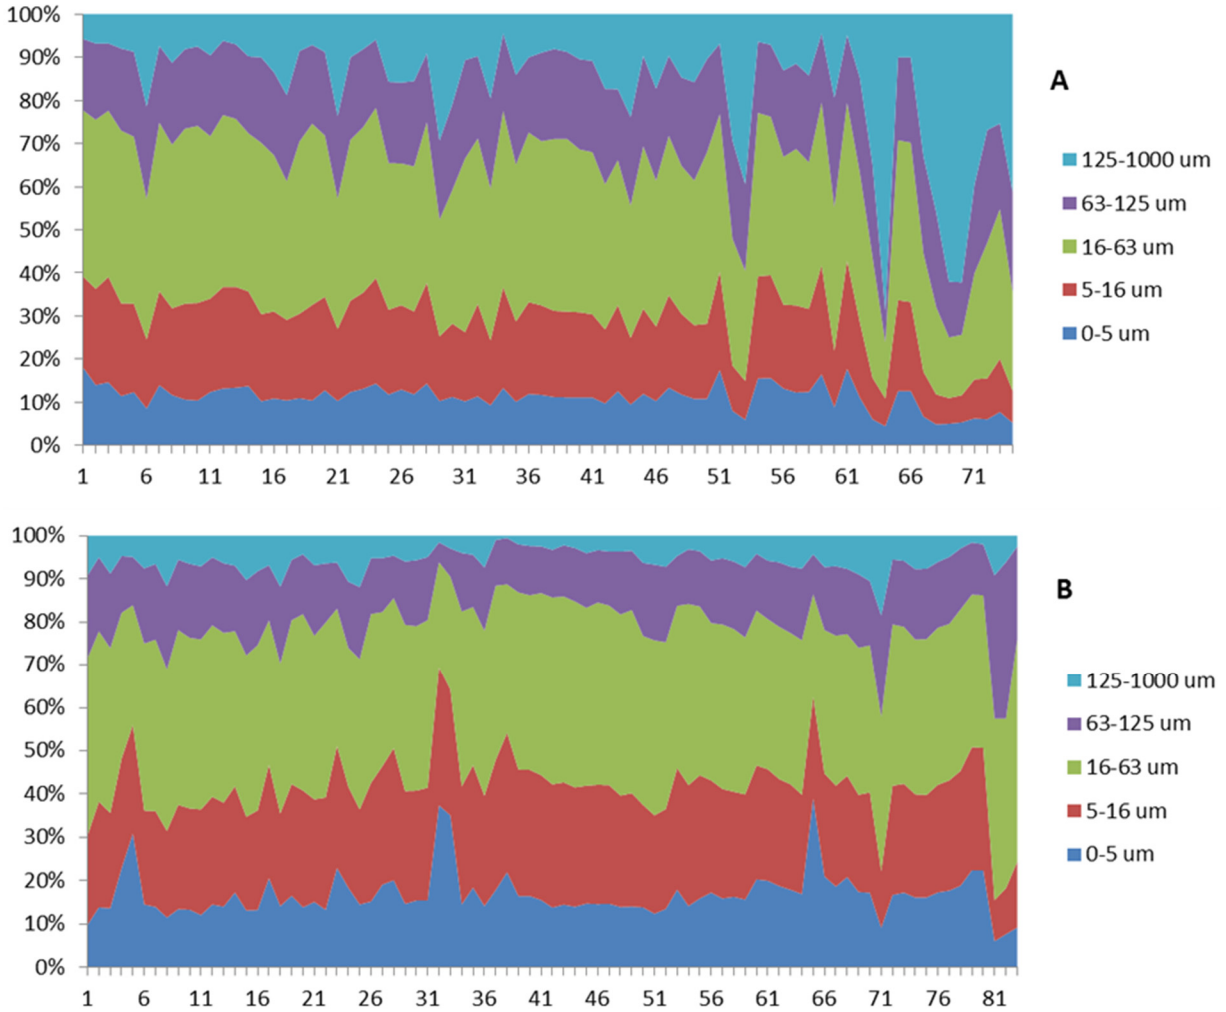
Figure 16. Particle size distribution of suspended sediment samples by site, RW-Abv is (A), RW-Blw is (B). The x-axis denotes the sample number collected at each site. Particle size fractionation is denoted by different colors for different size fractions. Pre-construction samples are #1-20 at RW-Abv (A) and #1-21 at RW-Blw (B).

Coarser sediments appeared to become depleted or deposited, as the mean particle diameter decreased in samples collected after March 16, 2014, despite discharge remaining elevated (Figure 16). If this coarse sediment source was from residual sediment left over from project construction or deposited by the large rain-on-snow, Event 53, it should not be observed in subsequent years. The largest water and sediment load events occurred on June 5-7, 2011 (Event 4) and September 26, 2012 (Event 17). The rain event of June 2011 was a long and intense storm over multiple days. The September 2012 event was a very short-lived and high intensity rain storm after a long period of warm, dry weather. This likely created the conditions under which RW-Abv saw discharge above 16 cfs and RW-Blw recorded TSS above 9000 mg/L.

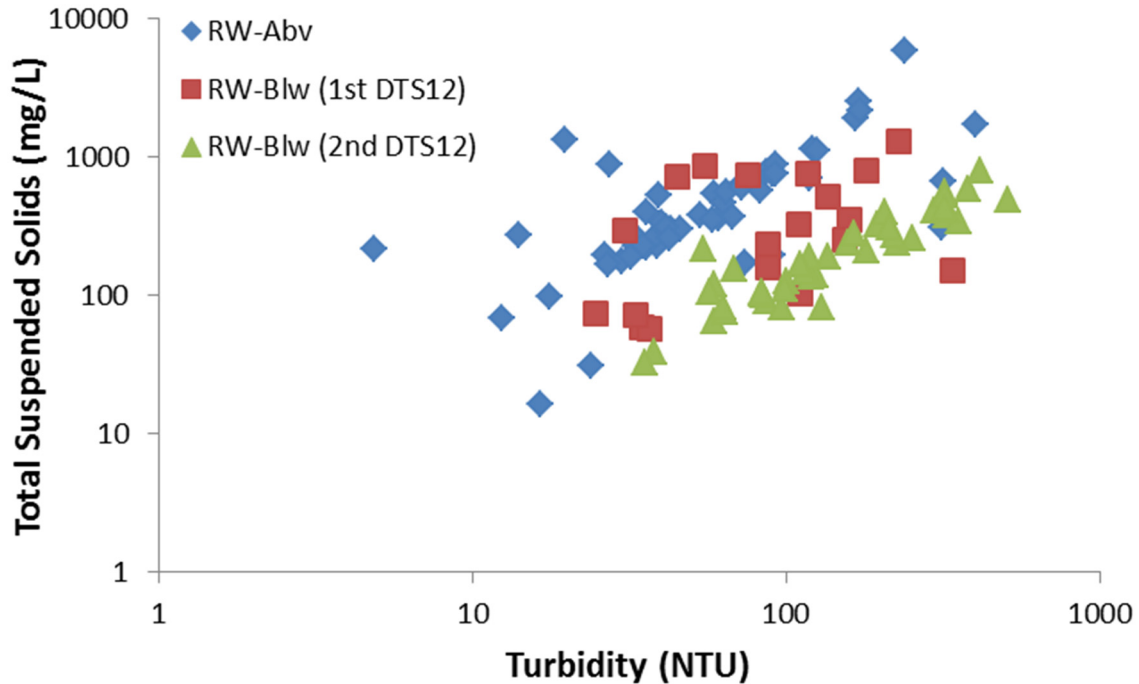
Figure 17. Comparison of TSS from discrete water samples and in-stream turbidity for RW-Abv (Northwood/Bridge) and RW-Blw (H28). The turbidimeter was replaced at RW-Blw in July of 2015.

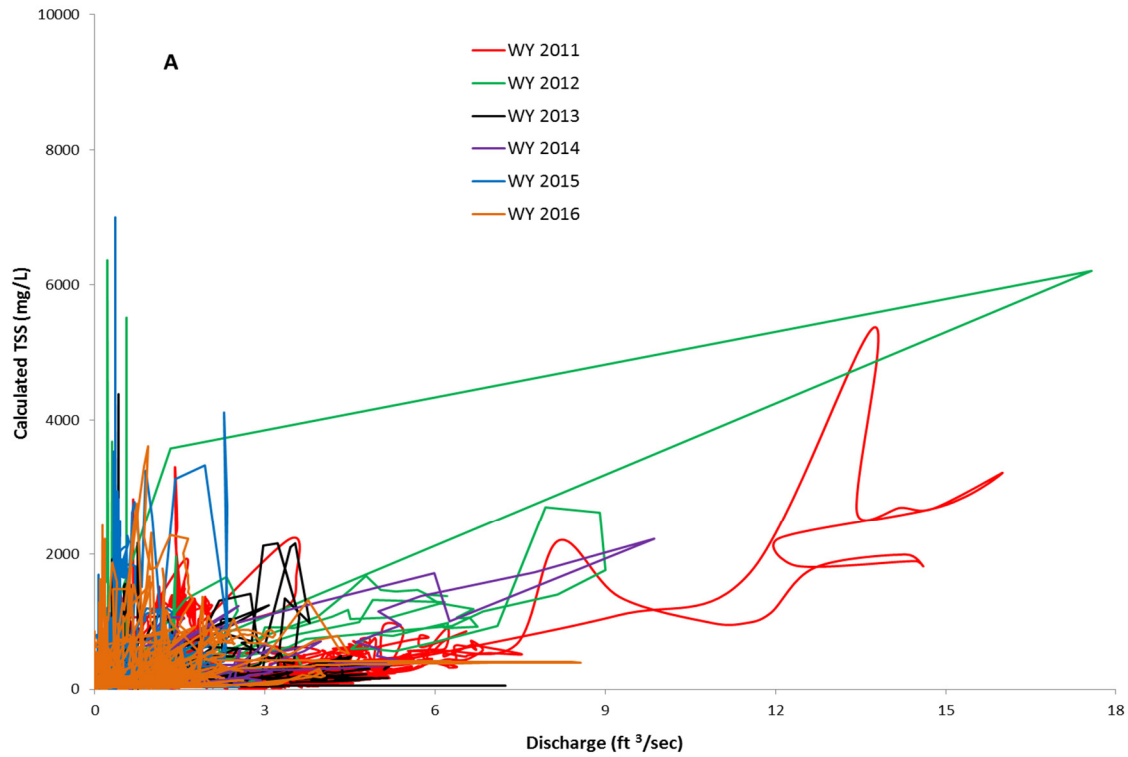
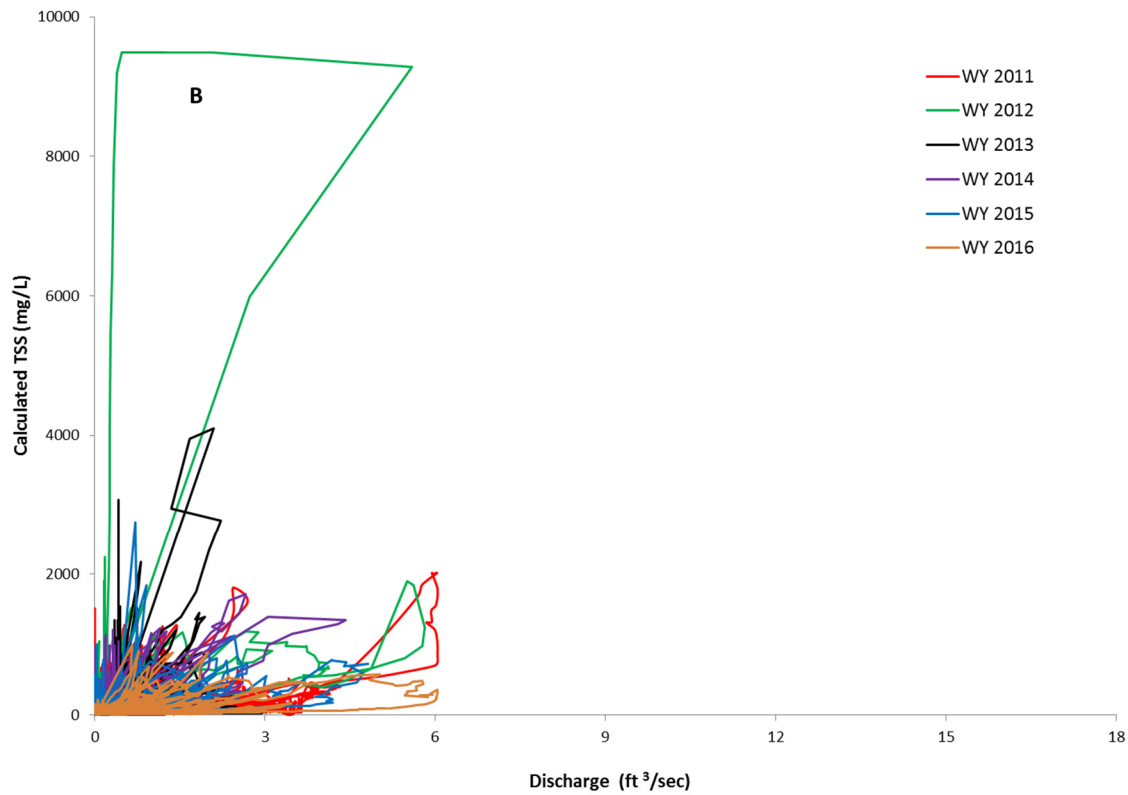
Figure 19. Hysteresis relationship at both Rosewood Creek sites between RW-Abv (A) and RW-Blw (B). The data in this graph uses lines rather than points in order to show changes through time.

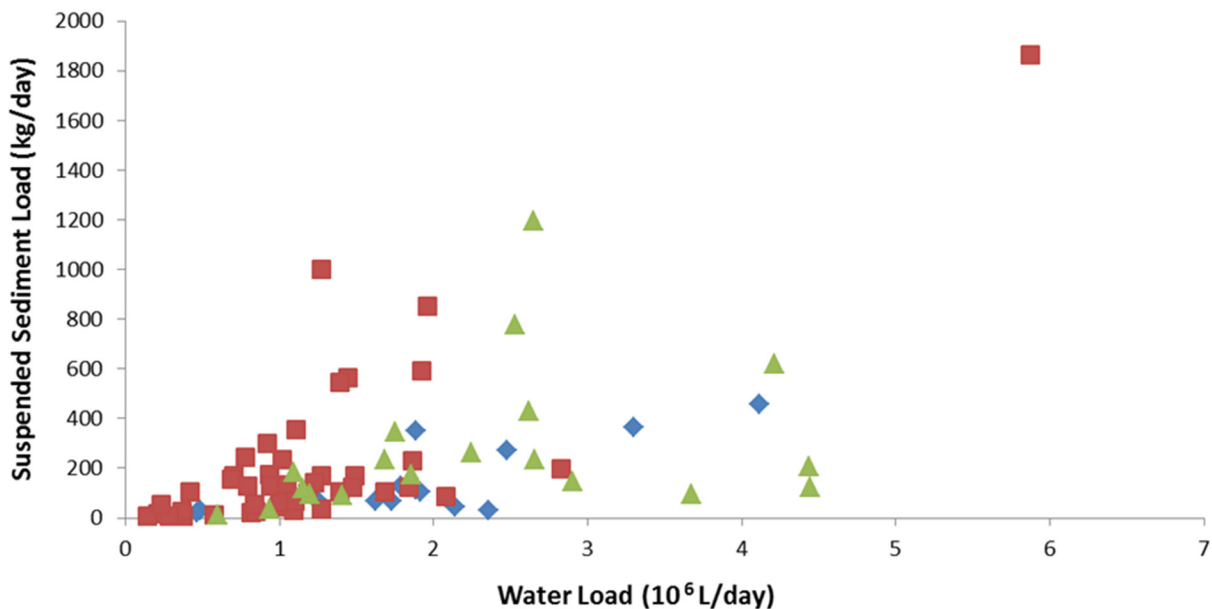
Figure 20. Water and suspended sediment loads from RW-Blw by event. Red squares are rain events, green triangles are rain-on-snow events, blue diamonds are snowmelt events.

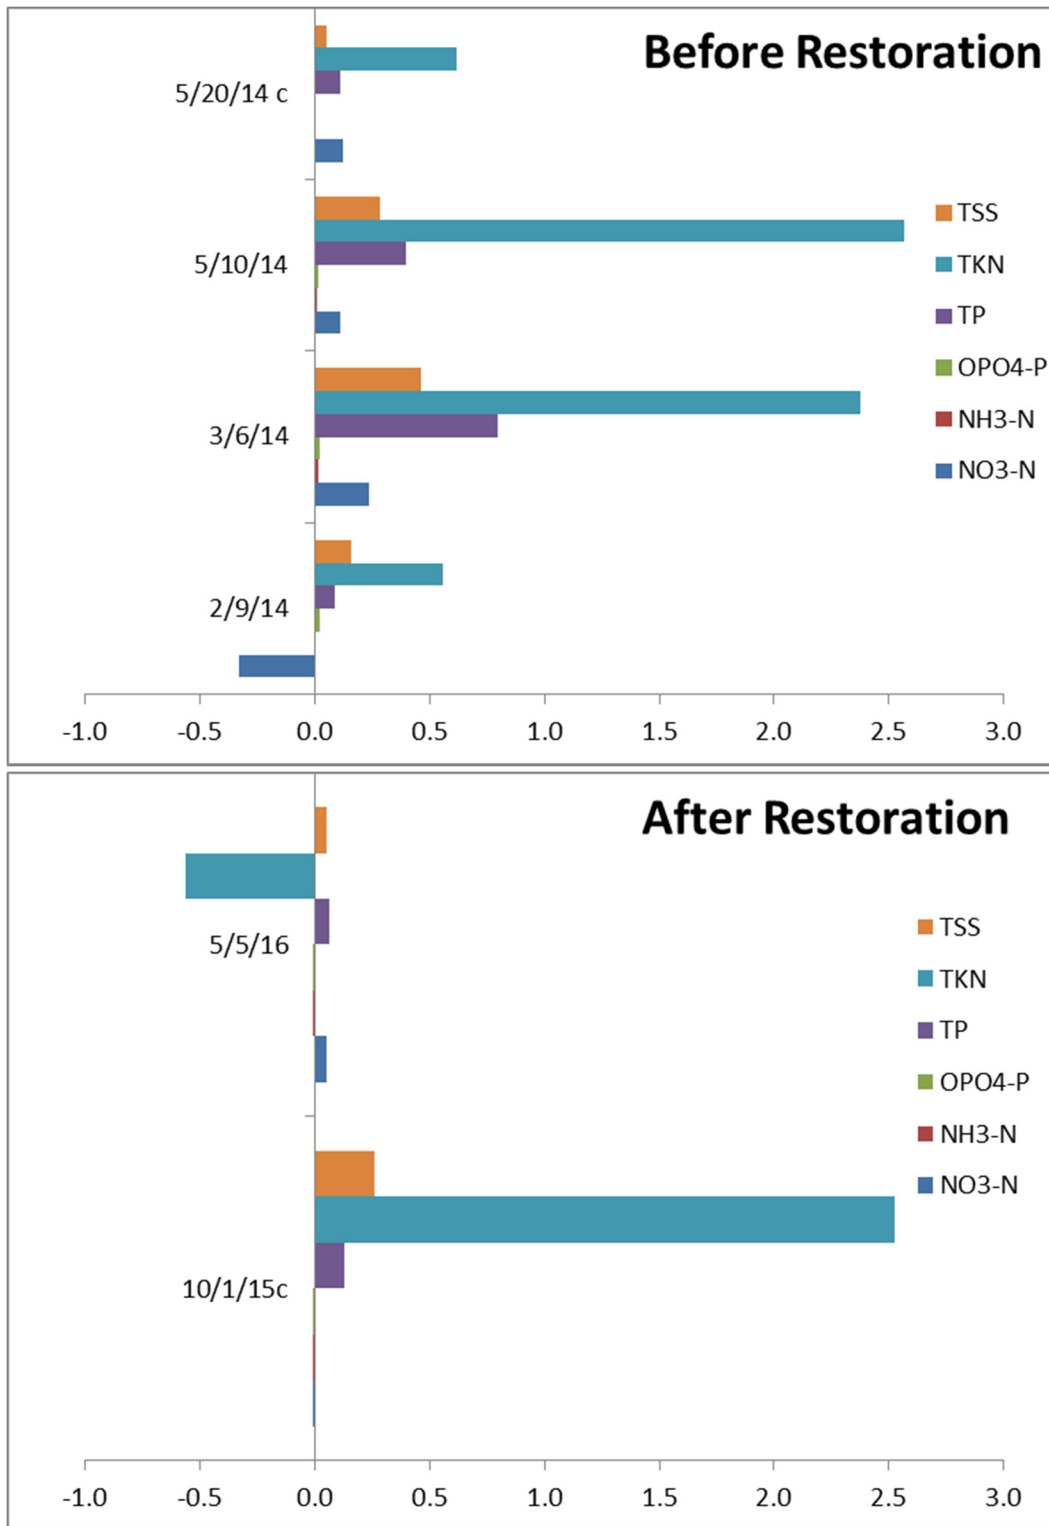
Figure 23. Cumulative difference in nutrient and sediment between RW-Abv and RW-Blw for events before and after restoration. These are event mean concentration samples, nutrients in units of Event Load (kg) per day. TSS in kg1000 per day. (Most normalized units possible, over time and over water volume or intensity).

Figure 23 shows the loadings for TSS and the suite of nutrients for before and after the restoration. This is another means of examining the discrete samples, but includes the calculation for an entire event loading. It would have been desirable to obtain more samples that allow for this type of calculation over the course of the period of record, but for a multitude of reasons the direct

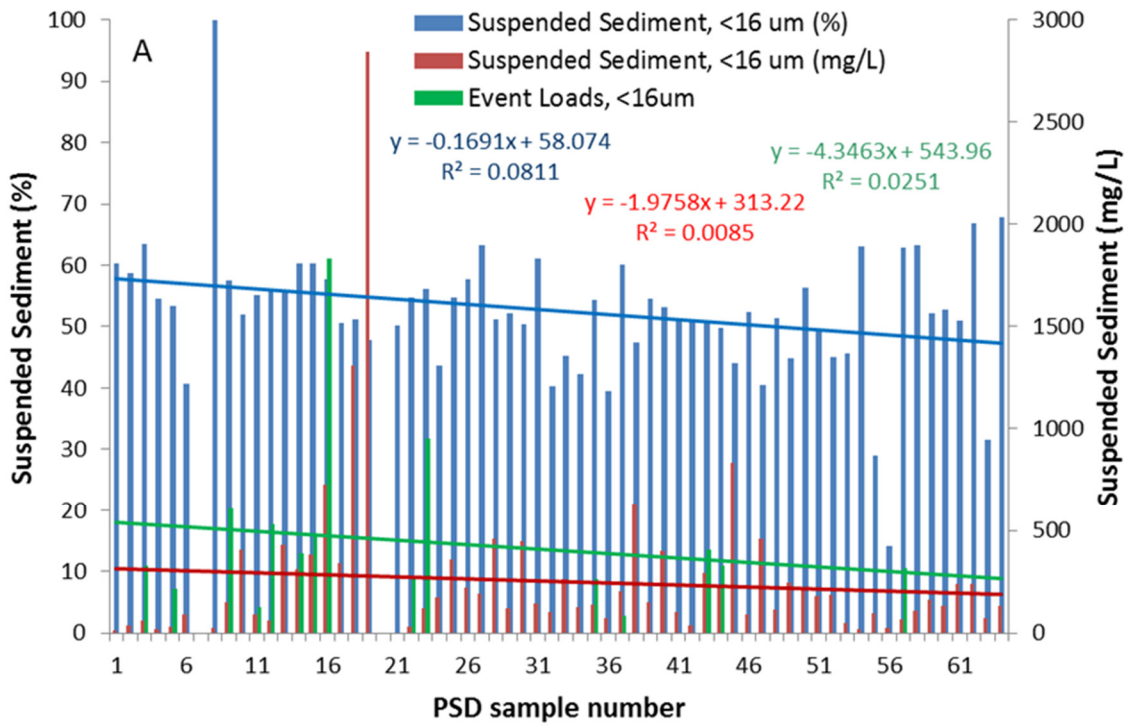
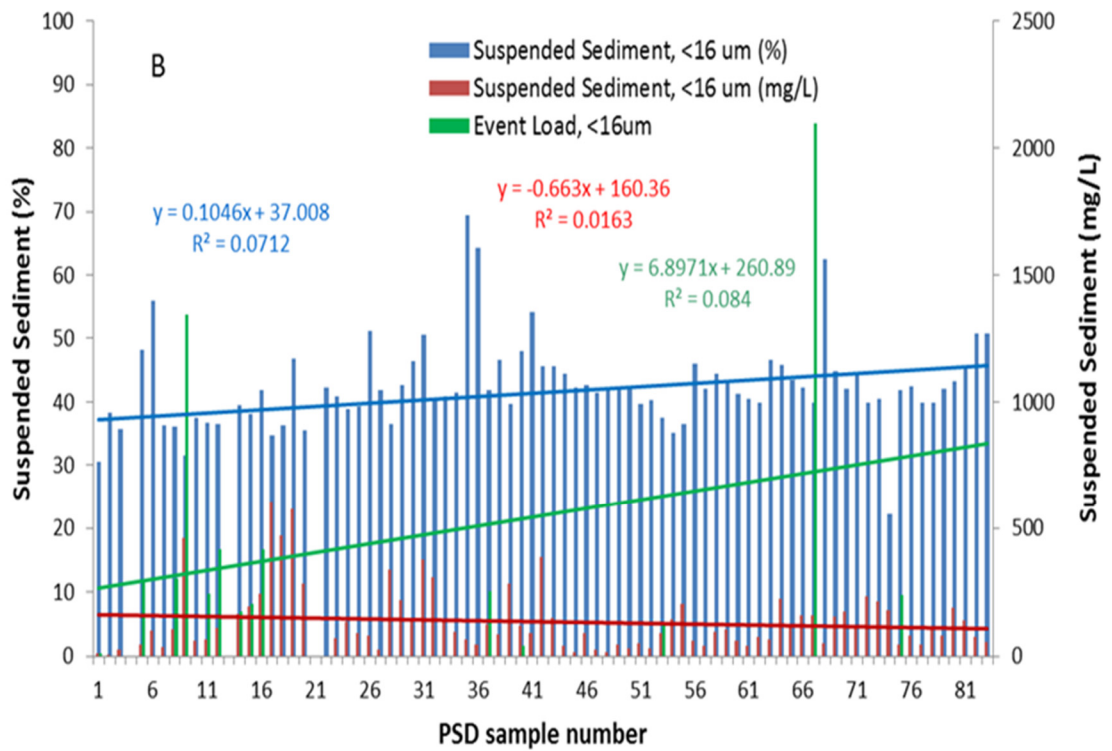
Figure 24. Particle size sample analysis for the ultra-fine fraction (under 16µm) over time at RW-Abv (A) and RW-Blw (B) for events before and after restoration. Water enters the restored channel at Sample 21 for RW-Abv and at Sample 22 for RW-Blw. Included are both event mean concentration and discrete samples.

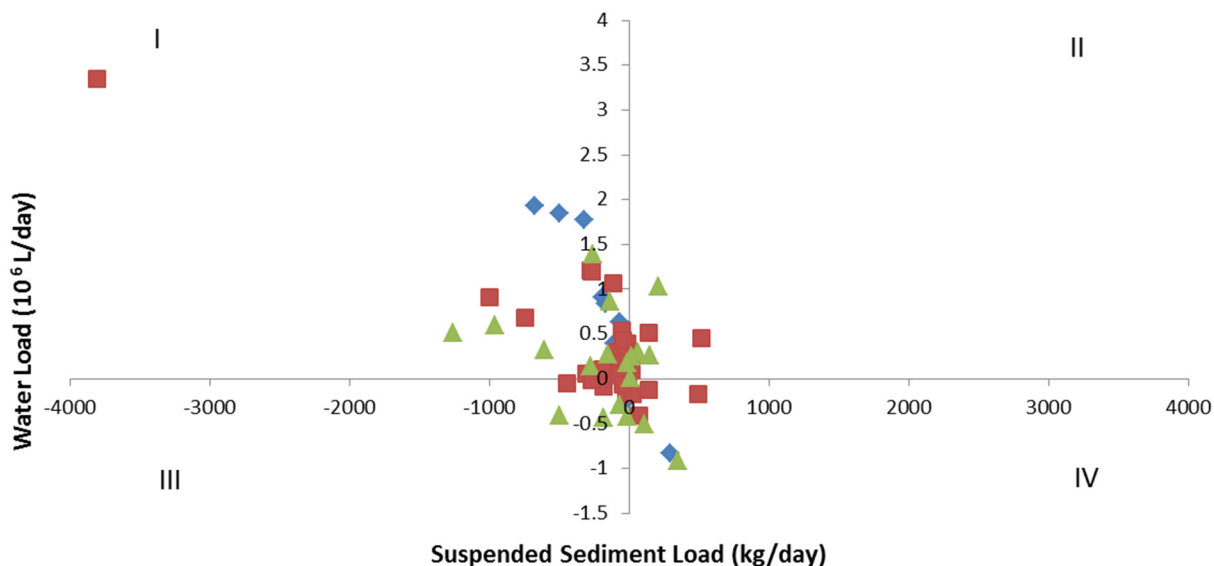
Figure 26. Reduction of suspended sediment load compared against reduction in water load from the restoration zone. Values were calculated by subtracting loads at RW-Blw from RW-Abv. Event loads are normalized by their duration, in days. Red squares are rain events, green triangles are rain-on-snow events, blue diamonds are snowmelt events.

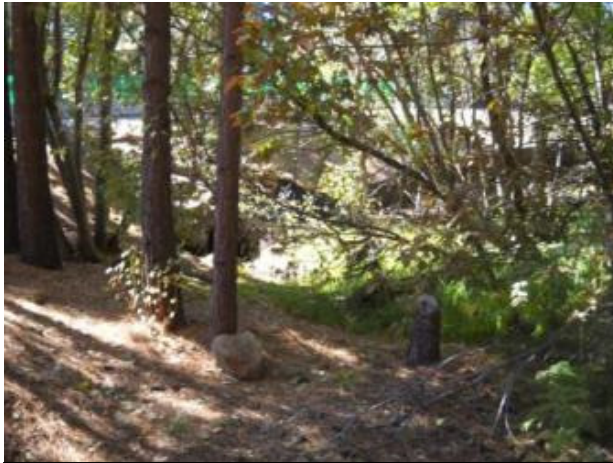
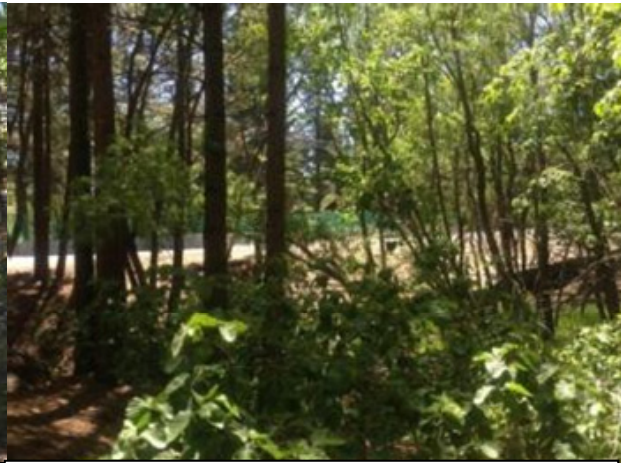
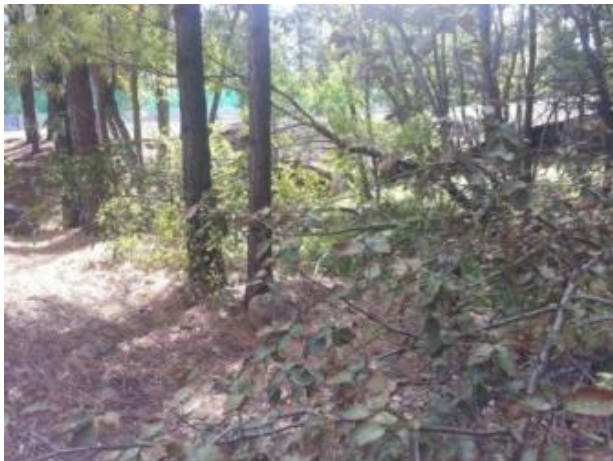
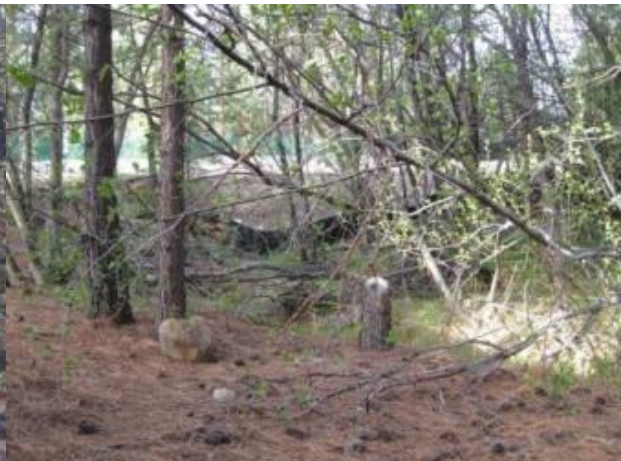
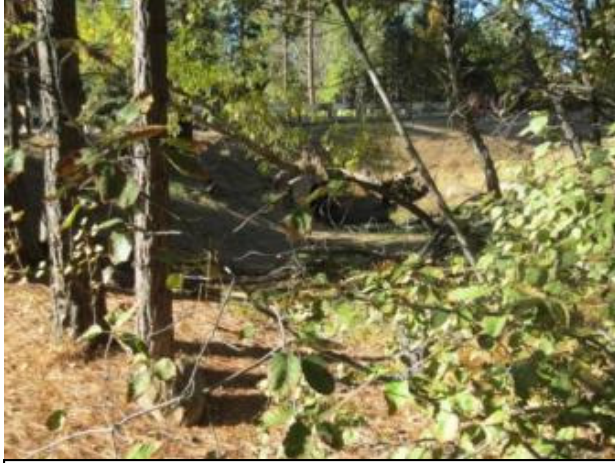
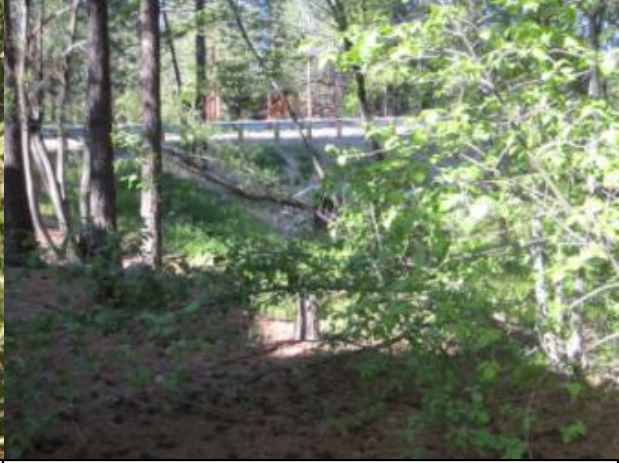
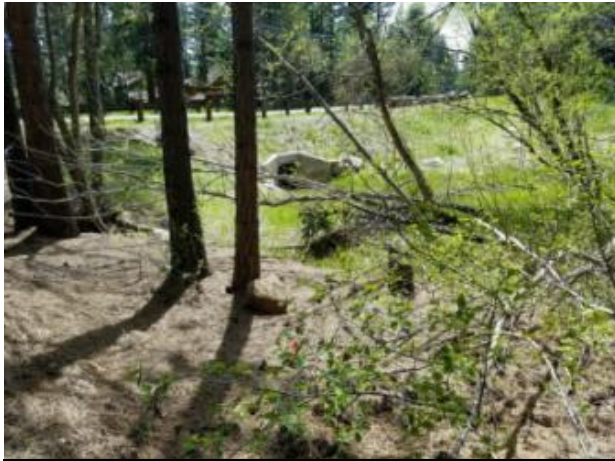
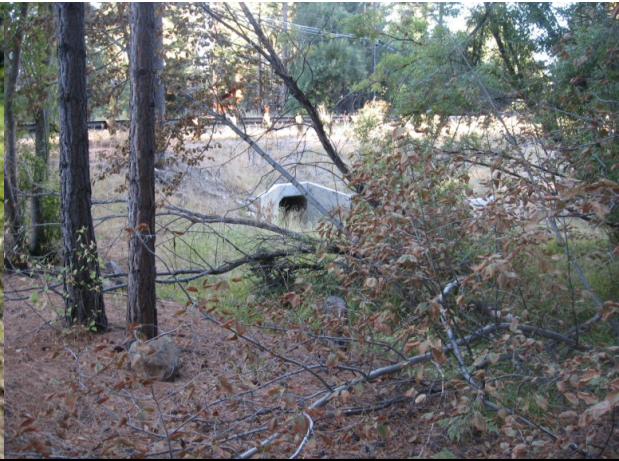
Photo Point 1: Upstream of existing culvert at upstream tie-in. This point looks at the area restored just upstream of the Northwood Culvert and though willow and alder obscure the view, the point shows that the vegetation on the slope above the culvert and the floodplain is vigorous and established on the slope around the culvert by May 2016. The work in this area was completed in October 2014.

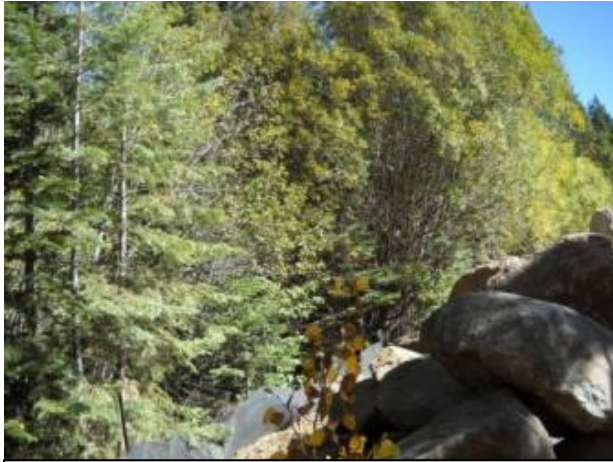
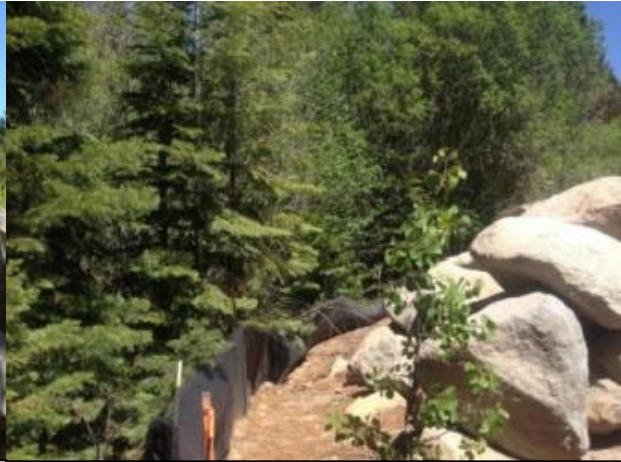
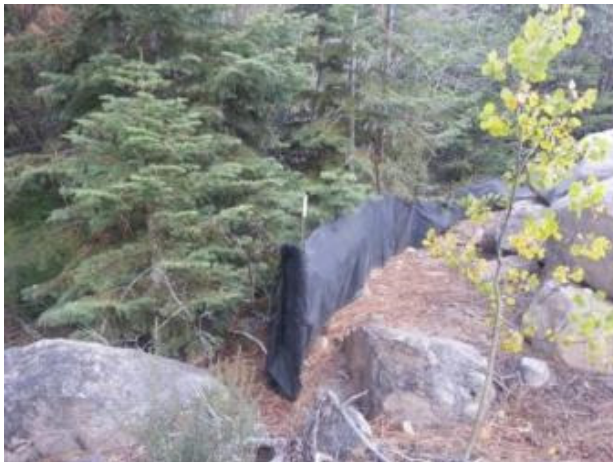
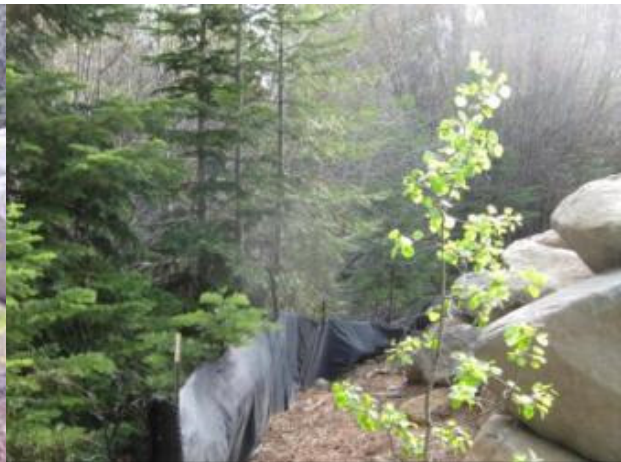
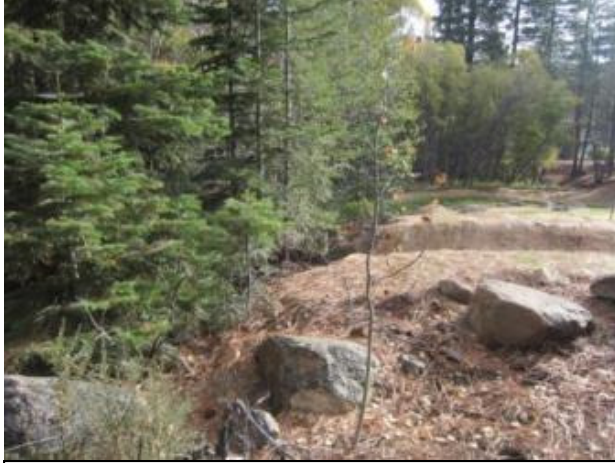
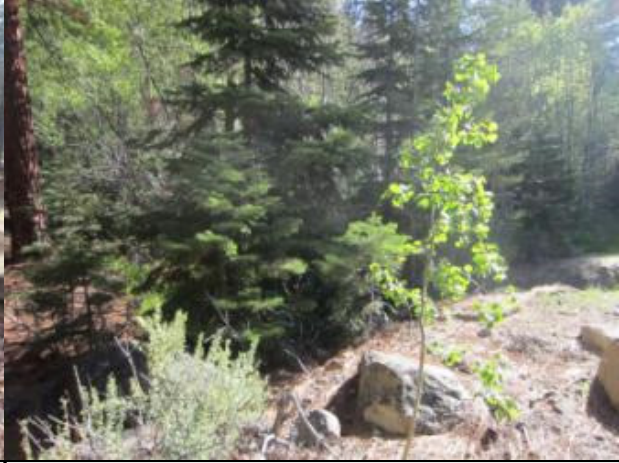
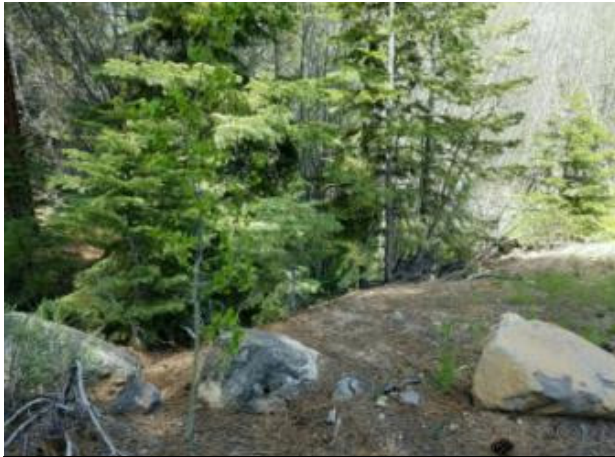
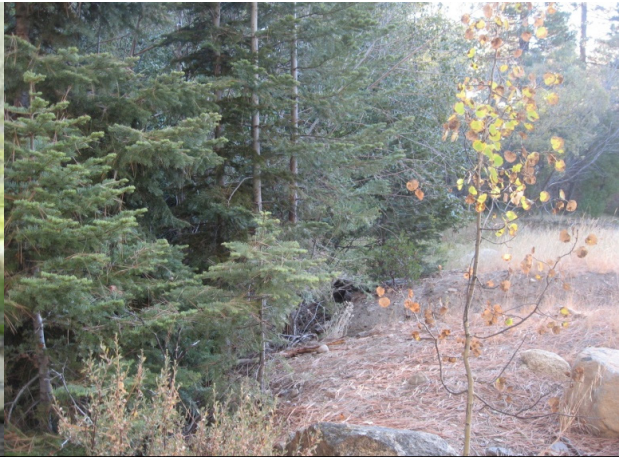
Photo Point 2: Staging area at Northwood Blvd to become wetland in Phase 3. This point looks at an area of historic fill that was removed during the project and converted back to a more natural slope. The area was also used for staging throughout the project. The photo point missed the main area of change which is best shown in the October 16, 2014 photo where the grade has been leveled and more riparian vegetation now occupies the point. The area also now has a swale to convey road runoff to a flat vegetated treatment area before entering the creek.

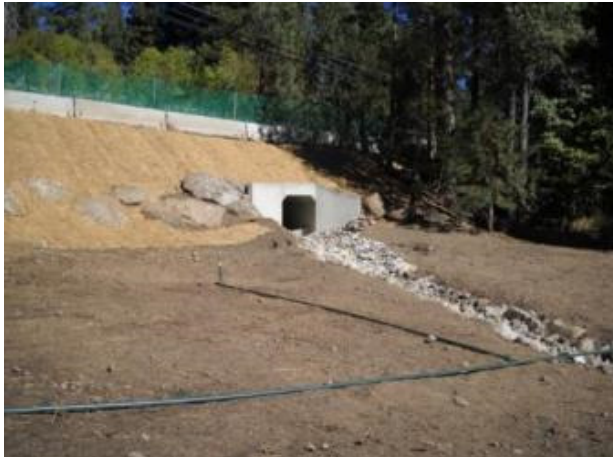
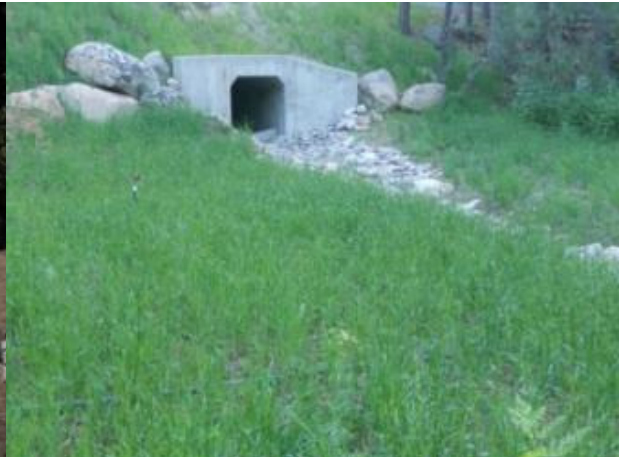
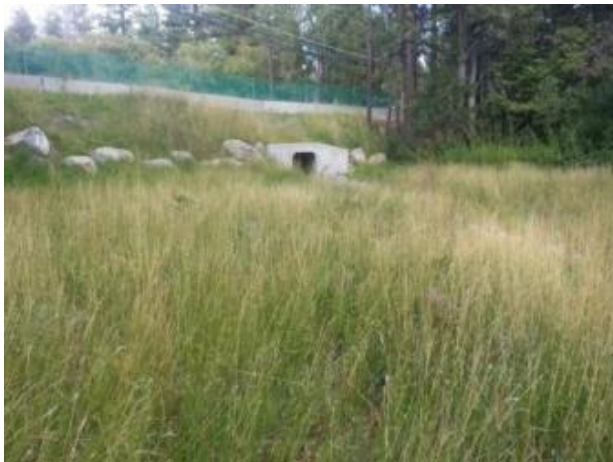
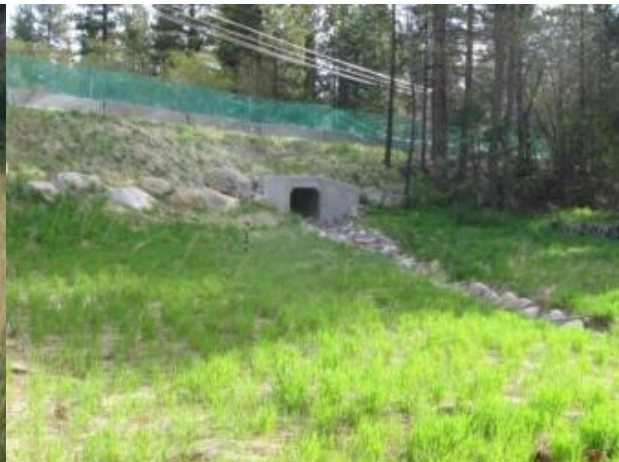
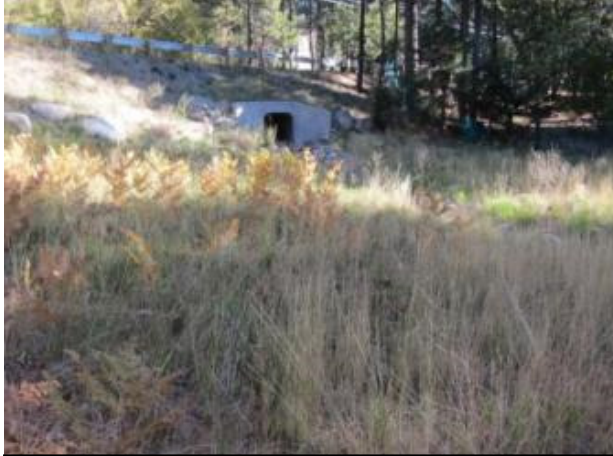
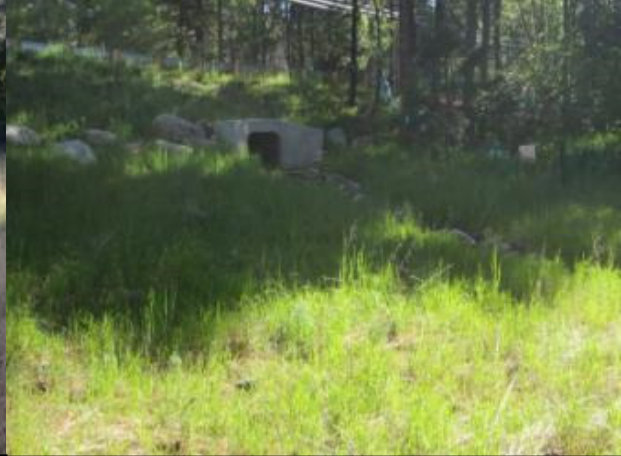
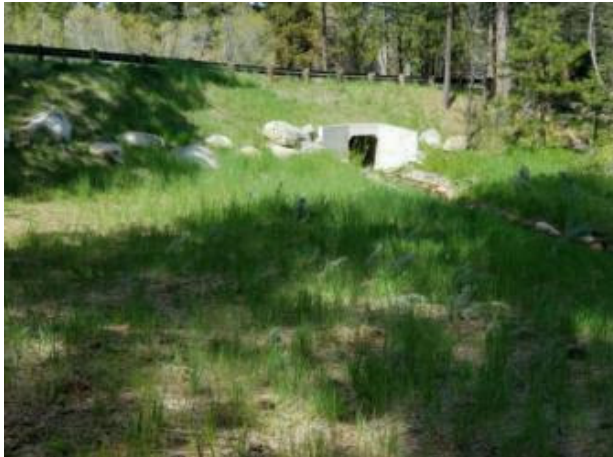
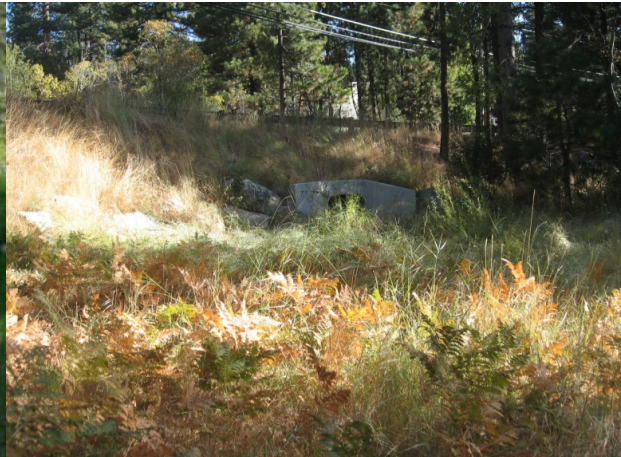
Photo Point 3: This point shows the downstream end of the newly installed culvert at Northwood Blvd. Vegetation was well established within 8 months of the completion of Phase 1 and vegetation continues to flourish after the creek occupied its new channel in September 2014 and irrigation was turned off. Nearby ferns have migrated into the area as they were not planted from seed.
