Final Report

Rosewood Creek Restoration, Area A

March 2017

Prepared by
Nevada Tahoe Conservation District
400 Dorla Court
Zephyr Cove, NV 89448

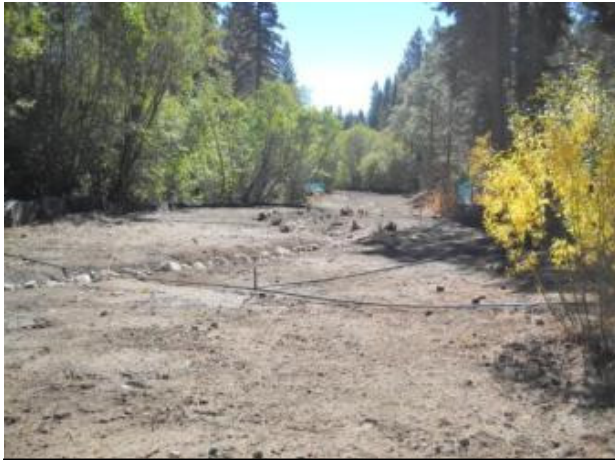
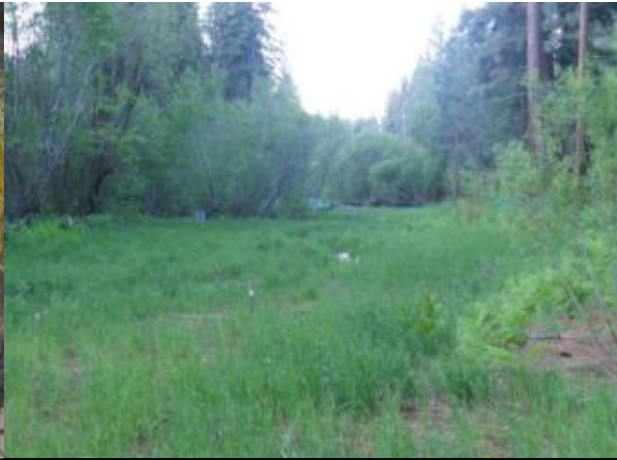
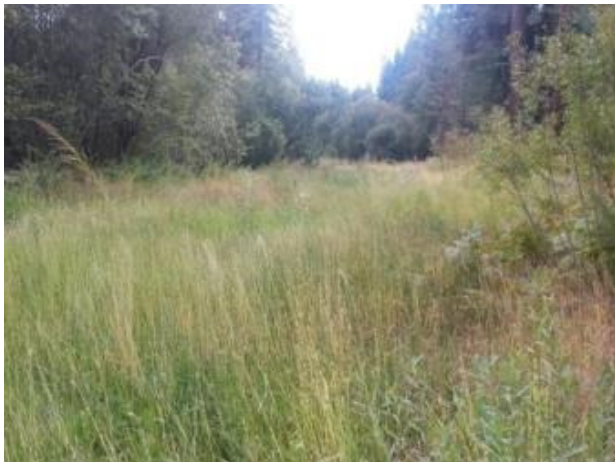
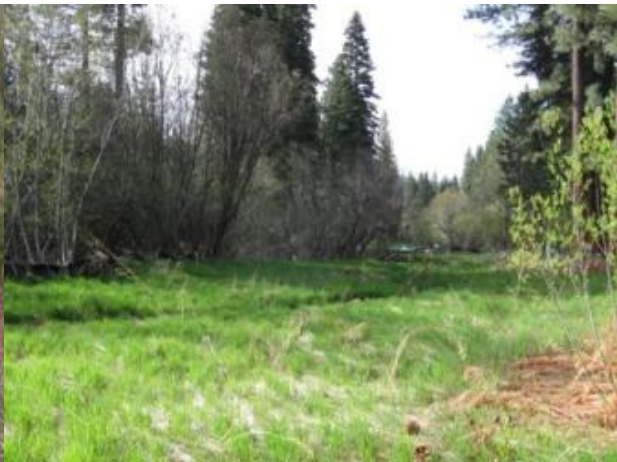
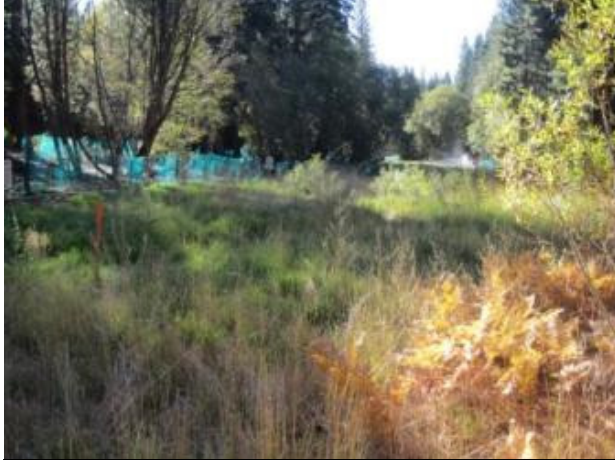
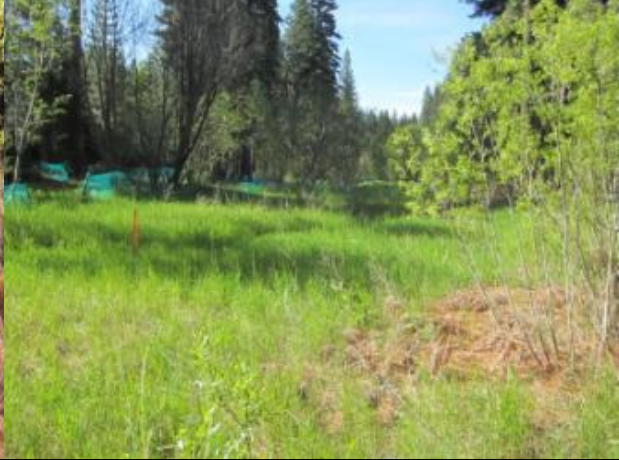
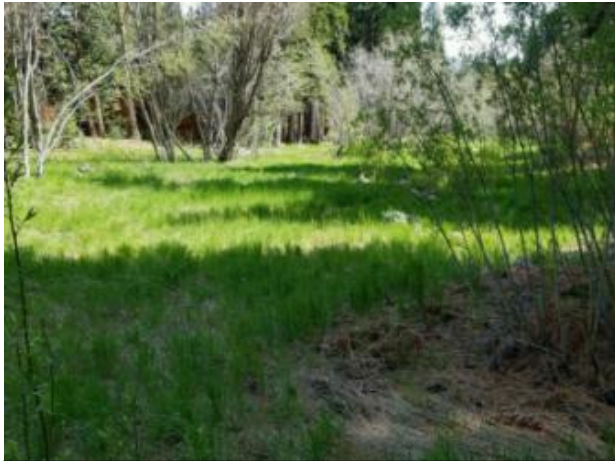
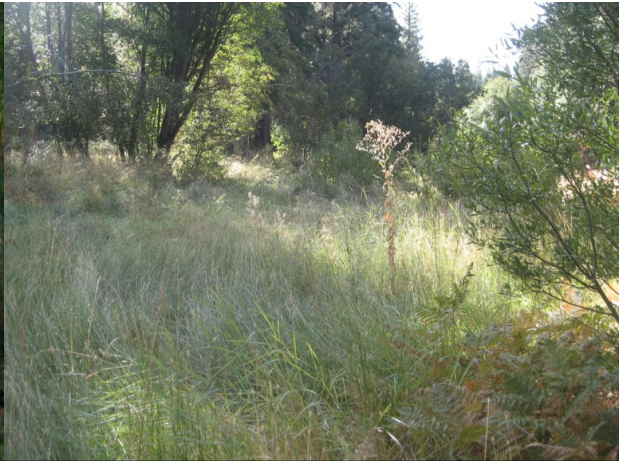
Photo Point 4: This point shows the new floodplain upstream of the tie in location. Vegetation was establishing well within 8 months after Phase 1 was completed and continued to flourish after irrigation was turned off in October 2014.

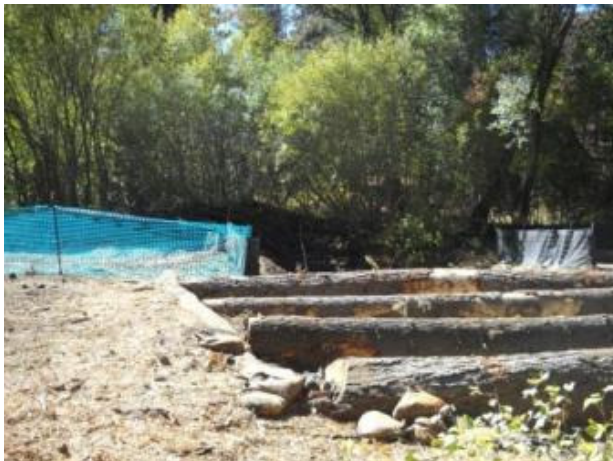
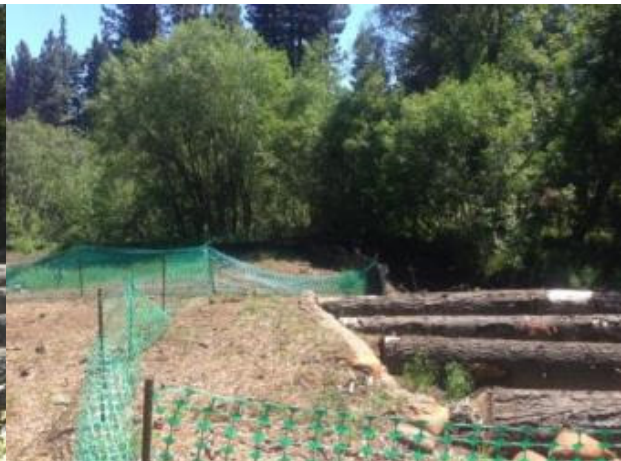
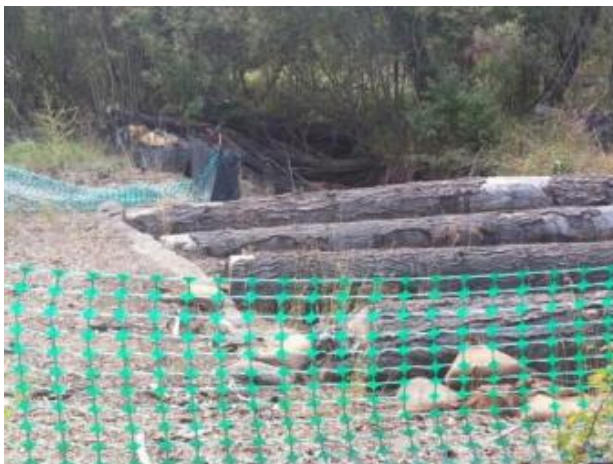
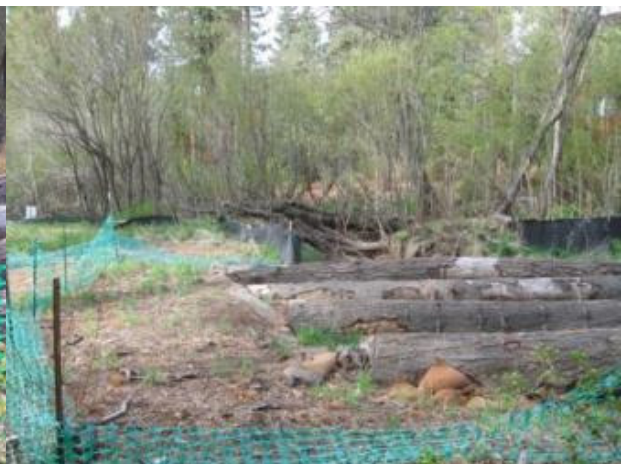
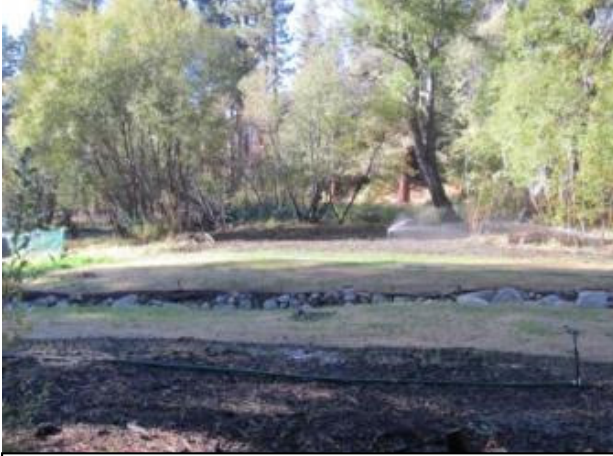
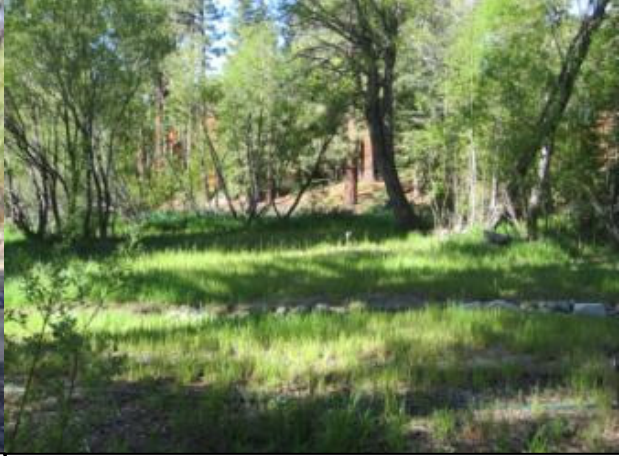
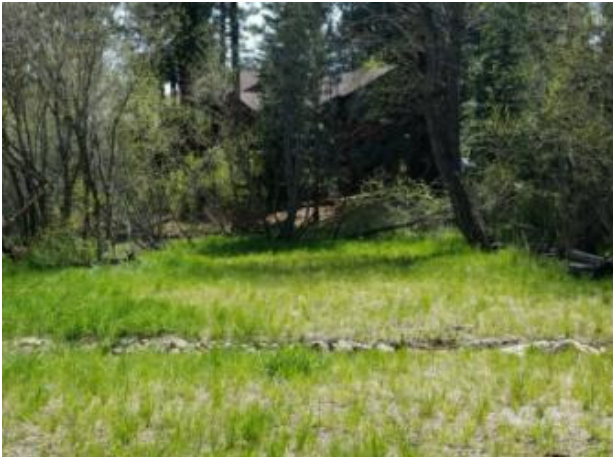
Photo Point 5: This photo is looking upstream from mid-channel tie-in – an area where the new channel crossed the old channel. The photos through May 2014 show the old channel as a wide (over 12’ wide) and deep hole. After Phase 3 was completed in October 2014, vegetation started to grow. The new vegetation was well established by May 2015 and continues to flourish. The HOA installed a walking path and removable bridge in the summer of 2016 which they place each June and remove each October depending on the weather. The design and size of their bridges necessitates removal or the bridges would be washed downstream and destroyed.

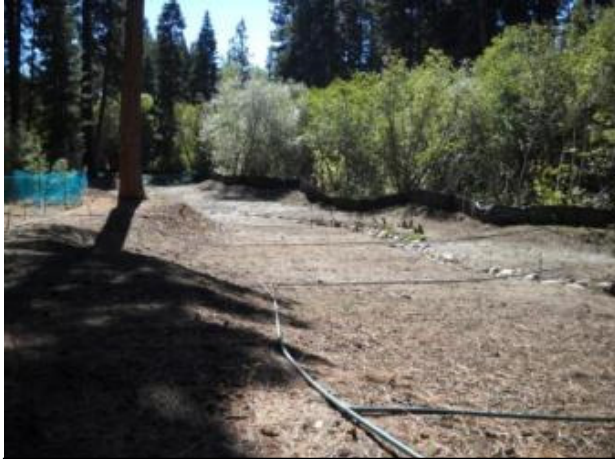
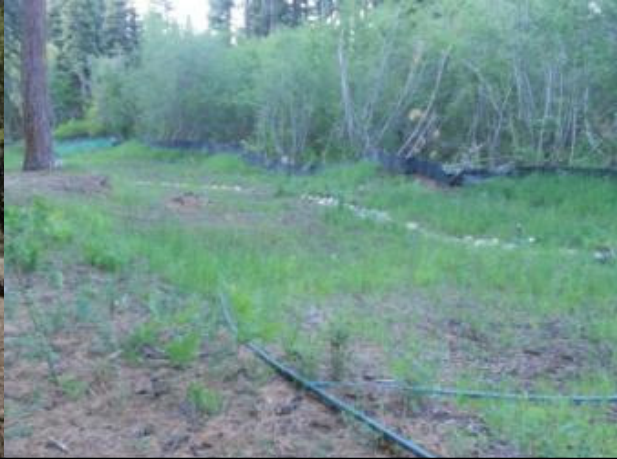
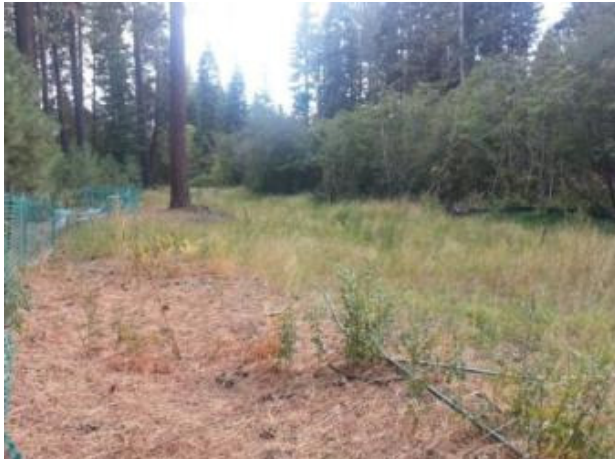
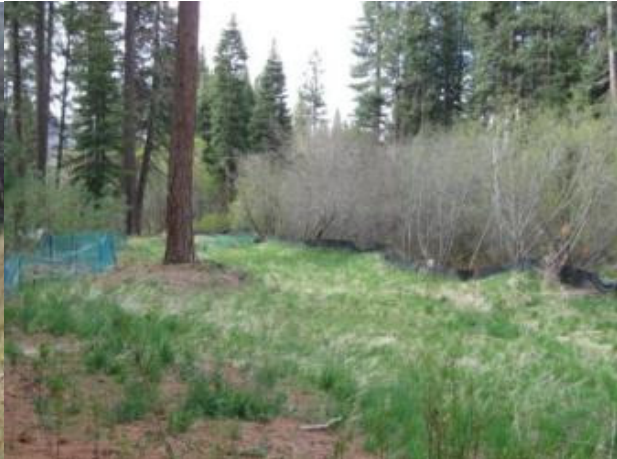
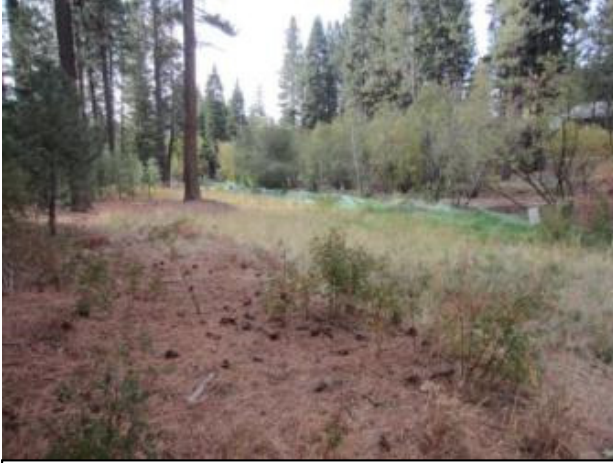
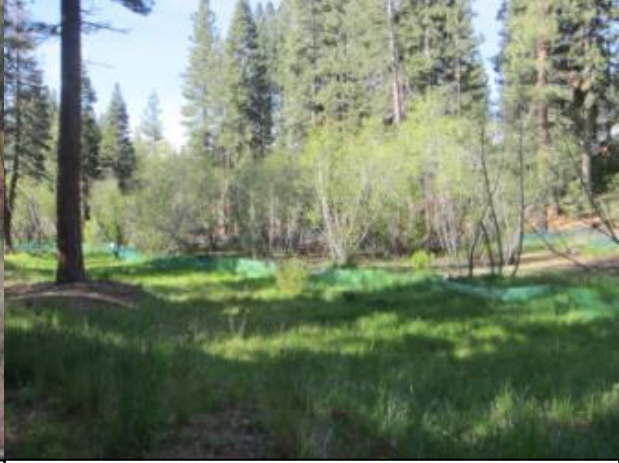
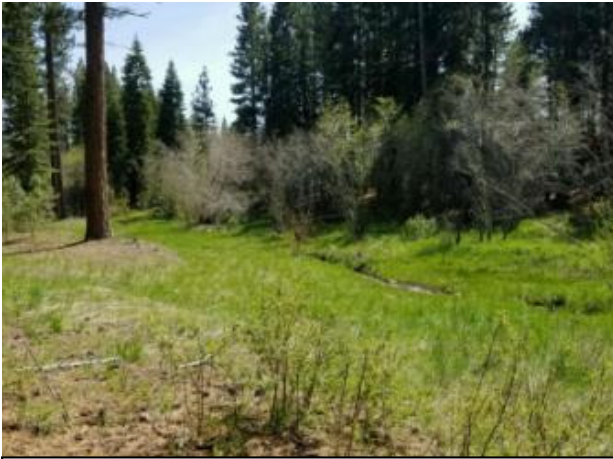
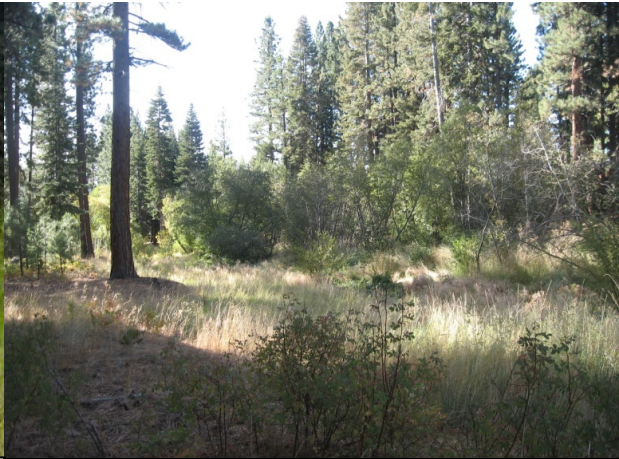
Photo Point 6: This point shows the new floodplain downstream of the tie in location. Vegetation was just starting to establish 8 months after Phase 1 and was well established a year and a half later. Vegetation continued to flourish after irrigation was turned off in October 2014.

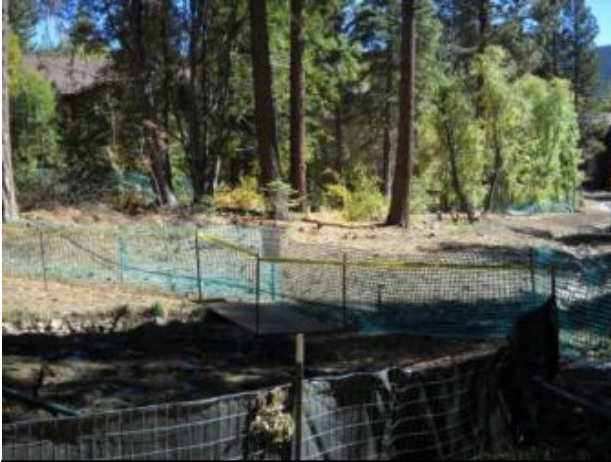
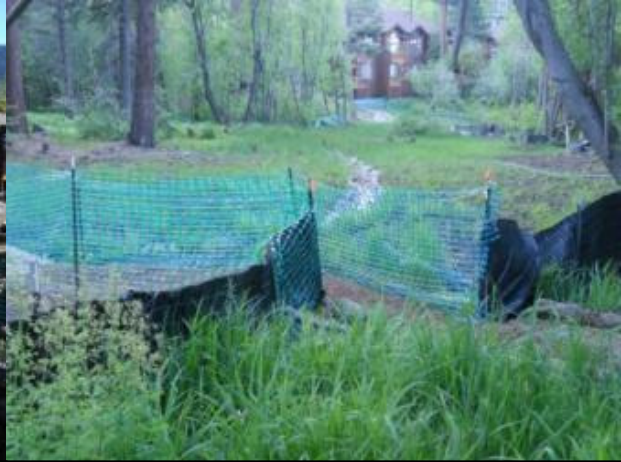
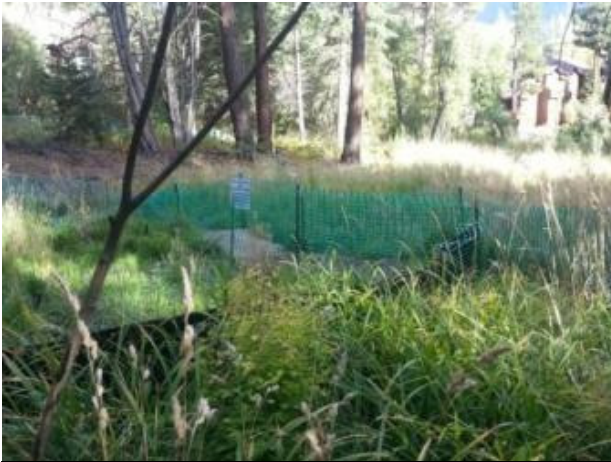
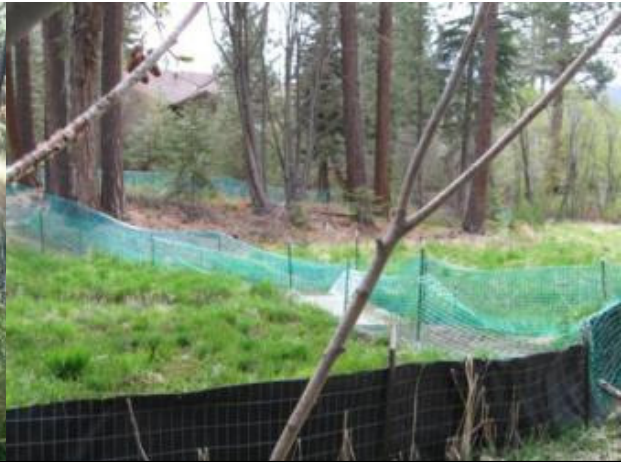
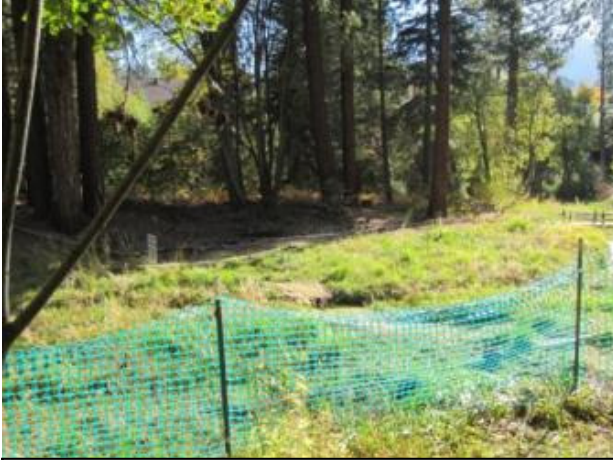
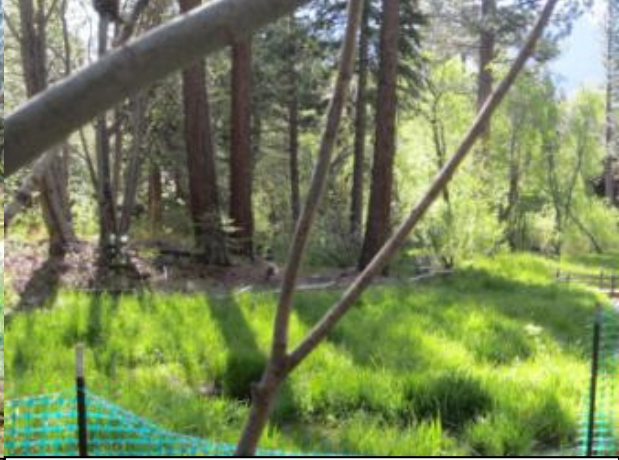
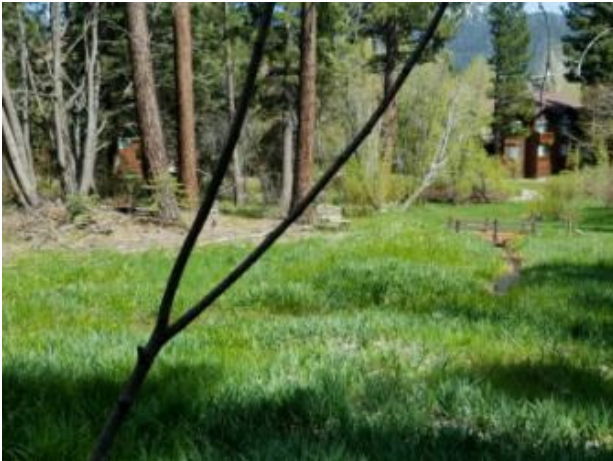
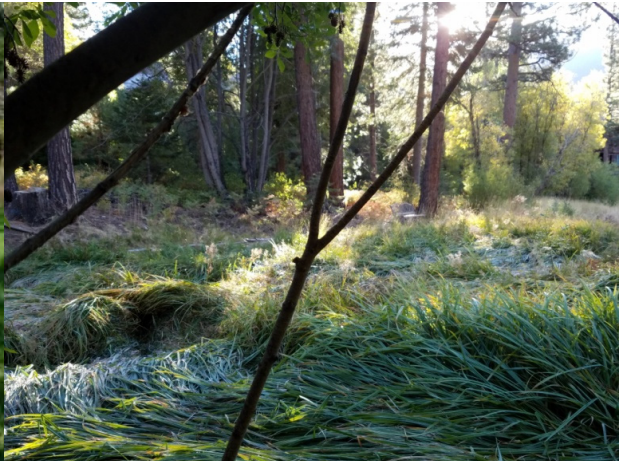
Photo Point 7: This point shows a wet area that was the least steep portion of the valley. Because of the wetness, vegetation took a bit longer to initially establish but was well established within a year and a half of the completion of Phase 1. The photo from October 6, 2016 shows that the floodplain was recently inundated in this area due to a rain storm and the vegetation offered floodplain roughness for overland flow.

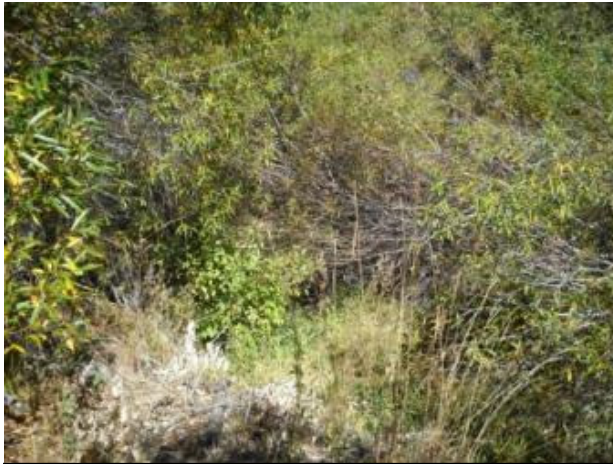
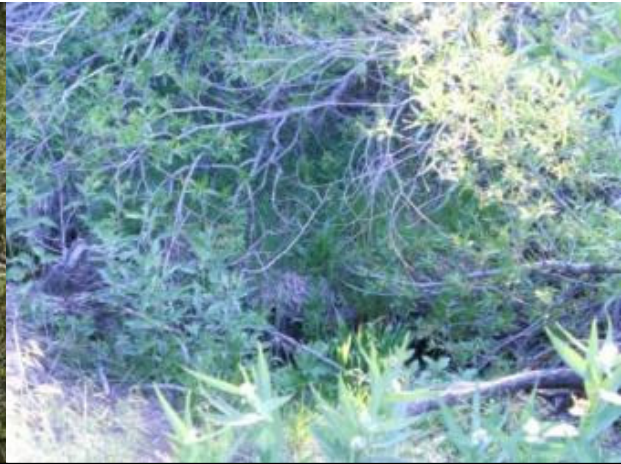
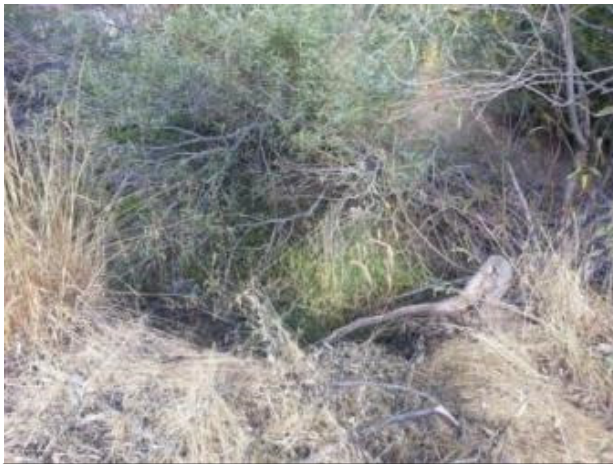
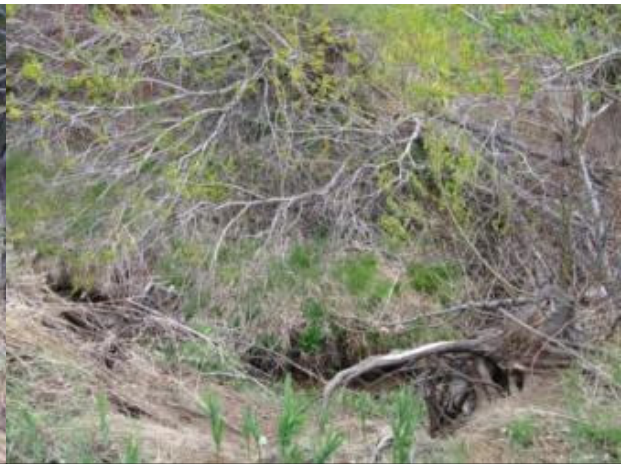
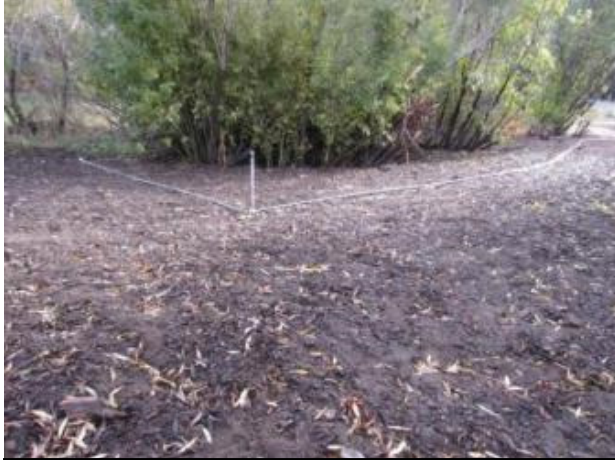
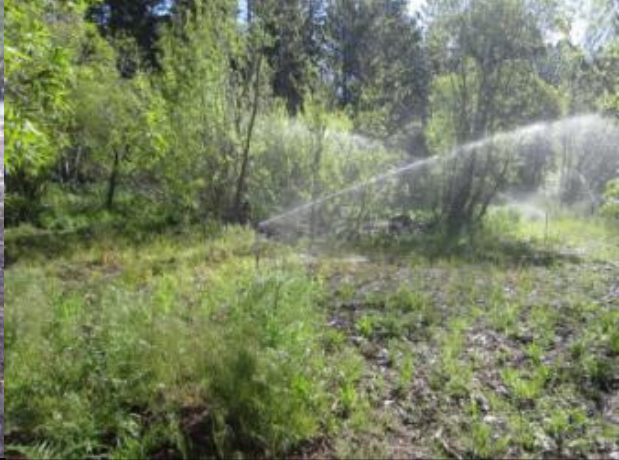
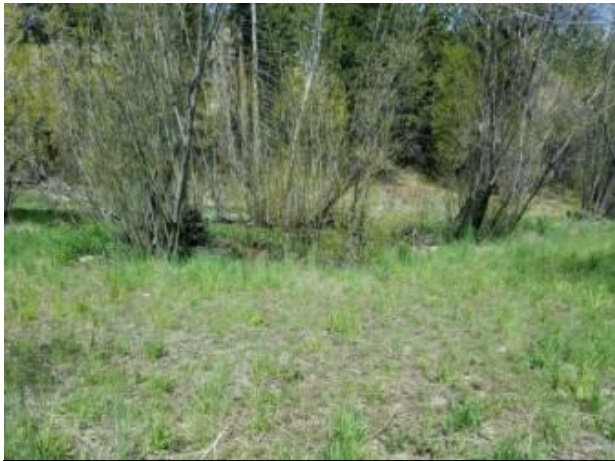
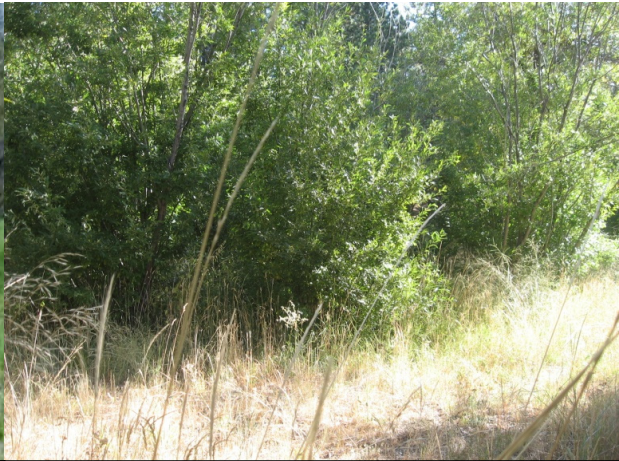
Photo Point 8: This point shows the location of the invasive weed such as common teasel on the banks of the old channel. The teasel was removed as part of the project and the channel was filled in this location. The weed was removed in Phase 1 (October 2012) and the channel filled during Phase 3 (October 2014). Vegetation was well established a year and a half later and the teasel did not return.

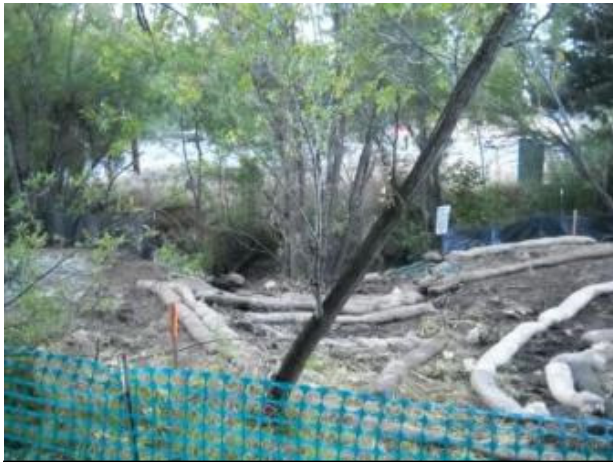
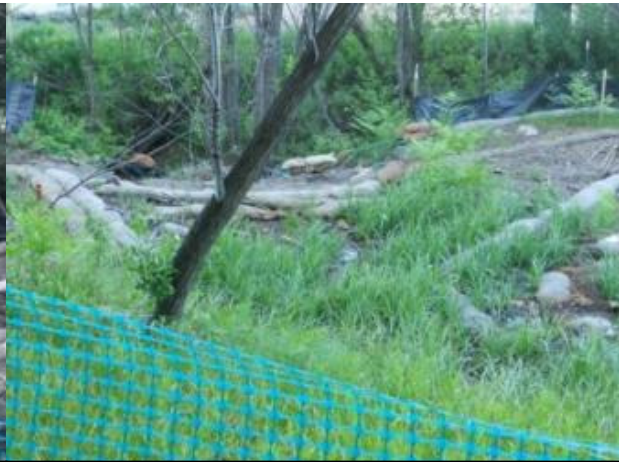
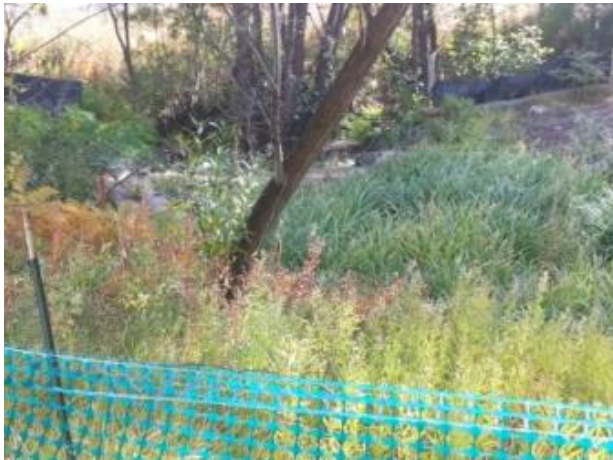
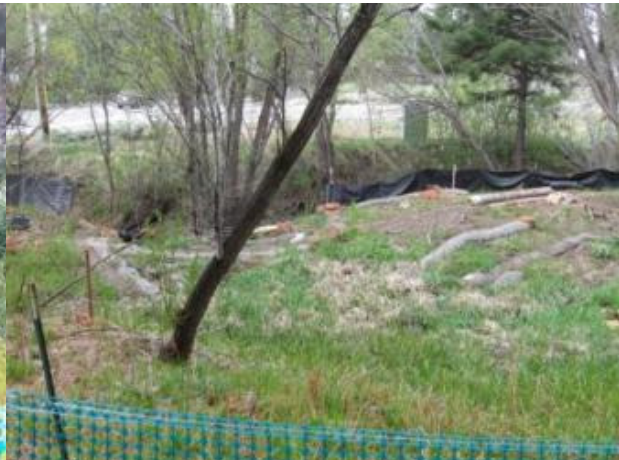
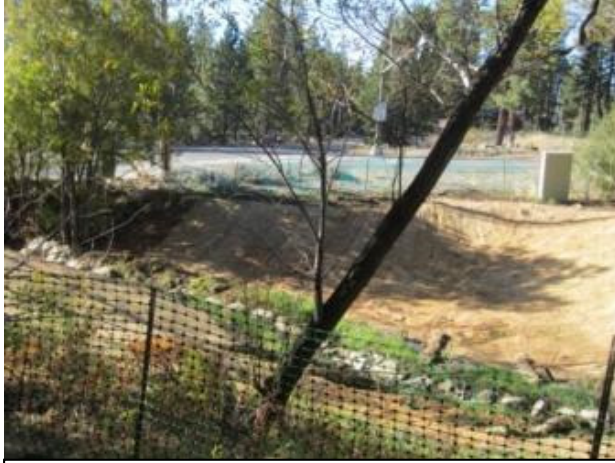
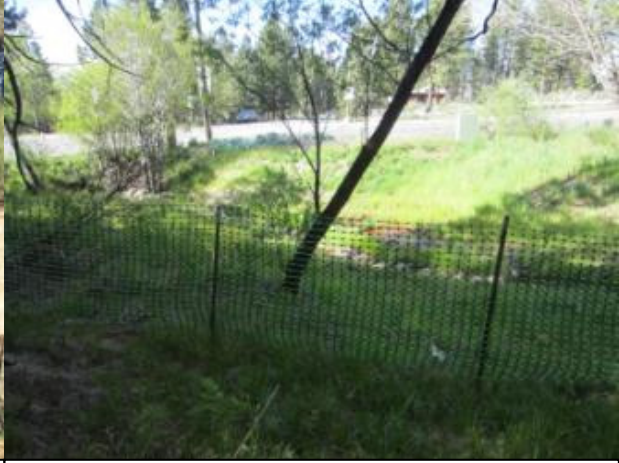
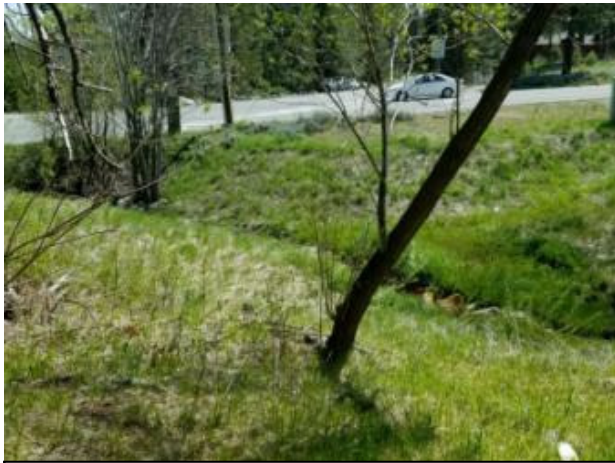
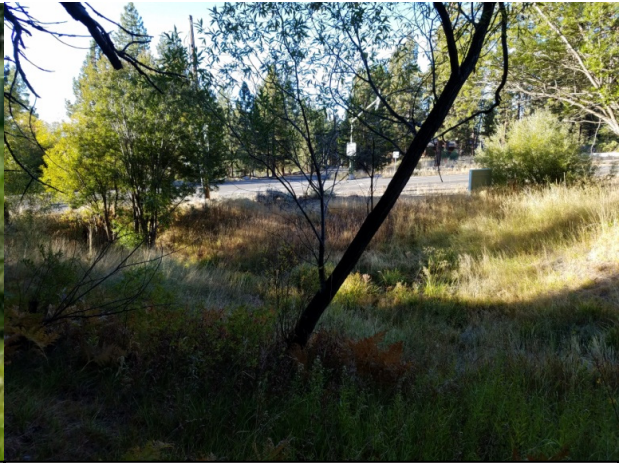
Photo Point 9: This point shows the most downstream area of the restoration project – the downstream tie-in at State Route 28. Before construction of the tie-in, at the end of Phase 1, the area was temporarily stabilized by placing multiple sediment logs in the flow path in the event that runoff from the construction site upstream would accumulate and flow to the existing creek. These construction best management practices stayed in place throughout Phase 2 and the area essentially turned into a small wetland by October 2013. The tie in was constructed in Phase 3 which started in August 2014 and was completed in October 2014. Vegetation was well established 8 months later and wetland vegetation began to thrive about one year later.

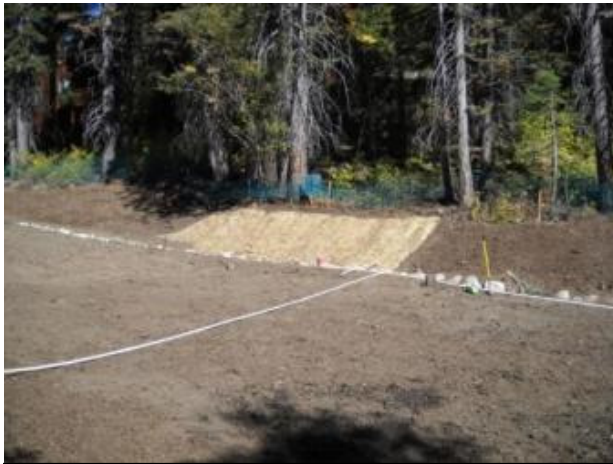
Photo Point 10 – October 16, 2012

Photo Point 10: This point shows a steep slope that was treated with erosion control blanket near the downstream end of the restoration. Erosion control blanket was used here and on one other steep slope in Phase 1 above the installed culvert. Erosion control blanket was also used in Phase 3 for the tie-in areas as they would not have a channel seasoning period before the introduction of flow. The area receiving blanket treatment appeared to have similar vegetation success as the area that did not receive blanket which was unexpected as typically blankets have been observed to slow the establishment of vegetation. The blanket was a fully biodegradable 30/70% coconut/straw mixture and due to the success here, we used this same blanket design on other revegetation projects.

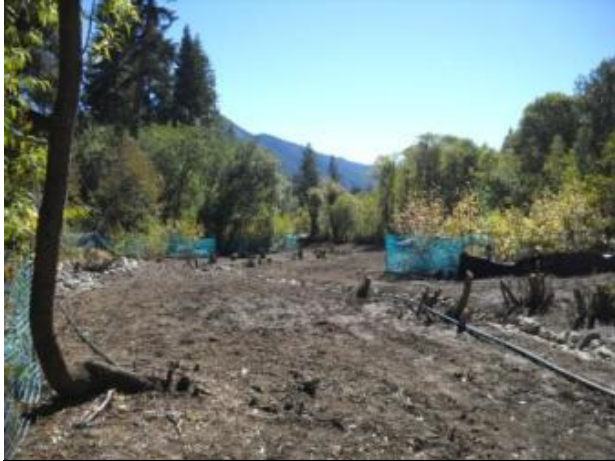
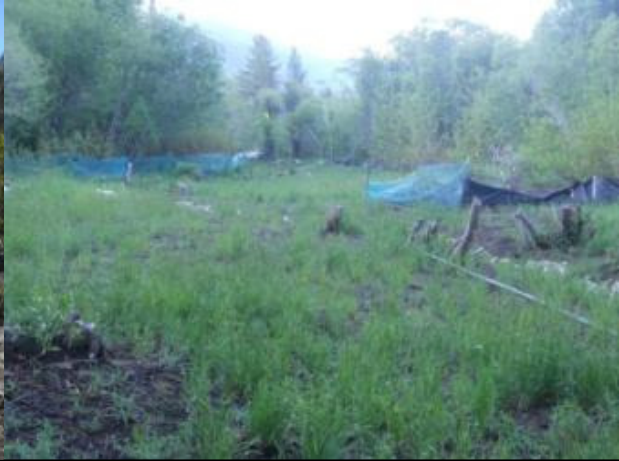
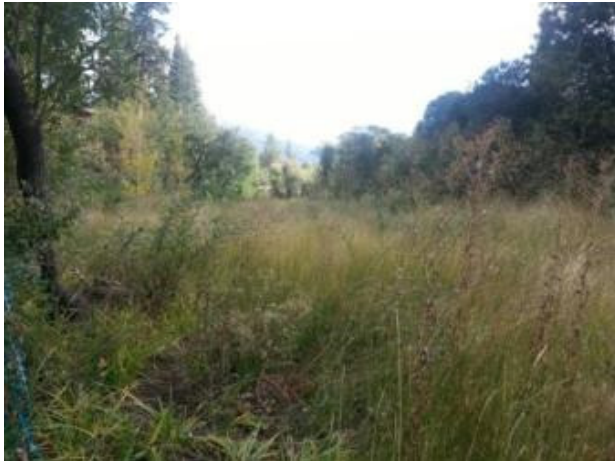
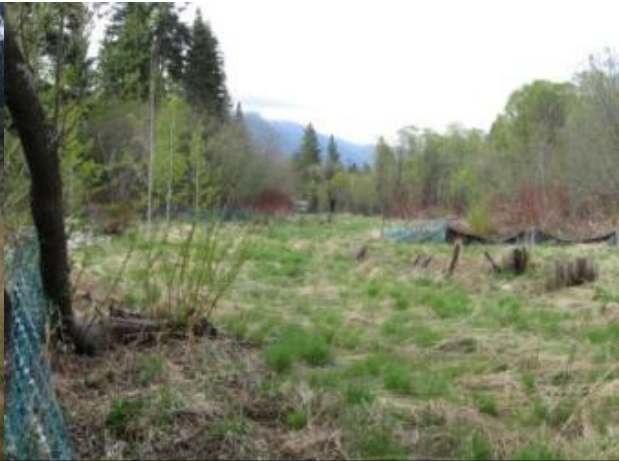
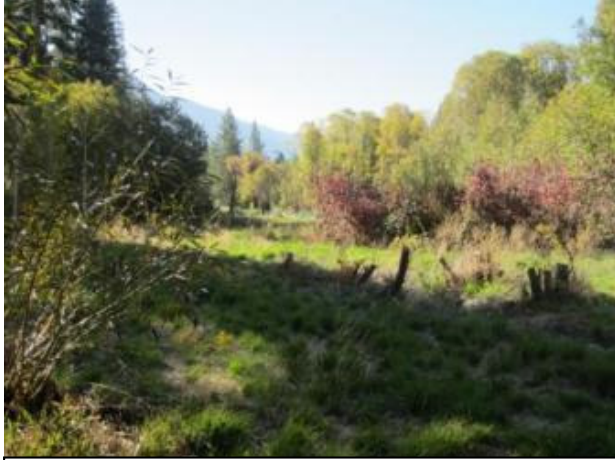
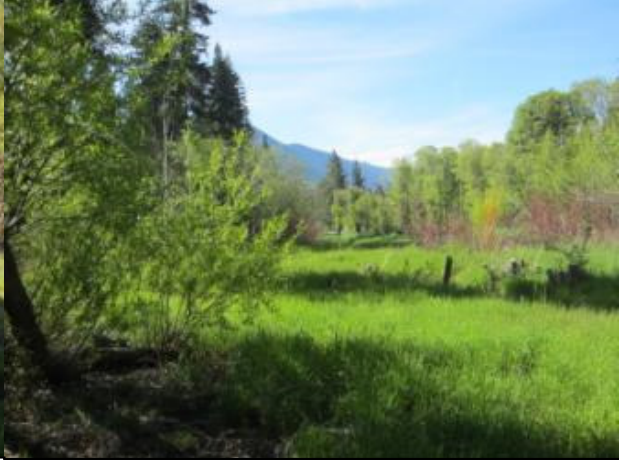
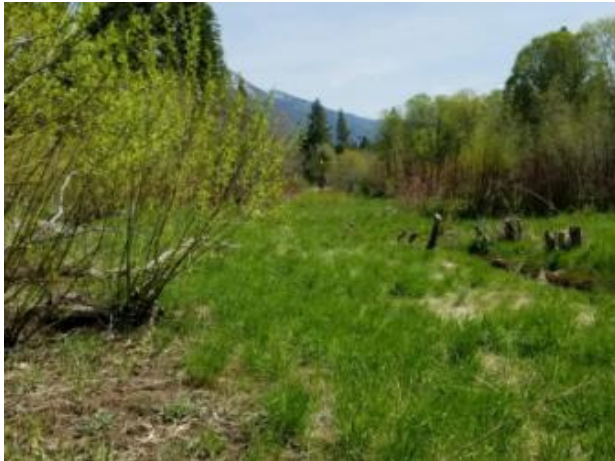
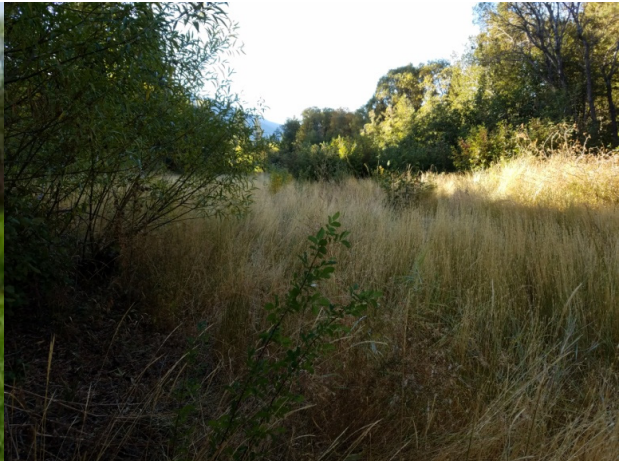
Photo Point 11: This point shows the downstream floodplain and transplanted willows root wads. Transplanted willow and alder root wads were only used on the steepest parts of the new channel in order to limit floodplain roughness to areas that could pass enough flow to not increase the boundary or the 1% and 0.2% floods per FEMA regulations. From the photo it is difficult to see the amount of growth on the relocated tree clumps, but only about 25% of the transplanted willow and alder showed unsuccessful growth within 2 years of relocation. The transplanted willows were more successful than the alder.
