100-Year Flood Analysis – Burke Creek Rabe Meadow Riparian Restoration Project

BY: MEGHAN KELLY, P.E. AND PATRICK JOHNSON, NEVADA TAHOE CONSERVATION DISTRICT

DATE: 4/6/2023

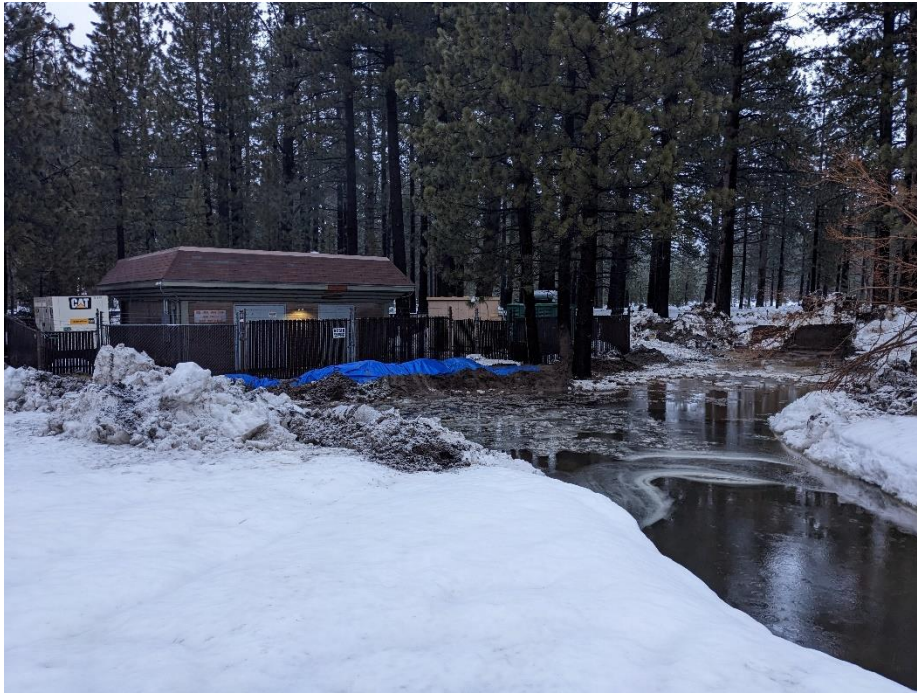
Figure 3: Flooding at the DCLTSA sewer pump station, March 2023 (Photo: NTCD)

Today, Burke Creek and its floodplain have several environmental and hydrological issues that have likely arisen due to the alterations to the creek. First, significant flooding occurs in the vicinity of the creek in Nevada Beach Campground, especially at the DCLTSA pump station and access road. This flooding often inundates asphalt roads, and poses a threat to the pump station, whose failure could lead to the spillage of raw sewage less than 600 feet from Lake Tahoe. Second, the inundation and conveyance of stormwater through the Burke Creek from roads and urban areas with minimal treatment has adverse effects on Lake Tahoe's health and clarity. Finally, significant sagebrush and conifer encroachment has occurred in the meadows and floodplain surrounding the creek, indicating an additional loss in riparian ecosystems beyond the areas already lost due to development.

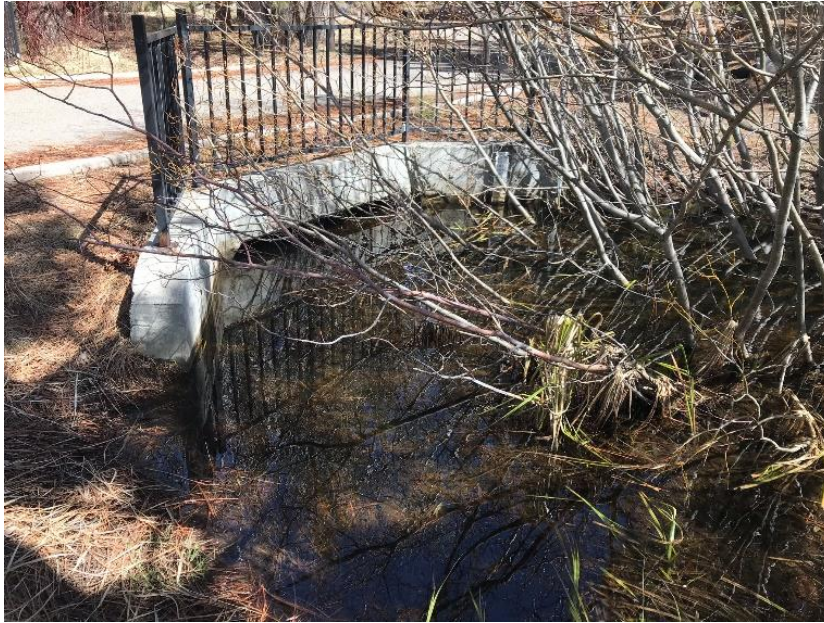
Figure 4: Concrete box culvert in Nevada Beach Campground at capacity during spring runoff, April 2019 (Photo: NTCD)

The Burke Creek reach in the vicinity of the upstream two box culverts in Nevada Beach Campground has no gradient according to field topographic surveys. These box culverts were installed as part of the 1993 project and likely have a low gradient due to the design requirements to allow the creek to route to its present-day northern outlet to Lake Tahoe. Significant aggradation has occurred in these culverts, decreasing their capacities, and increasing flooding at the DCLTSA access road and pump station.

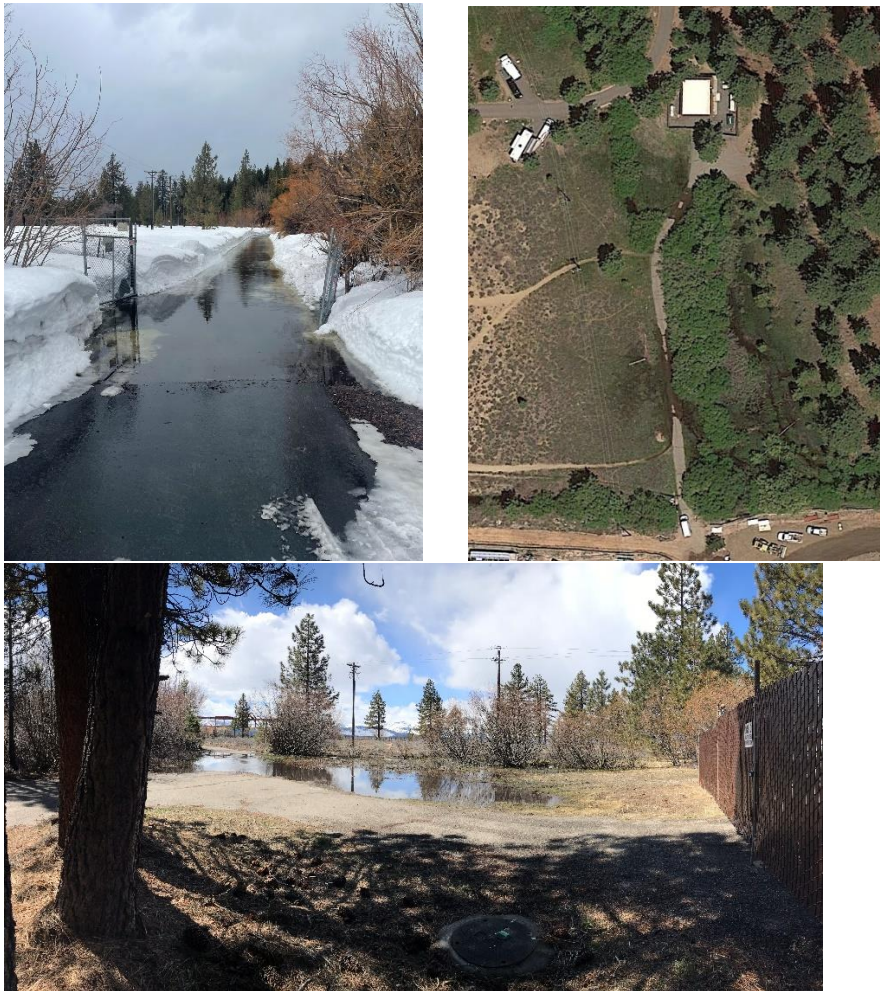
Figure 5: Top left, Flooding on the DCLTSA access road, March 2023 (Photo: NTCD). Top right, aerial image of flooding on the DCLTSA access road, June 2018 (Photo: Google Earth). Bottom: Flooding adjacent to pump station and on road, April 2019 (NTCD)

Access to the DCLTSA pump station is along an asphalt road adjacent to Burke Creek that runs from the Tahoe Beach Club property to the pump station. This road must be maintained to provide access to the plant at all times for both routine maintenance and emergencies. As mentioned previously, this road often becomes inundated during high flows as water in Burke Creek attempts to find the most hydraulically efficient route to Lake Tahoe. Inundation of this road creates a fine sediment pollution source and threatens the critical infrastructure at the DCLTSA pump station. A failure at this station would cause significant environmental issues both at the plant and in the entire casino corridor of Stateline which the plant serves. The road must be plowed during winter to maintain access to the station which can cause additional issues, as large snow berms combined with the plowed road can make the bare asphalt of the road become the most efficient conduit of Burke Creek's flows. An example of this problem arose in March 2023, when emergency actions had to be taken to build dirt berms and excavate drainage routes to Lake Tahoe after the plant became threatened when flows from the creek overtook the road.

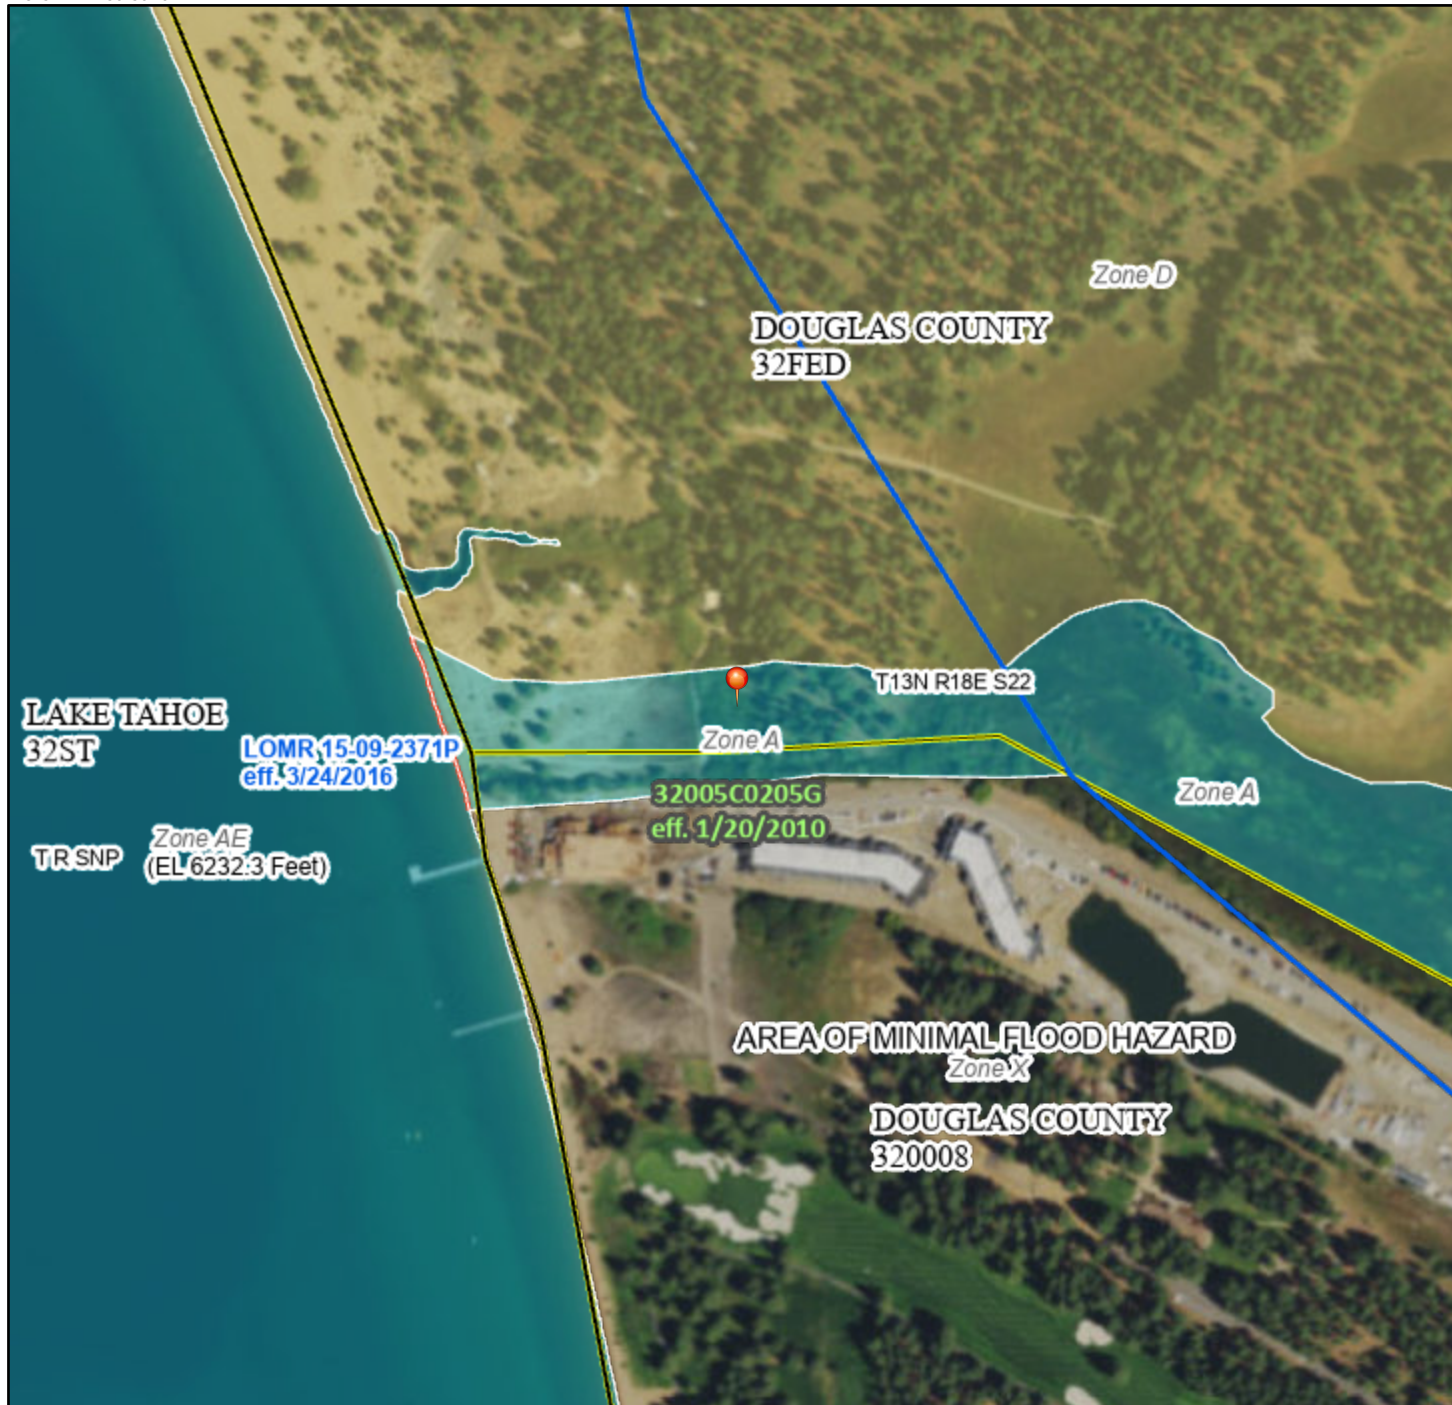
APPENDIX 1:
Existing FEMA Flood Panel

National Flood Hazard Layer FIRMette

The FEMA flood map for the project area is covered by map number 32005C0205G (Appendix 1). This map shows the area along Burke Creek in Rabe Meadow and along the Tahoe Beach Club property line classified as Zone A which indicates a special flood hazard area without a base flood elevation. As well, areas to the north, including the DCLTSA pump station and Nevada Beach Campground are shown as “Other Areas Zone D” indicating an area of undetermined flood hazard. The area of Burke Creek from its existing outlet to Lake Tahoe to just upstream of the downstream most box culvert is classified as Zone AE which indicates a special flood hazard area with a base flood elevation. This area is part of the greater flood area that encompasses Lake Tahoe and shows a base flood elevation of 6232.3’ NAVD. The FEMA flood zone delineation appears approximate in nature and does not precisely line up with observed flood behaviors in the area.
