MIDDLE ROSEWOOD CREEK GEOMORPHIC AND RIPARIAN ASSESSMENT

Geomorphic and Riparian Vegetation Assessment

FINAL

November 30, 2005

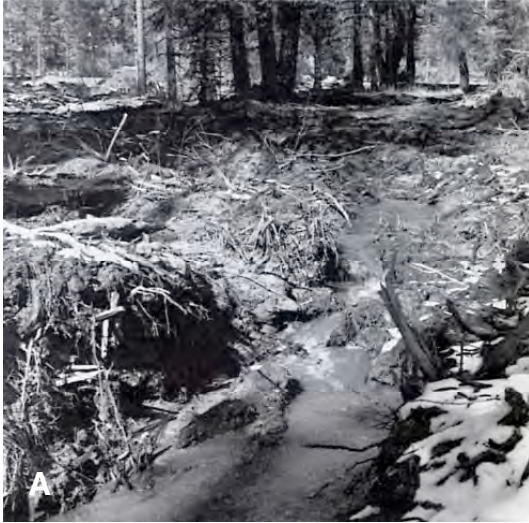
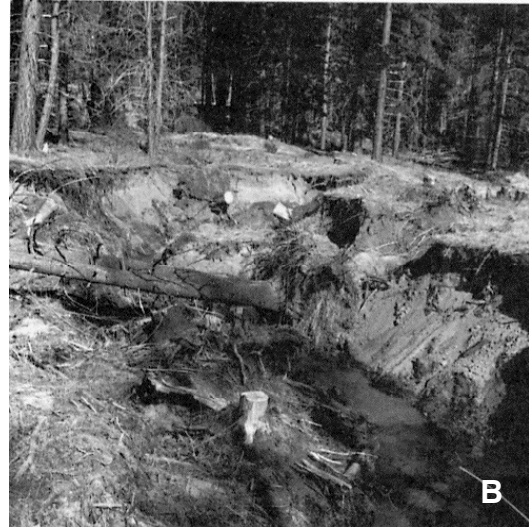
Land development progressed rapidly during the period between the late 1950s and early 1970s (Glancy, 1988). Photographs of land development activities adjacent to Rosewood Creek during the later part of this period (Figure 3A and B) show:

- SEZ Best Management Practice (BMP) measures within the SEZ were not used;
- Stream channel and stream bank disturbance was extensive; and
- Riparian vegetation was entirely removed.

These dramatic alterations to channel slope, geometry, bank stability and sediment supply provide an insight into the geomorphic and riparian condition and response of Rosewood Creek during the last 30 years.

Figure 3 A and B. Photos of Rosewood Creek showing SEZ impacts resulting from unregulated development activities. Figure 3A taken October 1969 of cleared subdivision; specific location unknown. Figure 3B taken April 1970 of relocated reach of Rosewood Creek upstream of confluence with Third Creek. Both photos from Glancy (1988).

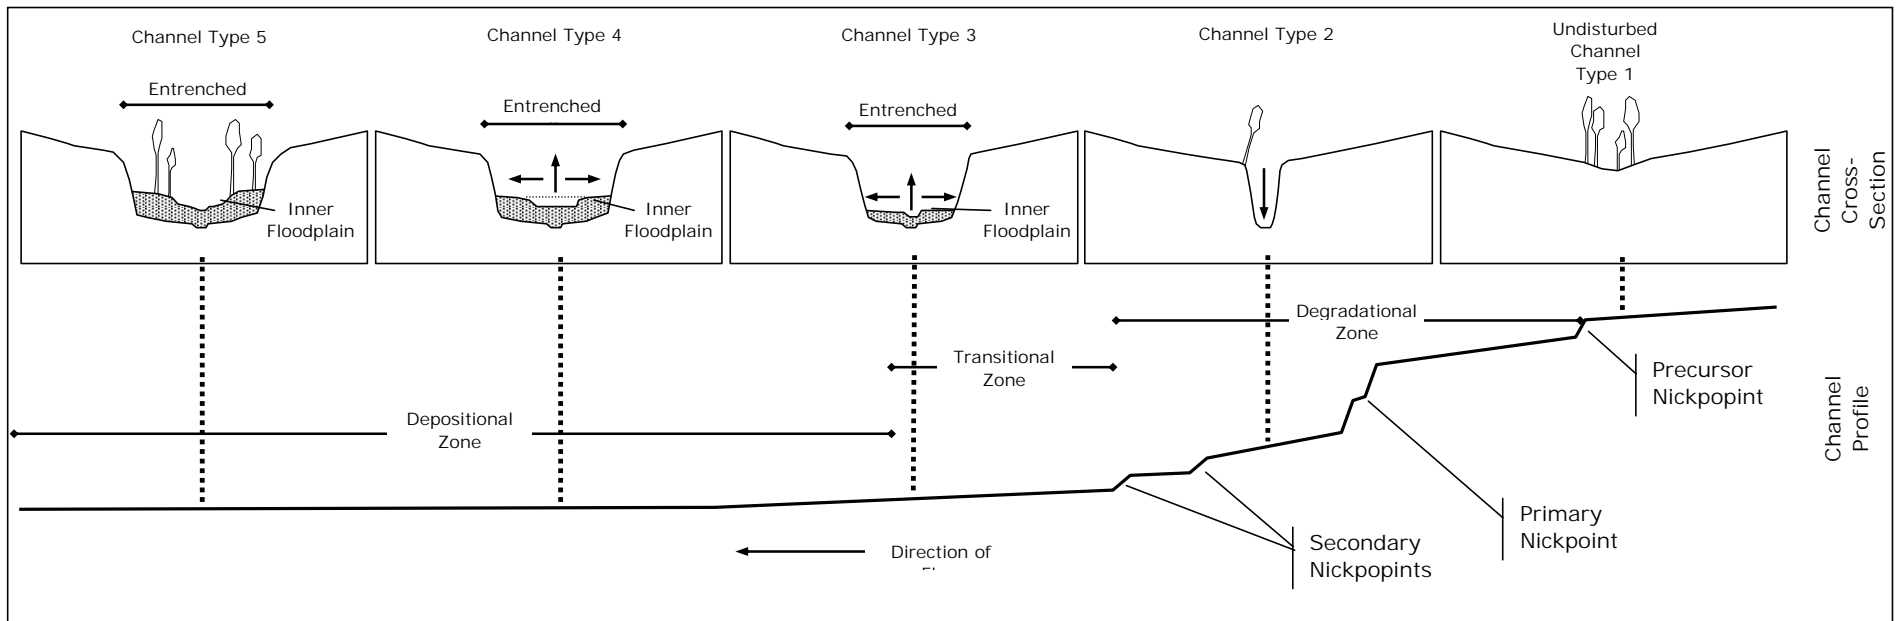
Researchers have proposed incised channel evolution models (reviewed by Darby and Simon, 1999), some involving channelized streams. The work by Schumm et al. (1984) provides the best representation of the multi-stage process through which incised channels progress from onset to natural recovery. This model has been modified to apply to the conditions found in Rosewood Creek; five steps in the incision process are identified (Figure 8):

- *Channel Type 1:* The channel is in an undisturbed state. The channel geometry is in dynamic equilibrium with flow and sediment. Healthy riparian vegetation exists. The floodplain is functional.

- *Channel Type 2:* Rapid downcutting of the channel bed results in over-steepened stream banks. The dominant progression of the channel bed is downward. The streambed profile exhibits pronounced nickpoints and associated

Figure 8. Incised channel evolution model, after Schumm et al. (1984). Arrows within the channel indicate the trend in adjustment.

grade instability. Riparian vegetation may be lost by physically falling into the stream, or may die due to water table lowering below the root zone.

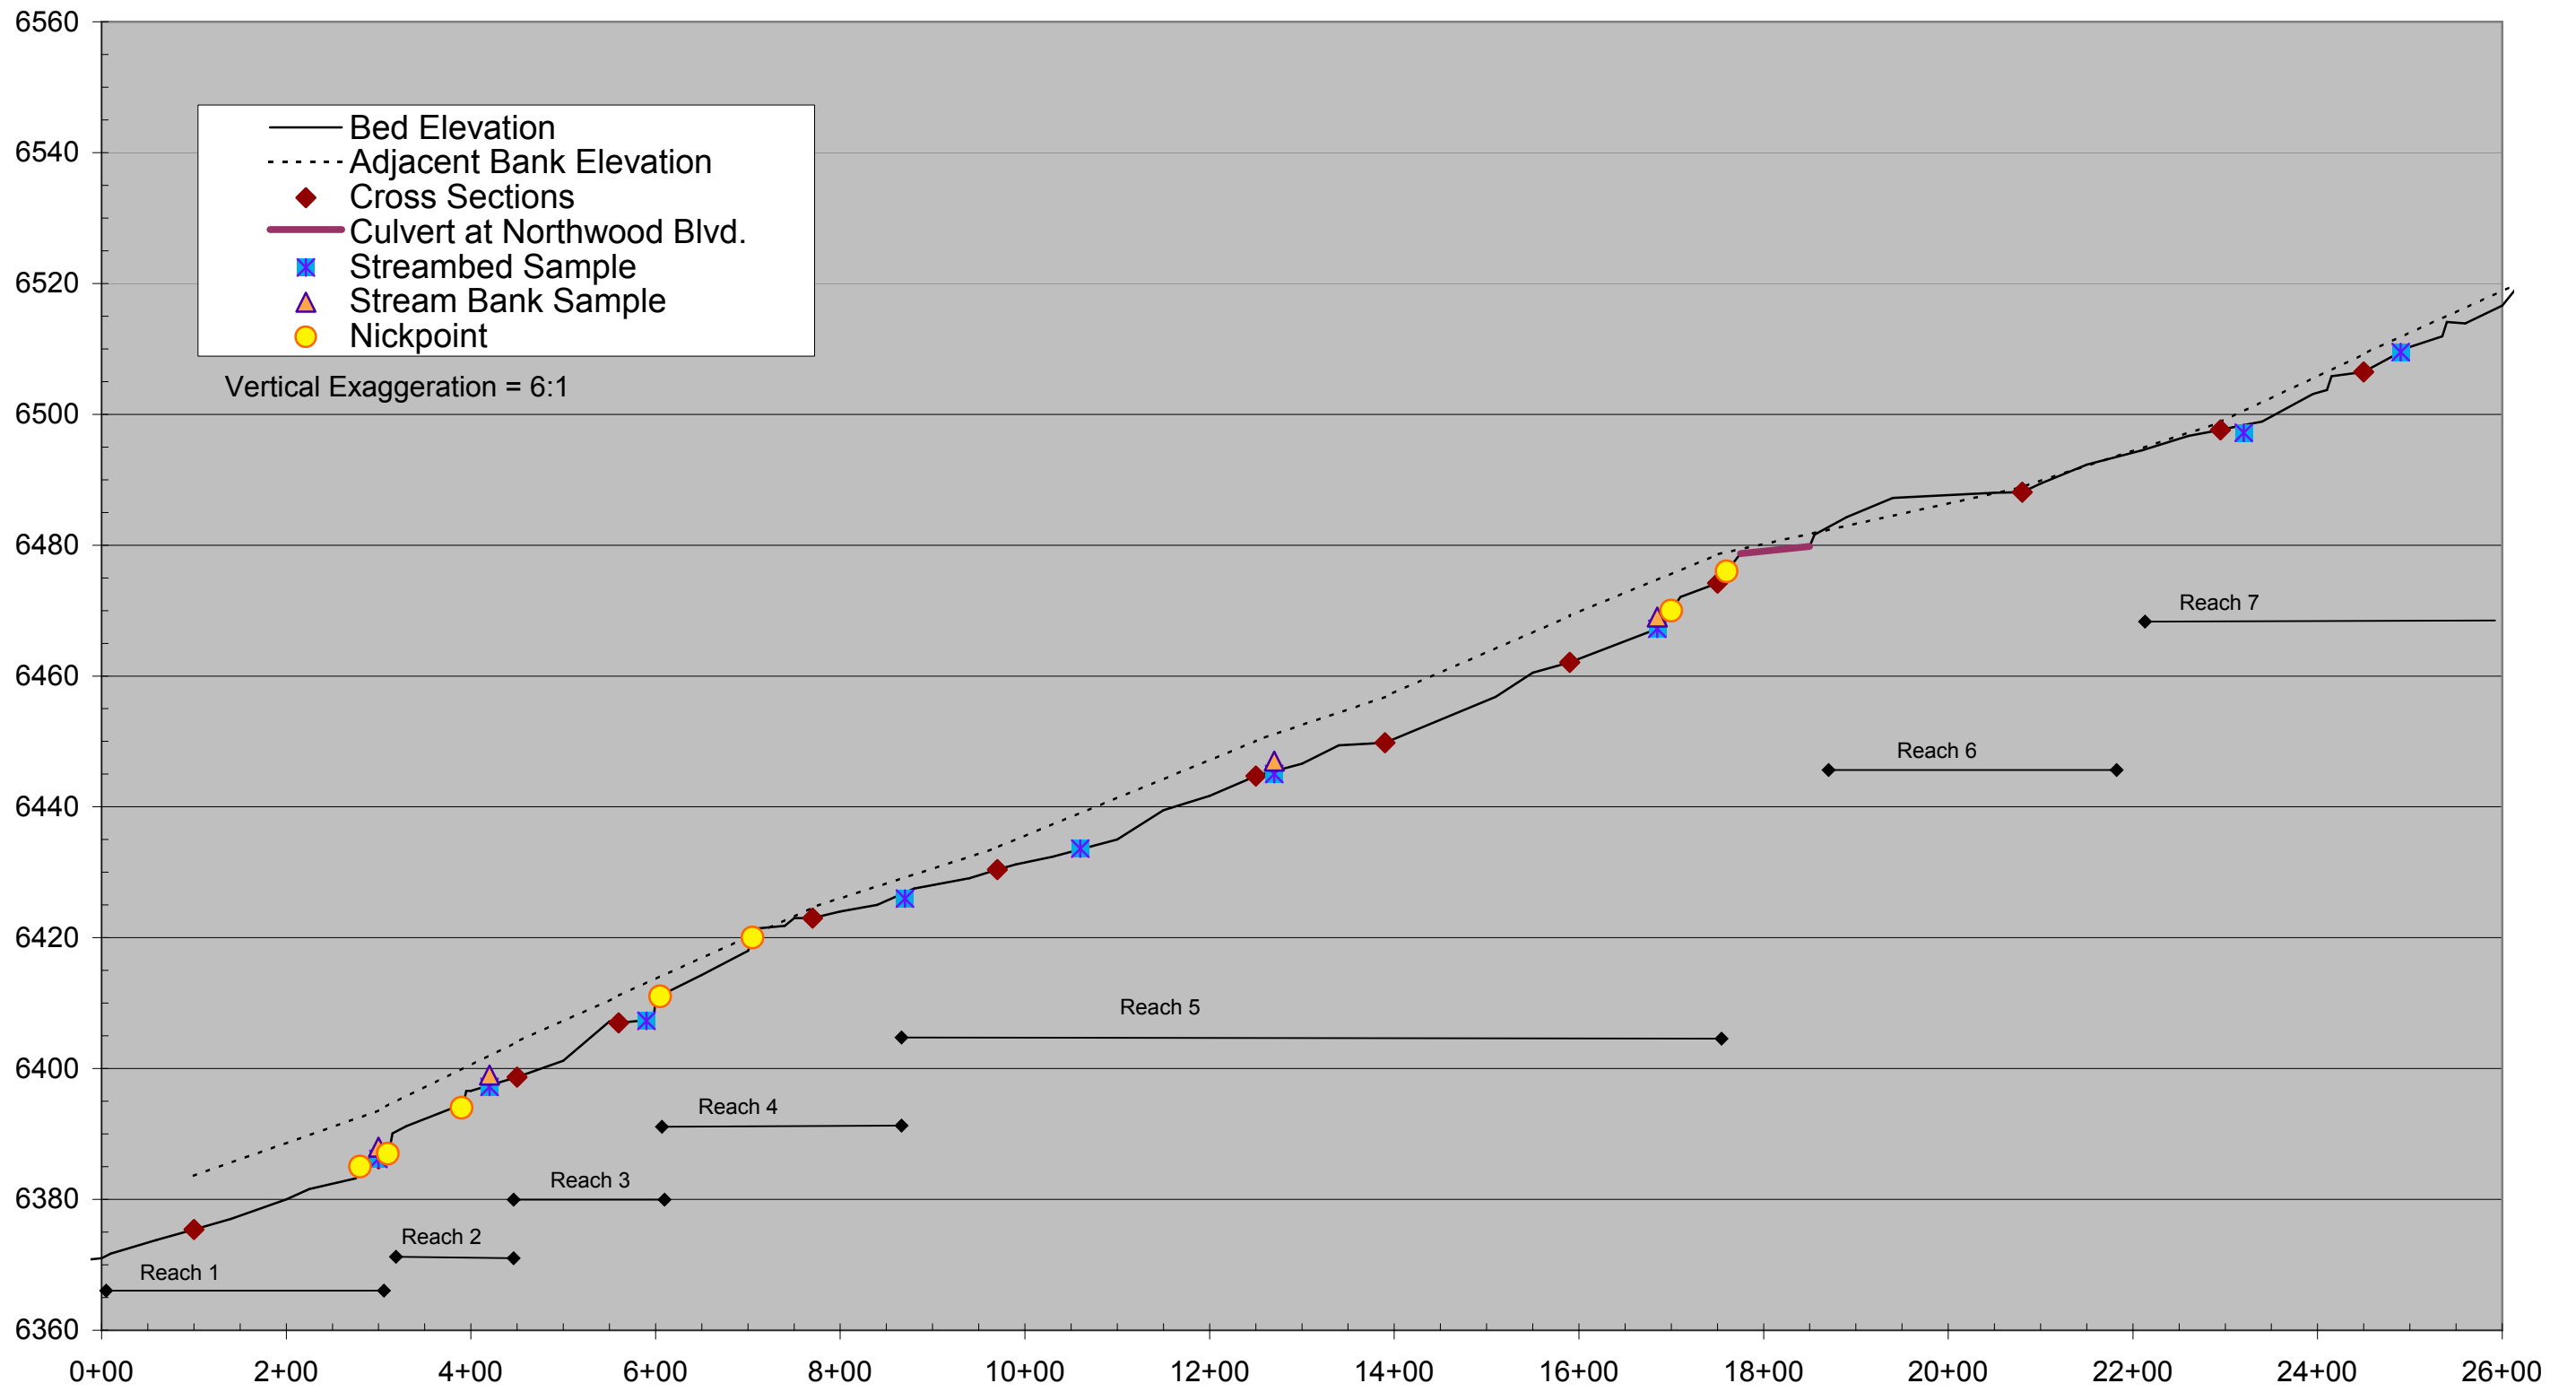
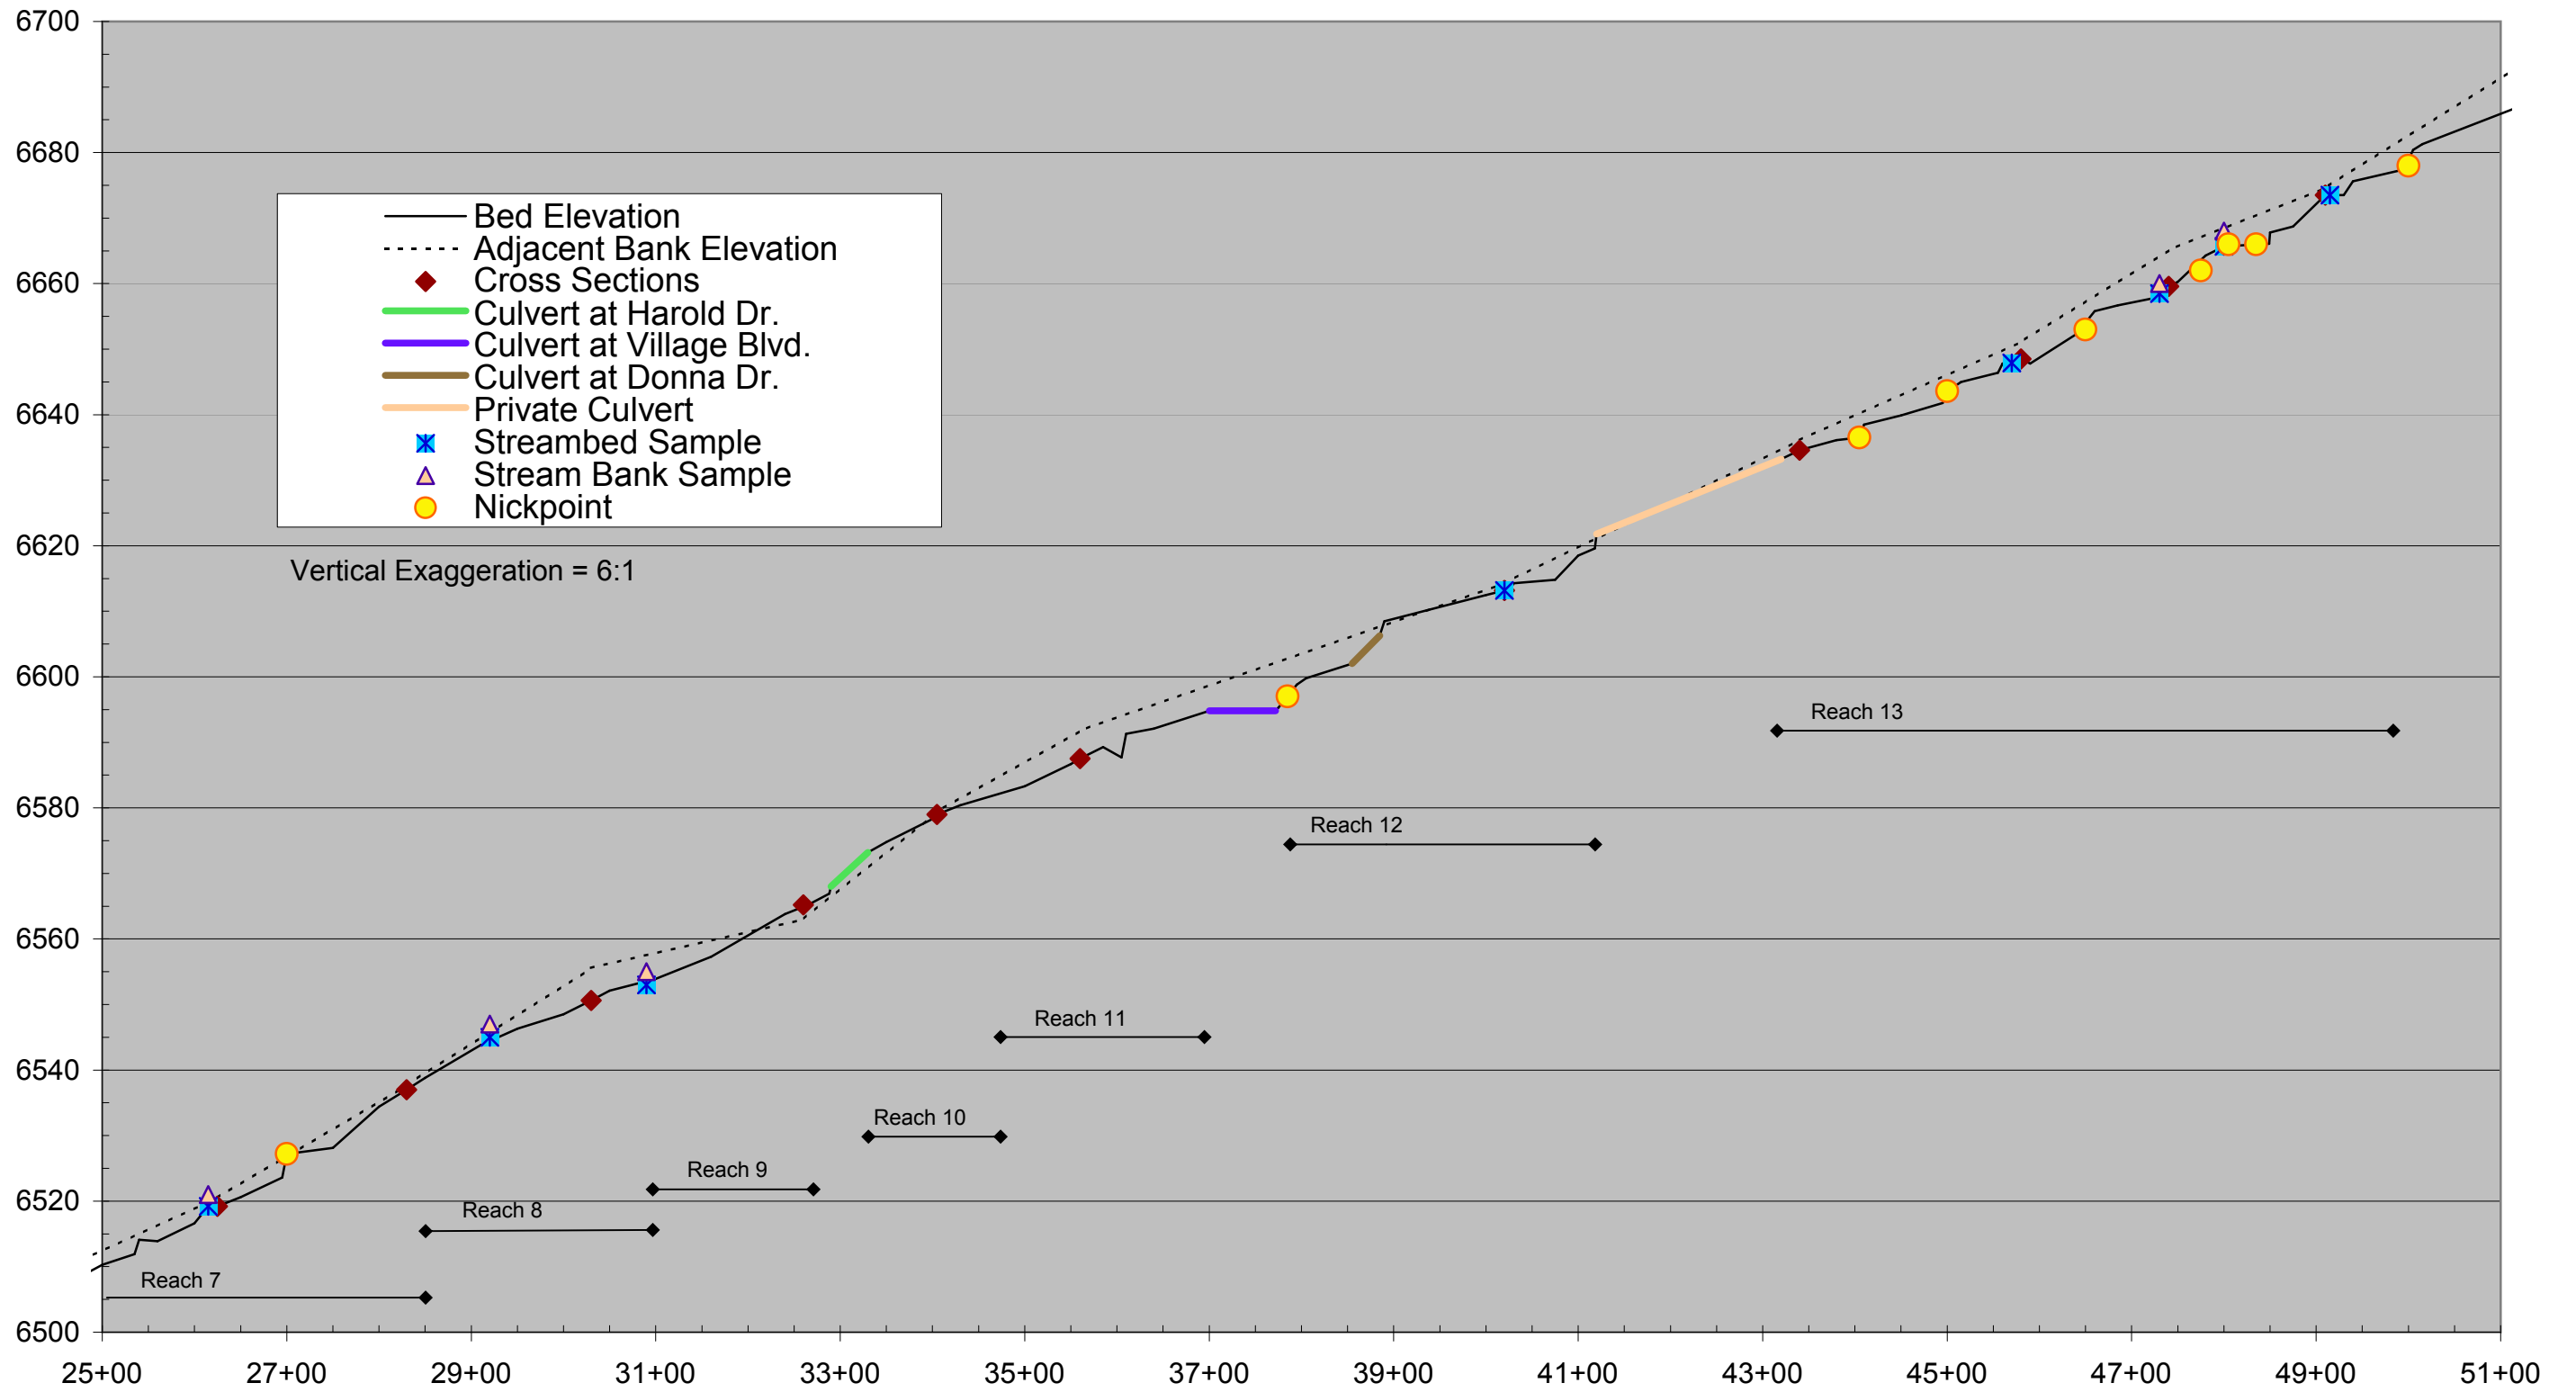
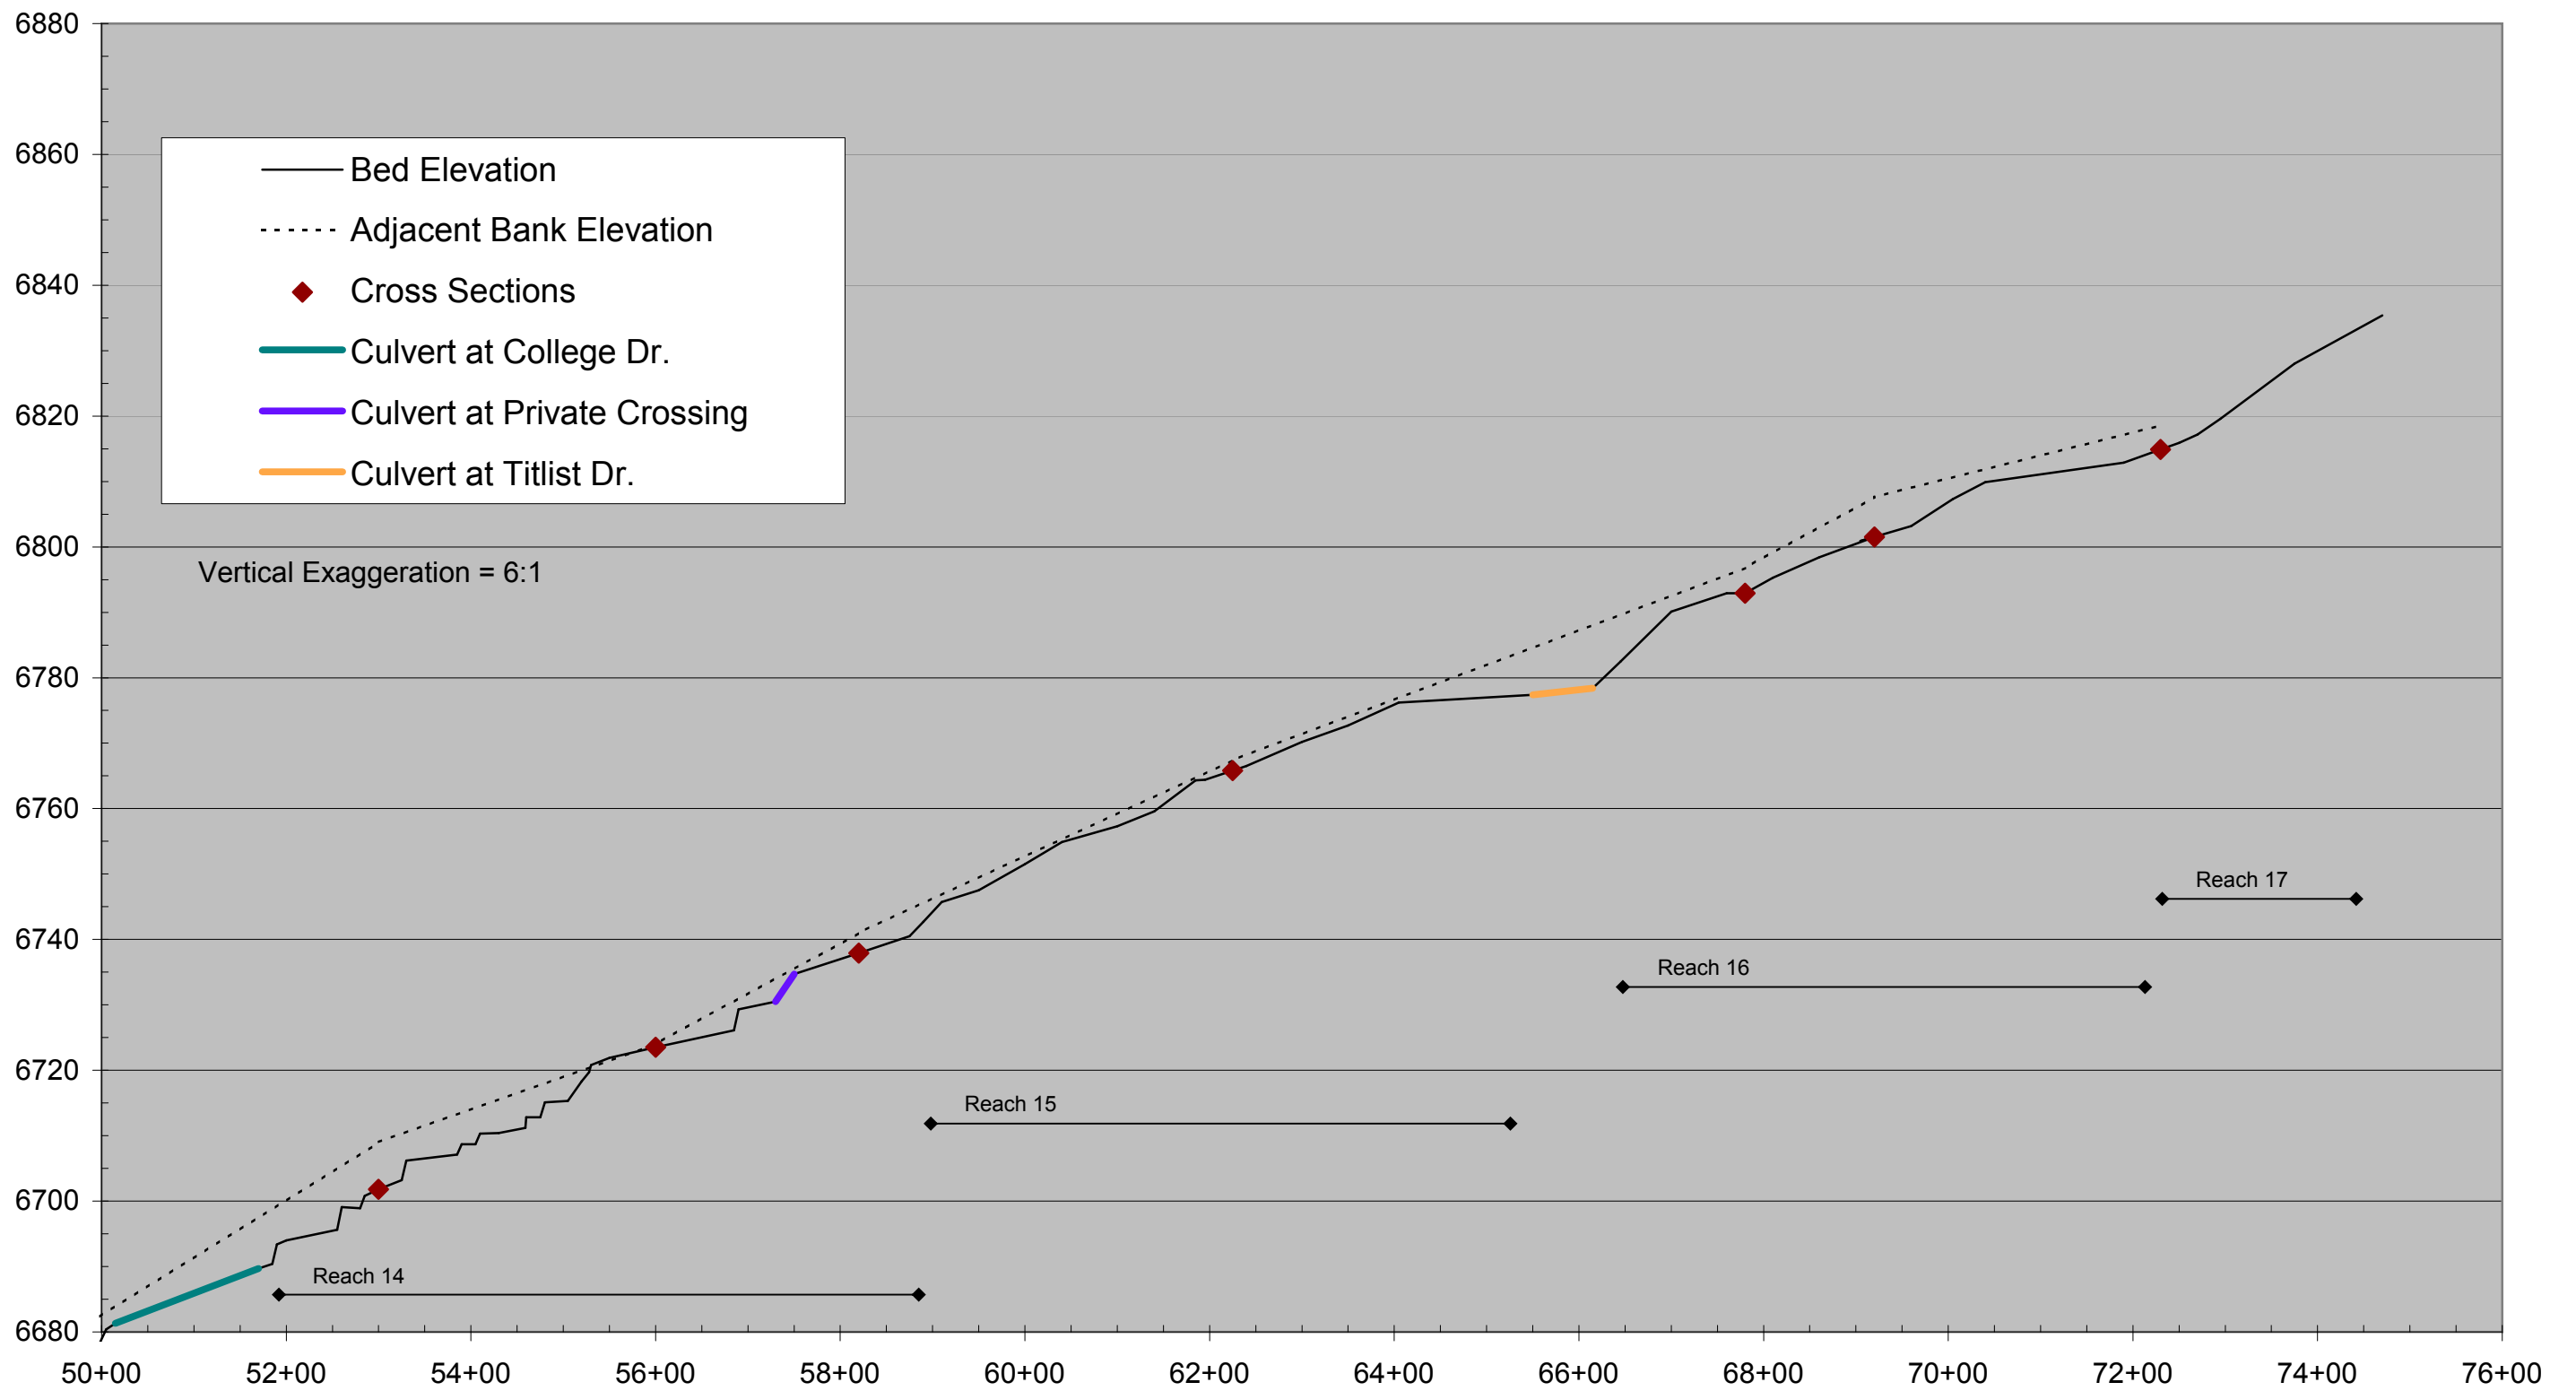
Figure 9A. Longitudinal Profile of Rosewood Creek

The longitudinal profile of the streambed of Rosewood Creek provides a graphical representation of the slope within each reach. Figure 9 shows the profile by station and reach. The adjacent bank elevation is shown; this is an approximation drawn from the cross-sections. The profile also indicates the culverts, observed nickpoints and locations of the streambed and bank sediment sample locations (discussed in a subsequent section).
