Cave Rock Community Stormwater Summary

Prepared for:

Cave Rock Estates General
Improvement District

Nevada Tahoe Conservation
District

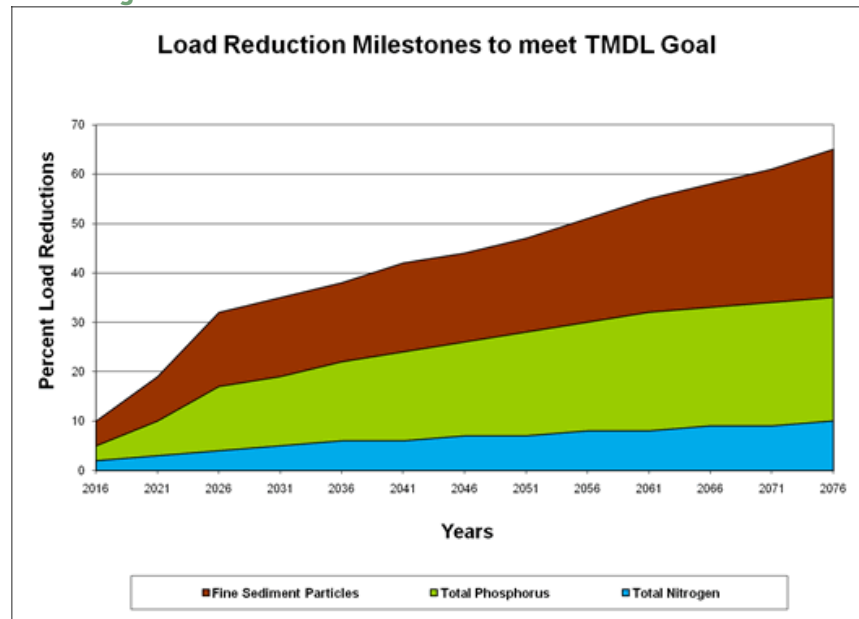
Figure 1: Load Reduction Milestones for Lake Tahoe

Lake Tahoe was designated as an impaired water body by the Environmental Protection Agency (EPA) in 1988. One of the requirements after designation is the creation of a Total Maximum Daily Load (TMDL) which set limits on the total amount of pollutants a water body can receive and still meet safe water standards. In 2011, after much research and development, a TMDL for Lake Tahoe was approved. The goal of the Lake Tahoe TMDL is to restore the Lake to its historic water clarity level of 97.4 feet. It established thresholds of pollutants (namely fine sediment, nitrogen and phosphorus) and calculated the load reductions needed from the four largest sources (urban and forest stormwater runoff, stream channel erosion, and atmospheric deposition) to achieve the TMDL by 2076. The Clarity Challenge was created as an interim goal to the TMDL numeric target. This goal is to meet a target of 78 feet of lake clarity by 2026 and considers opportunities for achievable load reductions in all source categories.

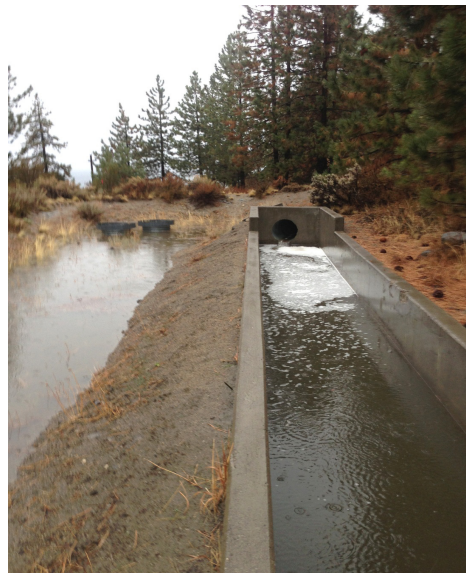
Figure 2: CRE Stormwater System 2011

Cave Rock Estates is an area with steep, rocky slopes and minimal places to infiltrate stormwater runoff. These geographical barriers have made this location an appropriate place to consider larger, area-wide treatments. The Cave Rock Estates Erosion Control Project (1990), Slope Protection Project (2003), and Bed Filter Retrofit (2014) were large capital improvement projects that installed treatments to control the sediment load that comes from this area.

The Cave Rock Estates Erosion Control Project (EIP #10078) was completed. This project created a conveyance system to move the bulk of Cave Rock Estates stormwater runoff to 2 basins in Cave Rock Estates; a detention basin at the bottom of the subdivision and an infiltration basin on Chukkar in the upper area of the GID. The detention basin's runoff joins with Nevada Department of Transportation (NDOT) stormwater runoff, and sent through two deep sediment traps before entering Lake Tahoe.

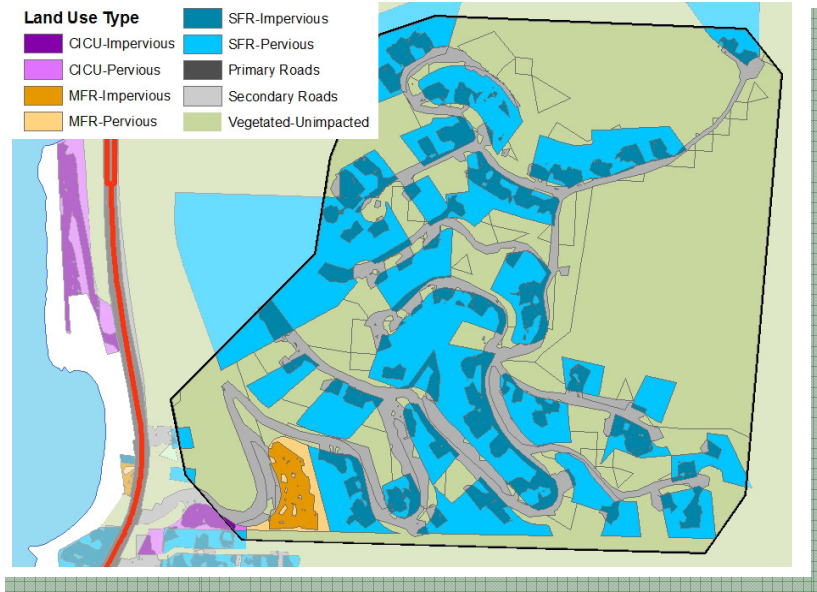
Figure 4: Land Use - 88.74 Total Acres

More than half of the area is comprised of open space owned by federal, state, and local entities. Single family residences comprise 38% of the area with only an additional 2% contributed by multi-family residences (MFR).

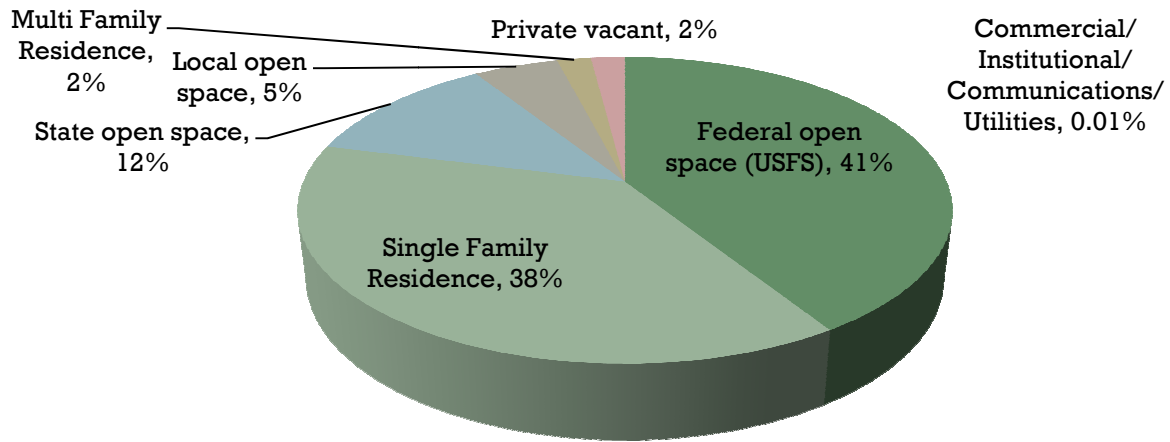
Figure 5 & 6: Parcel Ownership - 74.5 Total Acres without roads

22.5% Impervious
77.5% Pervious

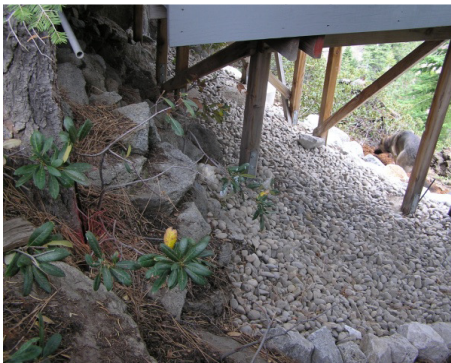
Figure 14: Armor under elevated

In conjunction with the community-wide stormwater treatment systems, single family residences (SFRs) and multi-family residences (MFRs) are working to complete and maintain their private parcel BMPs. The community system accepts and treats homeowner's driveway runoff that flows off of property, but homeowners are still required to armor drip lines and elevated structures and implement slope stabilization measures. In November 2013, all homeowners in the Cave Rock Estates community received an email through the CREGID board and a letter from TRPA consisting of a packet of information detailing the BMPs recommended for their area (pages A11-21). Maintenance of existing system includes refreshing drip lines, decks and impervious surfaces on the property, and tending to bare soil and steep slopes. Driveways that flow to the street can allow their water to discharge into the street. If the driveway flows onto the property, armor needs to be maintained in the area that water exits the driveway.

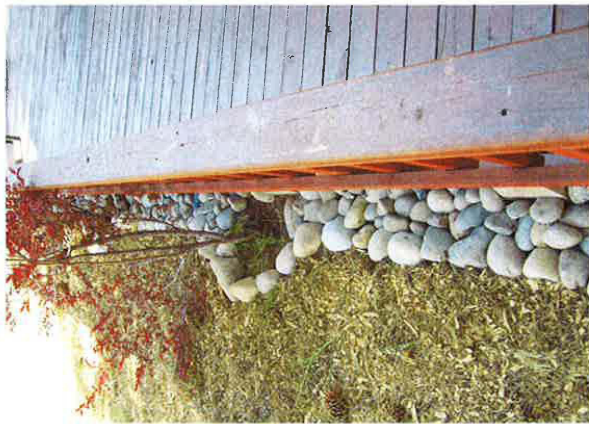
Erosion Control at Perimeter of Low Deck

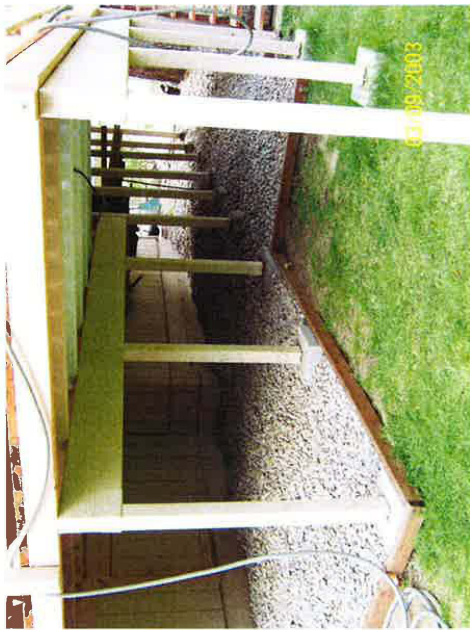
Erosion Control under Elevated Deck

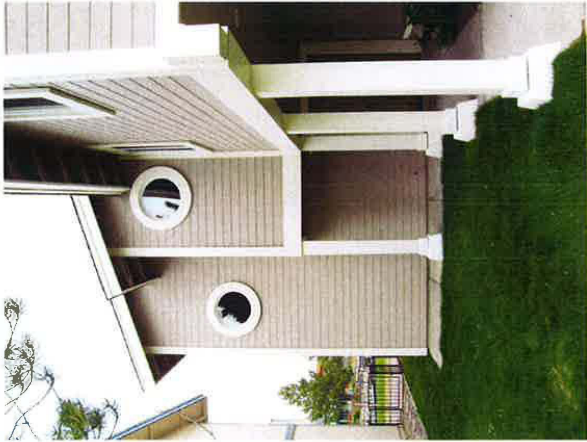
Roof Runoff Infiltrates in Turf

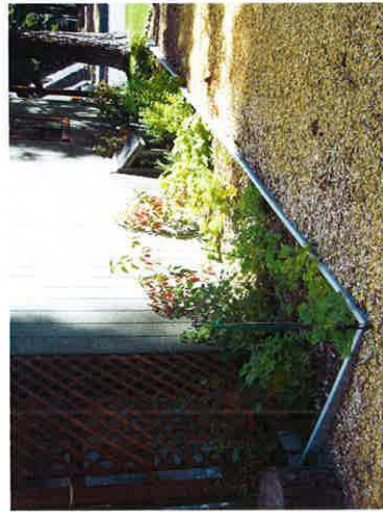
Roof Runoff Infiltrates in Vegetated Bed

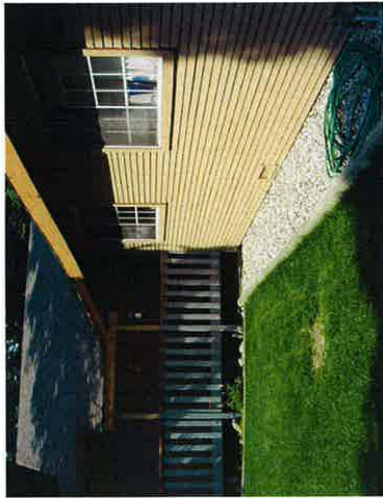
Roof Runoff Infiltrates in Rock Armor

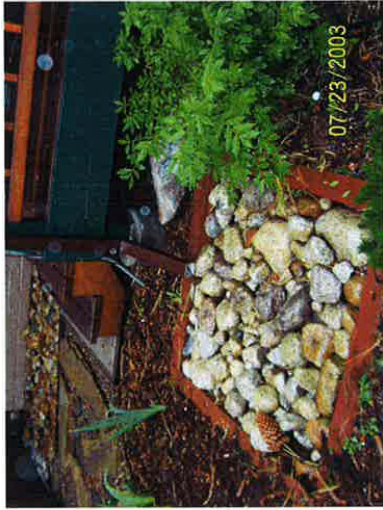
Roof Runoff Infiltrates in Energy Dissipater under Gutter Downspout
